**REQUEST FOR PROPOSALS FOR
TEMPORARY EMERGENCY
GENERATION**

COSTA SUR RECOVERY PROJECT REPORT

Strategic Action Plan
Condition Assessment, Value Engineering and Decision Making
Restoration of Lost Power Capacity at Costa Sur Power Plant (CSPP) due
to Earthquake Damages

***Emergency Structural Inspection and Assessment
Preliminary Report of Immediate Remediation Needs
And Repair Approach
1-30-20***

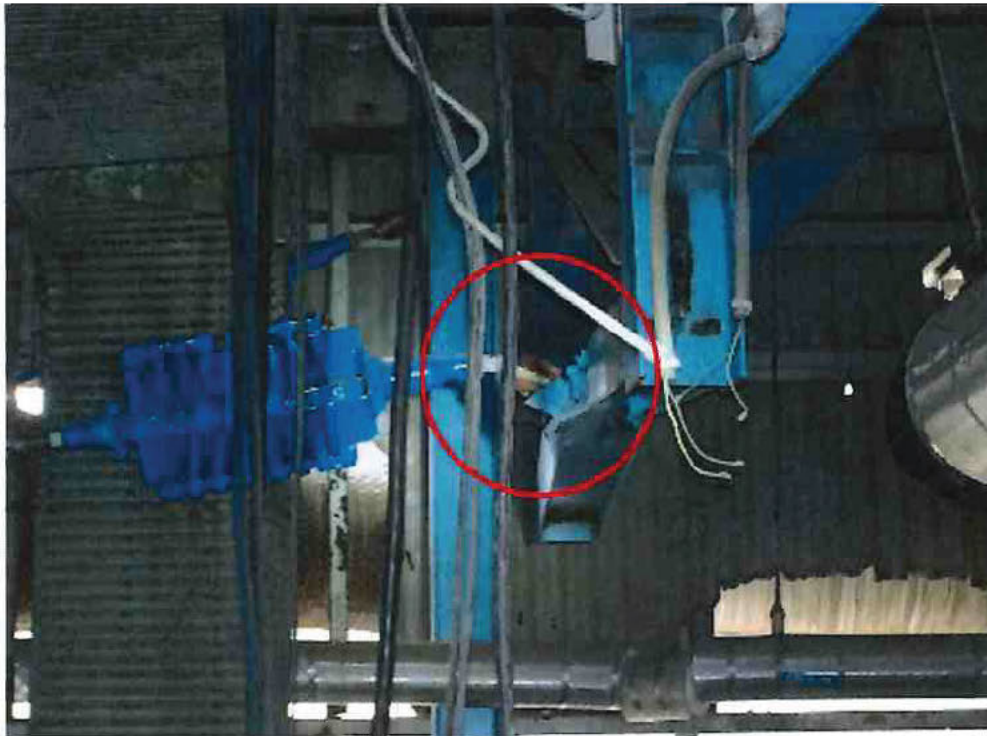
**Bent WEAR Restraint rod and I-beam.
Risk of damage to MS pipe supports
and added stress of MS pipe during
major wind or seismic event.**

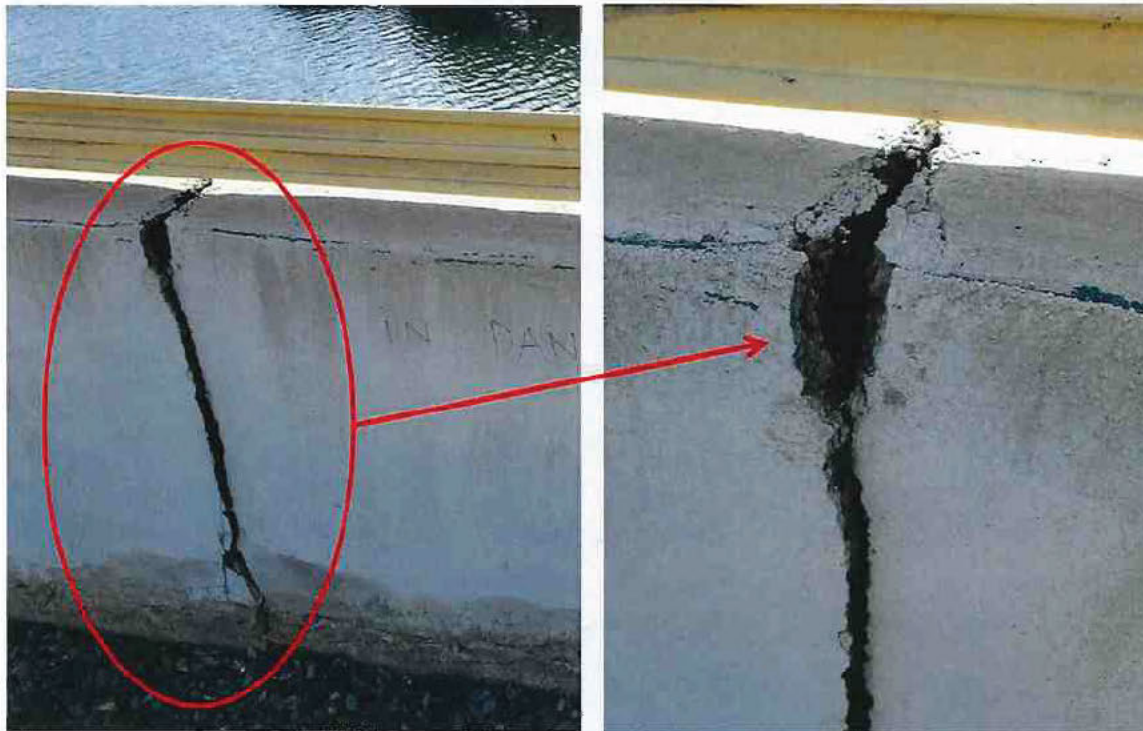
20 ft wall segment with structural damage. Structural cracks form top to bottom on cold joints at both ends.

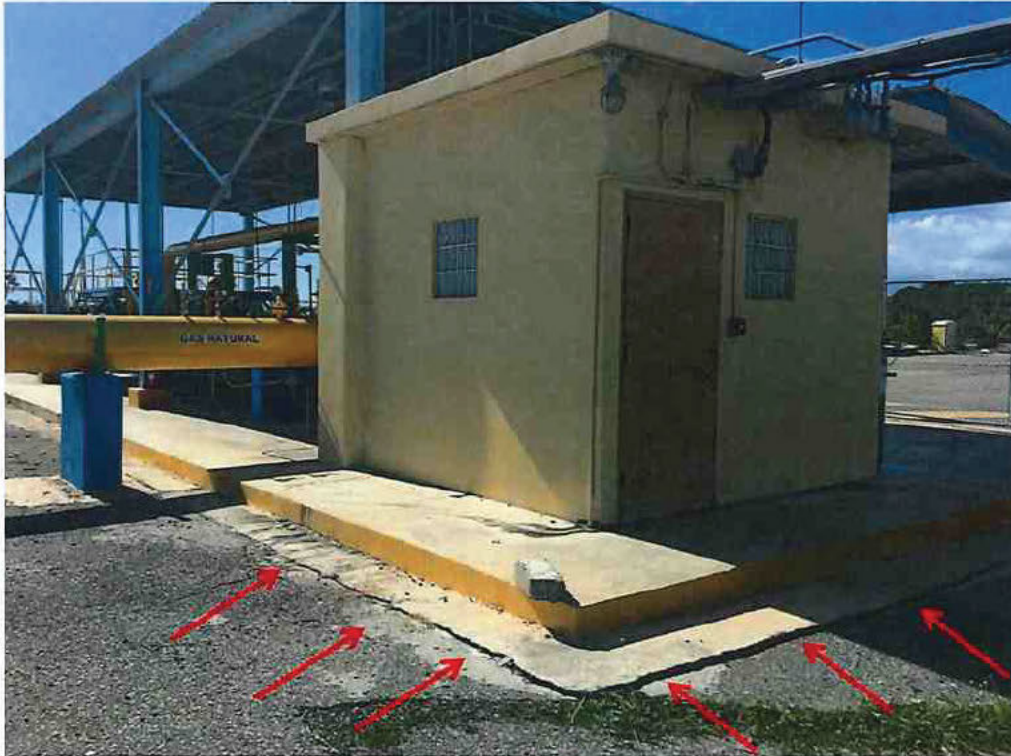
Major crack under gas metering station area

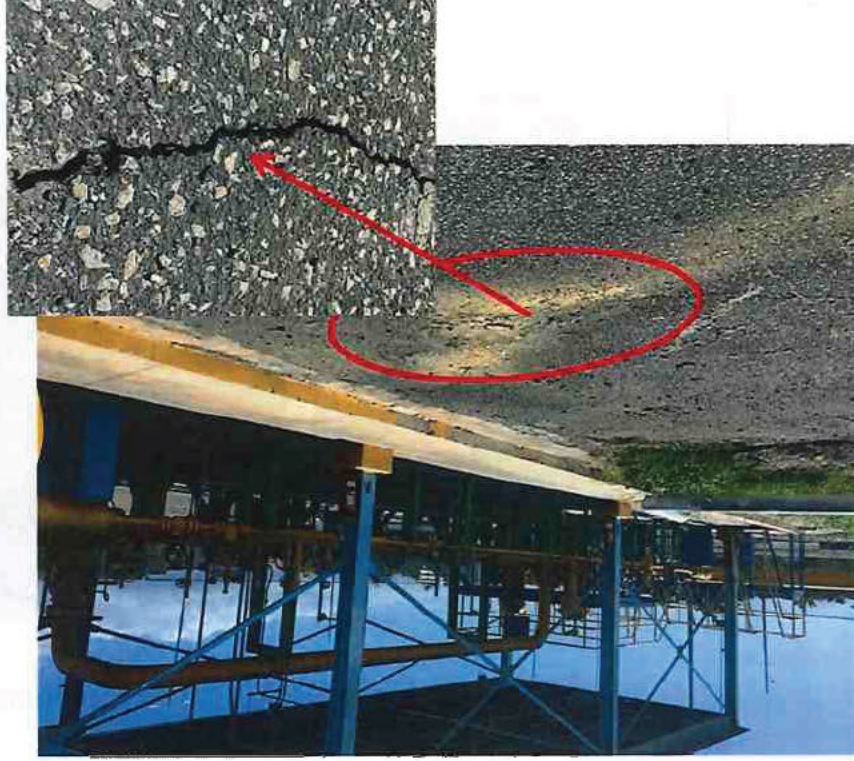
Major crack under gas metering station area

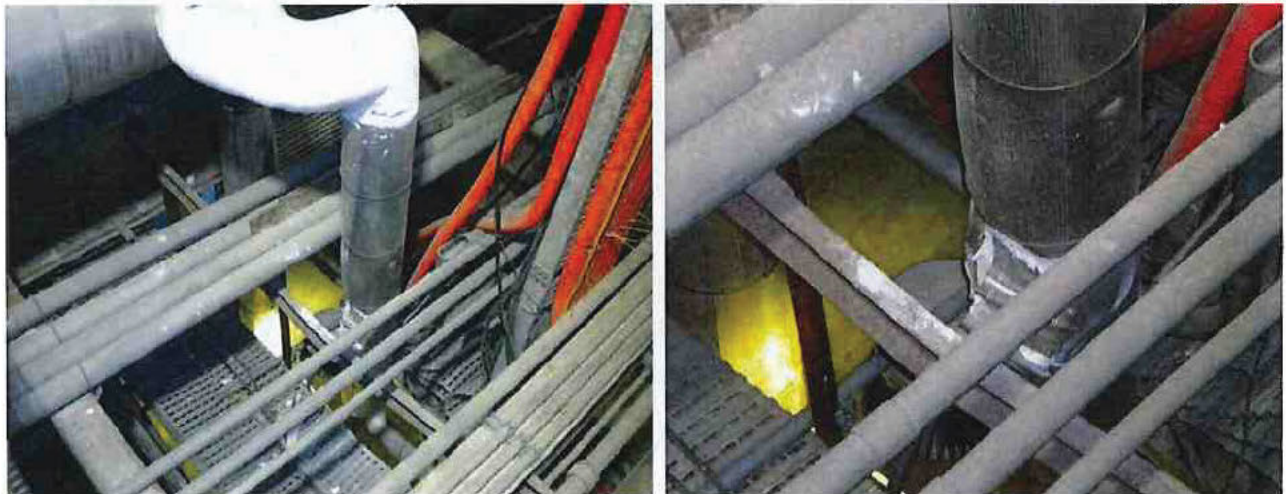
Photo 14- U-5 Bent Channel from Displacement of the Hot Suction Branch Line

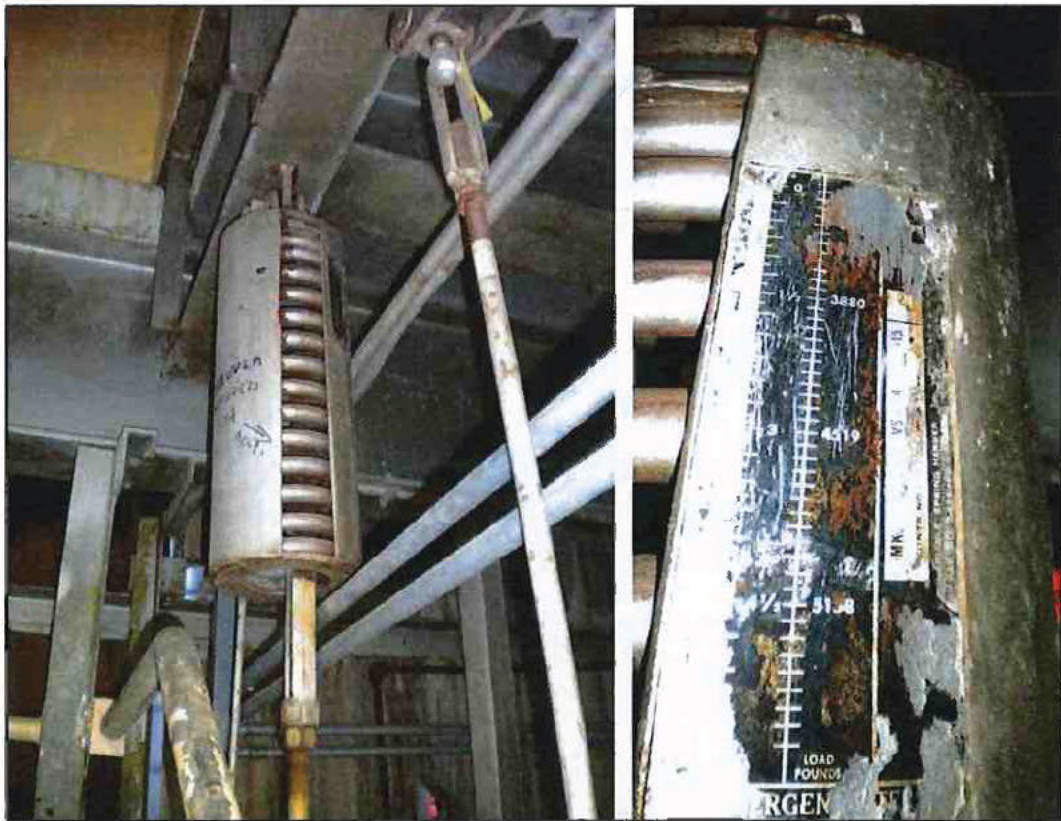
Photo 15 - U-5 Condensate to Deaerator Failed Spring Hanger

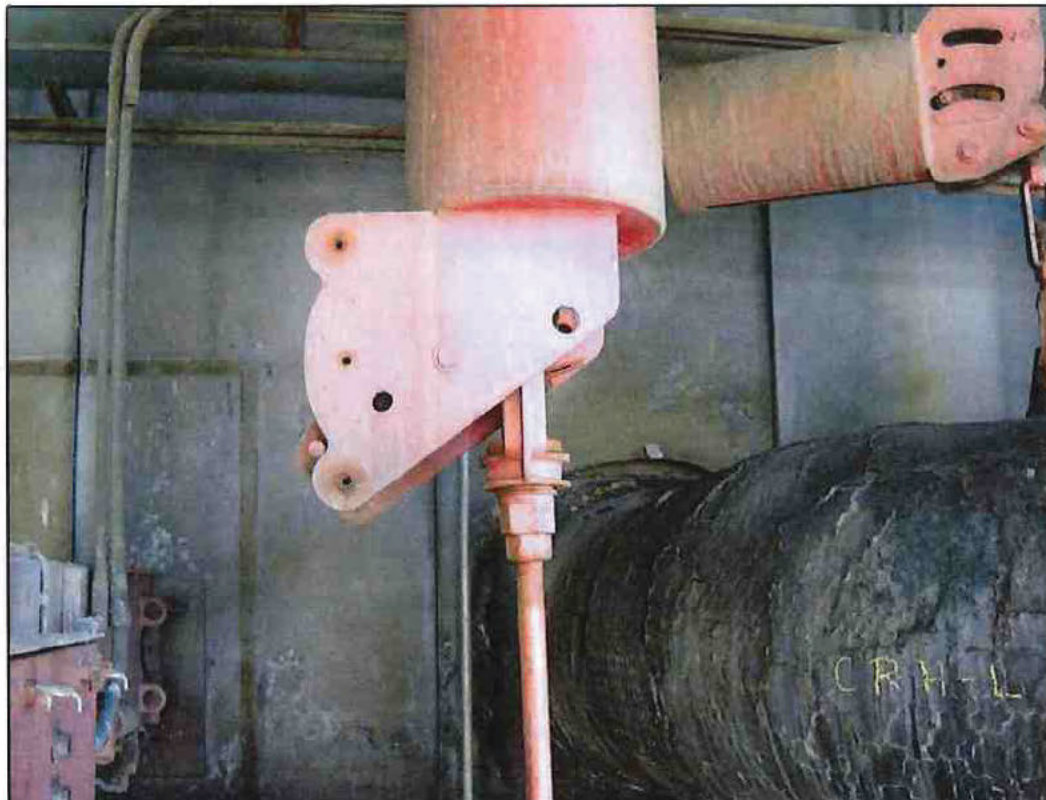
Photo 26 - U-6 Topped Out BF Hanger BF-2

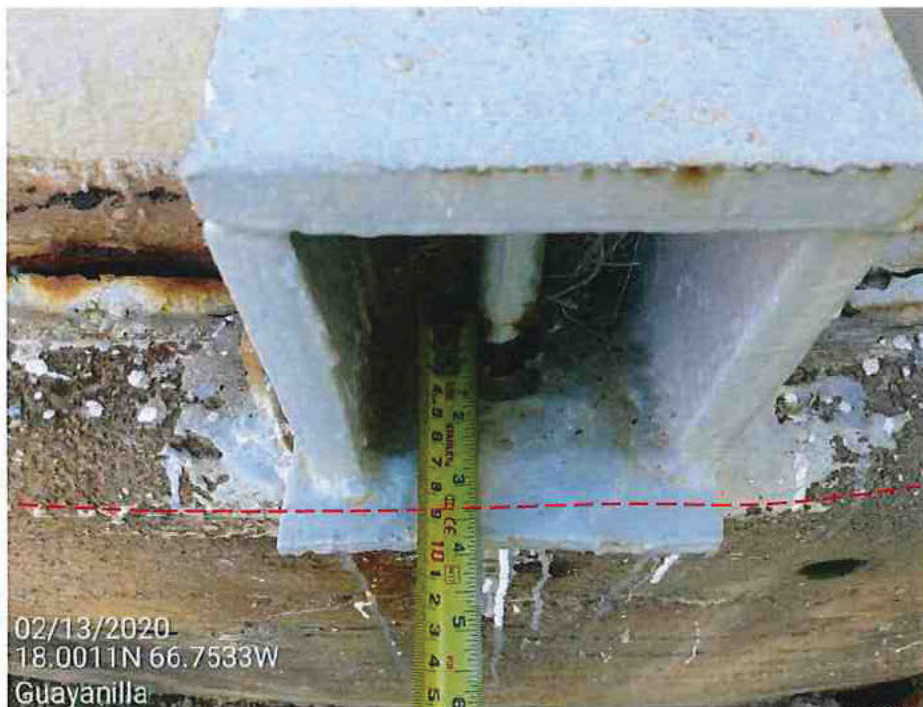
Picture 9 – Anchor bolt center is about 3.25" to 3.5" clear cover, from foundation exterior face.

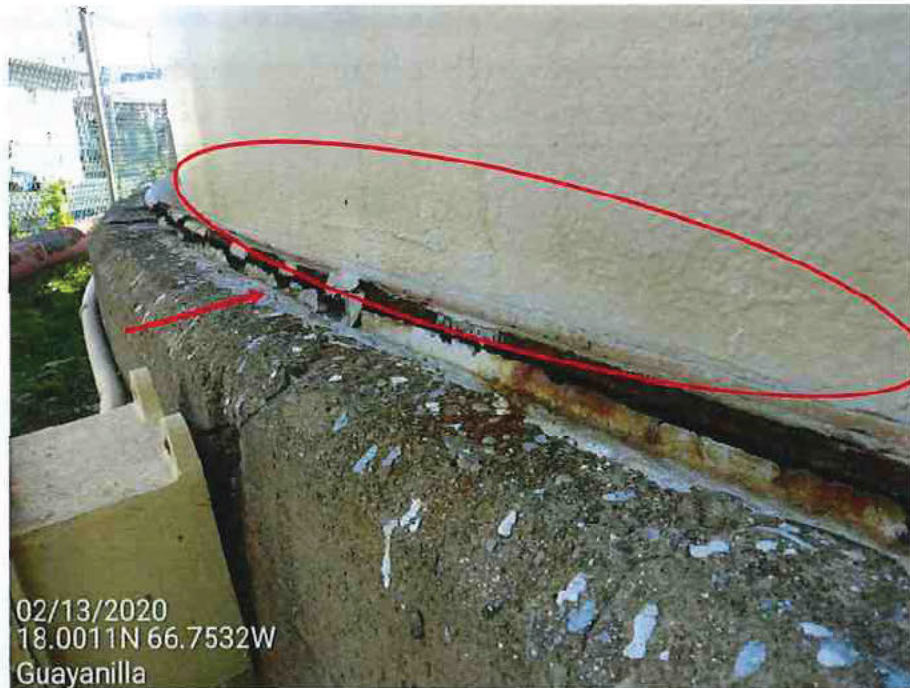
Picture 10 – Tank bottom seal joint cracked and tank shell have elephant foot buckling areas at first ring, due to seismic overturning moment.

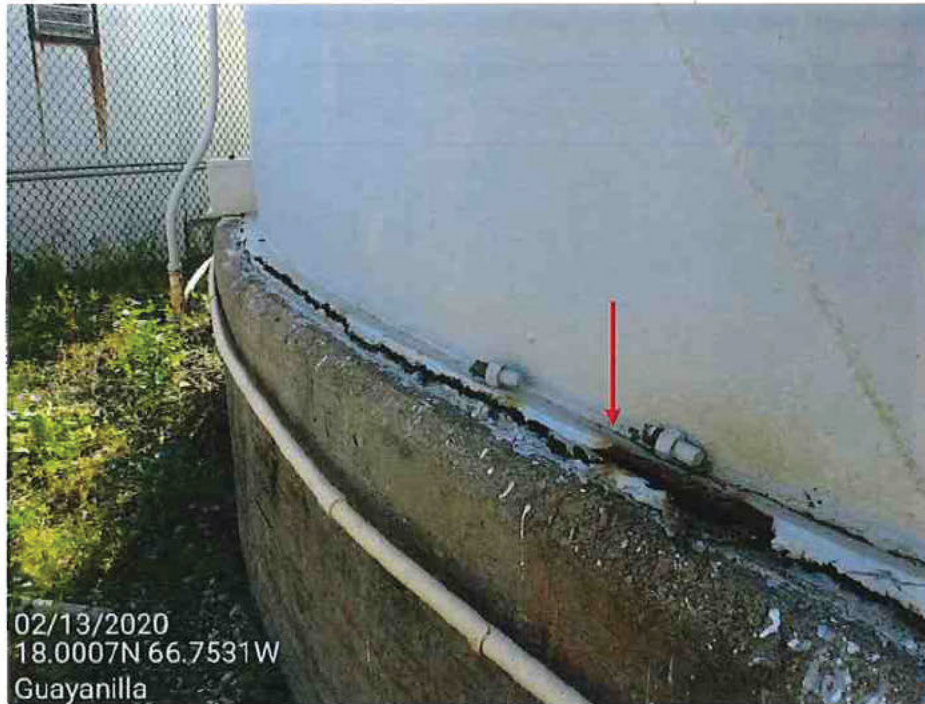
Picture 12 – Tank bottom seal joint cracked.

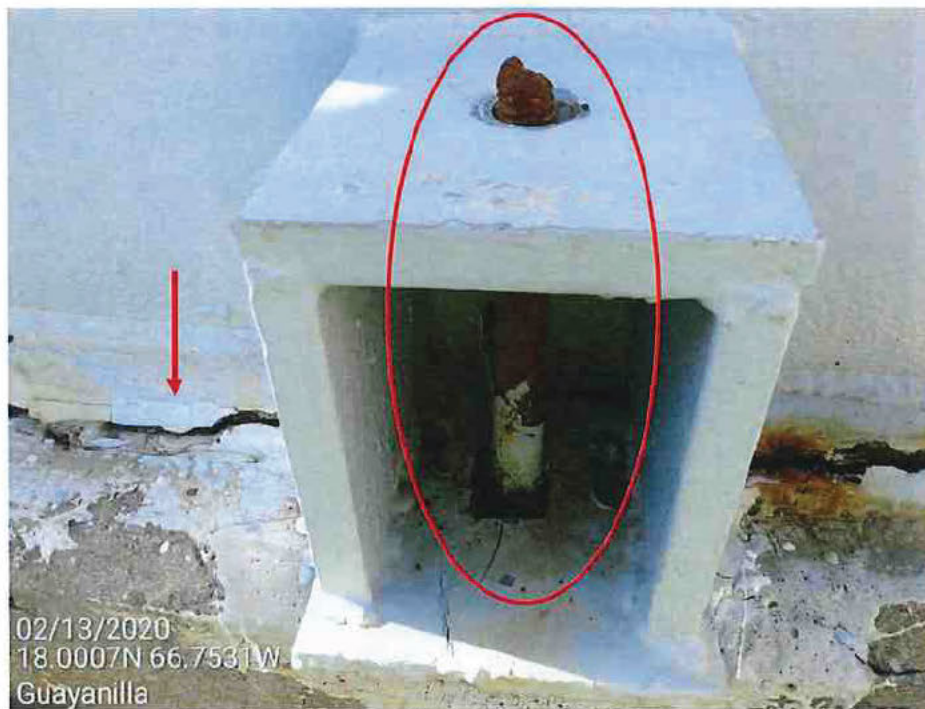
Picture 13 – Anchor bolt nut failure due to seismic overturning moment.

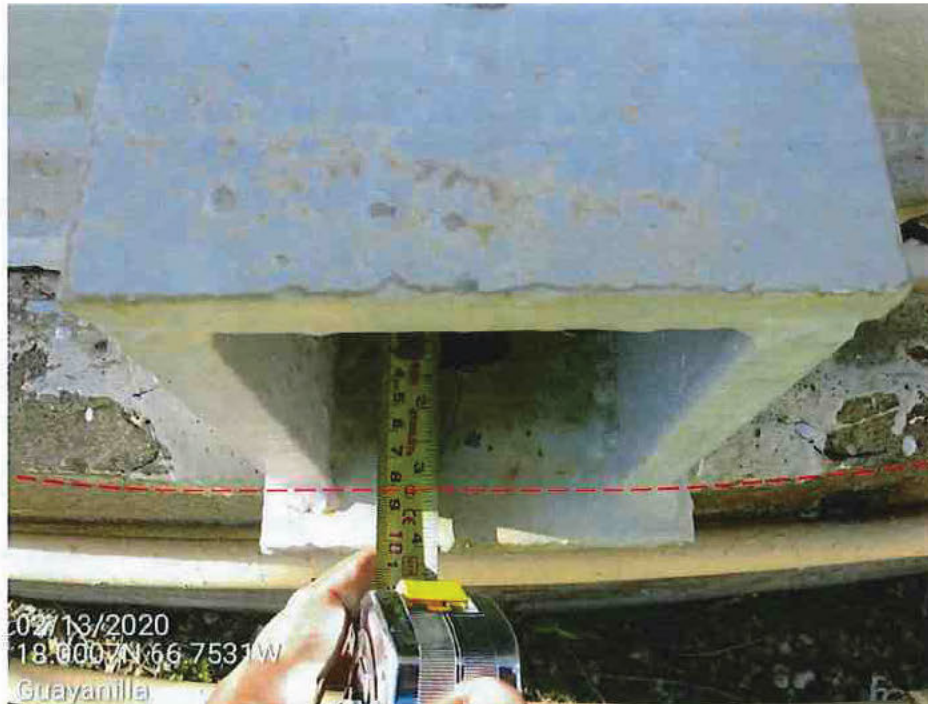
Picture 14 – Anchor bolt center is about 3" to 3.25" clear cover, from foundation exterior face.

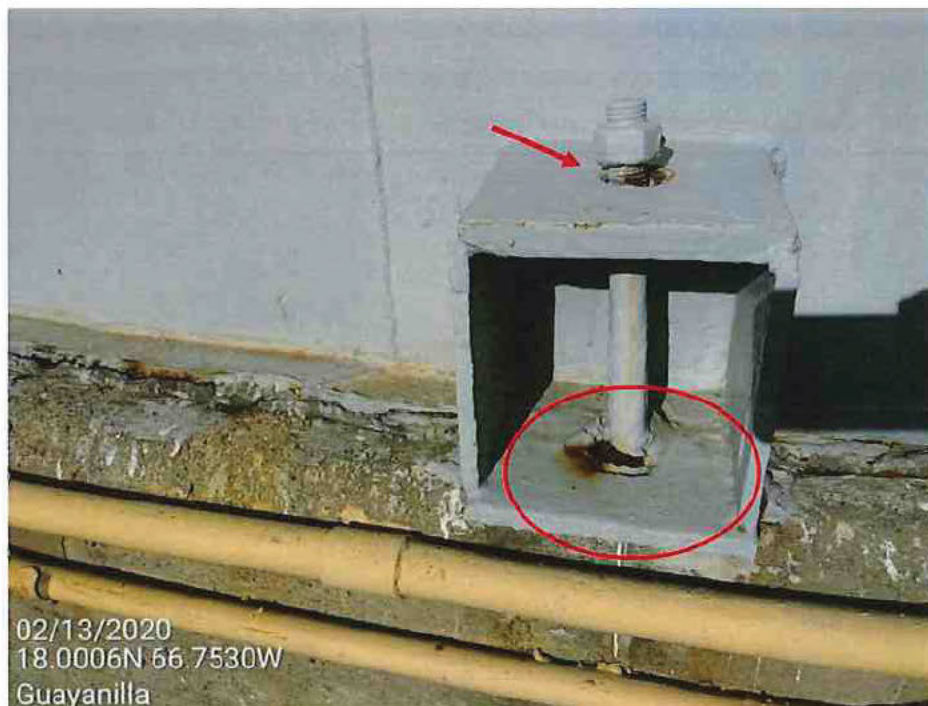
Picture 18 – Anchor bolt corrosion signs and loose anchor bolt nut from anchor chair assembly. Anchor appeared to have elongated due to tension forces.

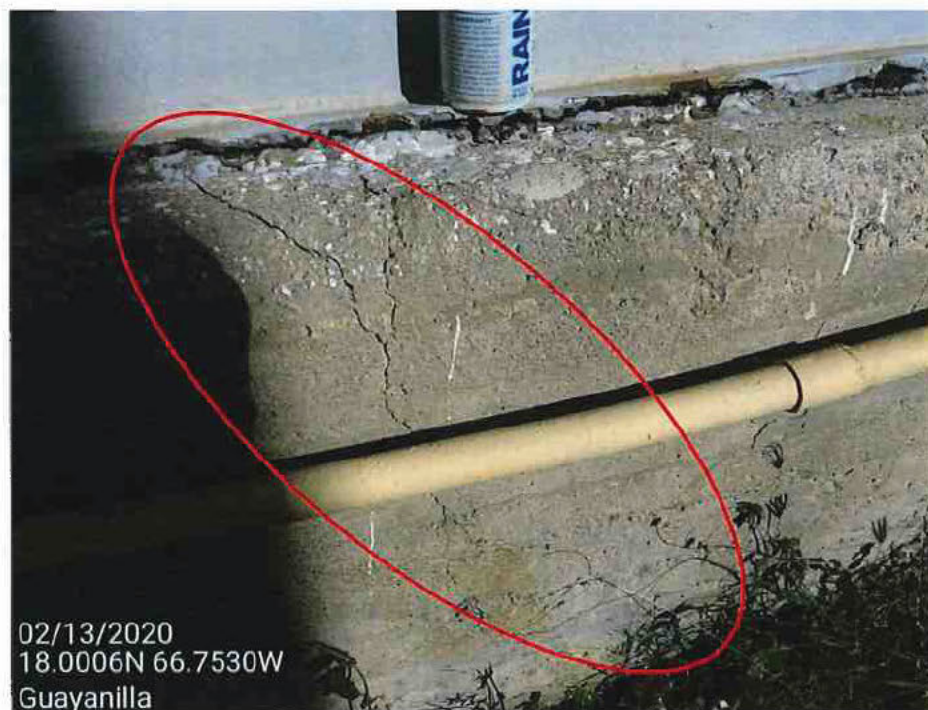
Picture 19 – Concrete foundation base cracked.

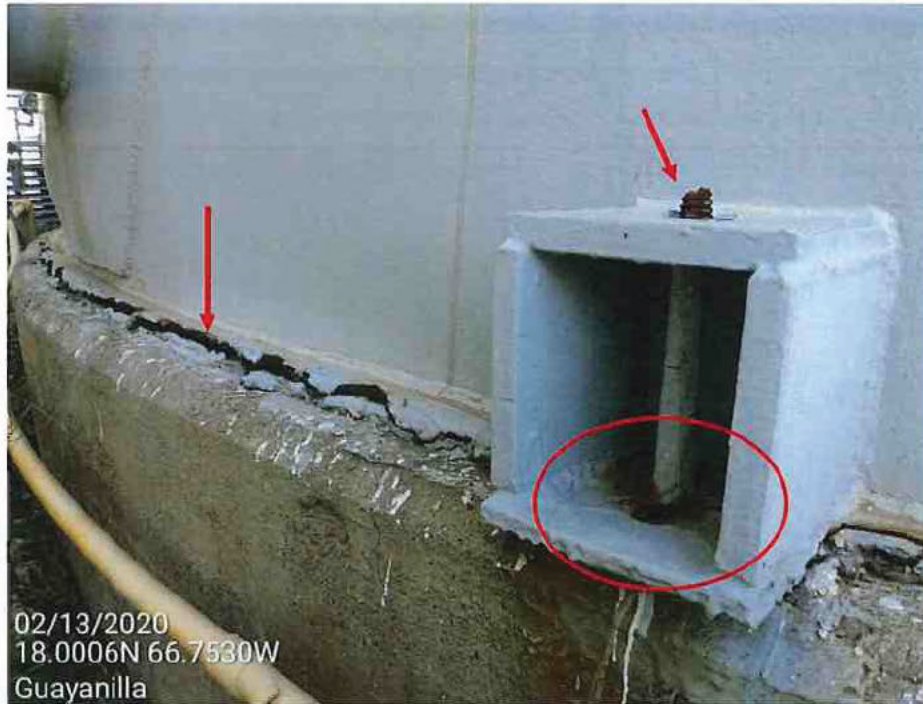
Picture 20 – Tank bottom seal joint cracked, anchor bolt nut ripped off due to seismic overturning moment. Anchor bolt has corrosion.

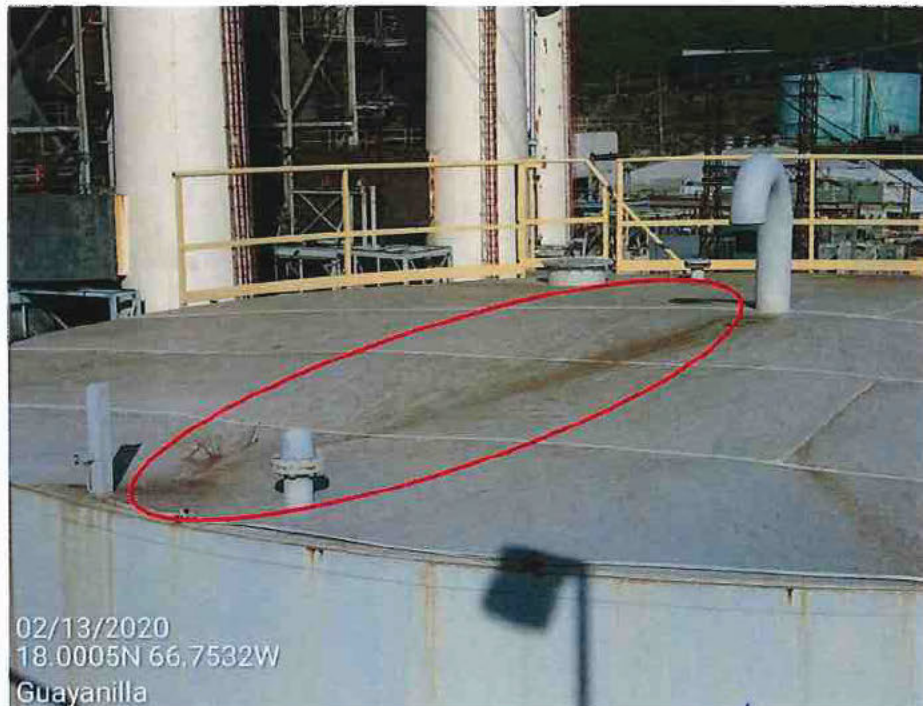
Picture 21 – Condensate Tank 5 roof paint deterioration, corrosion signs and partial roof collapse.

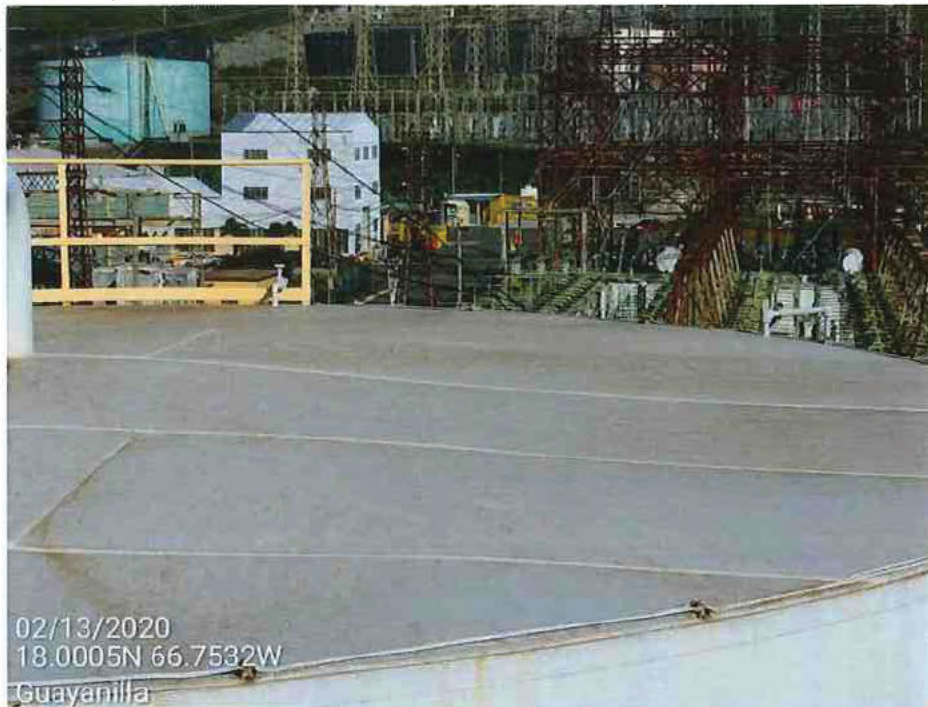
Picture 22 – Condensate Tank 5 roof paint deterioration and corrosion signs.

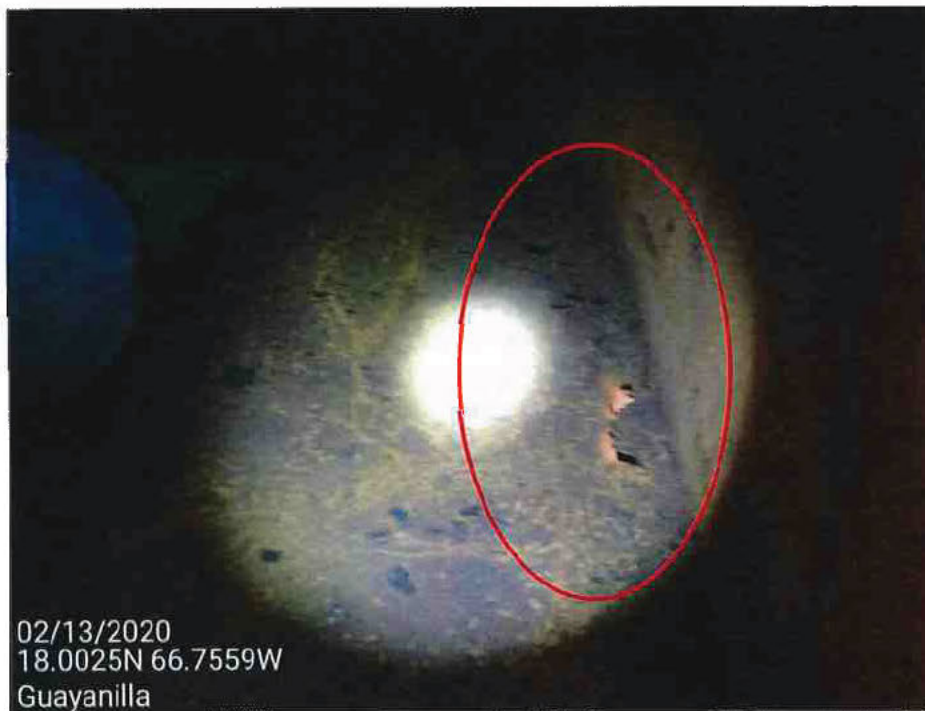
Picture 27 – Tank floor has corrosion sings and is broken at weld joint with shell.

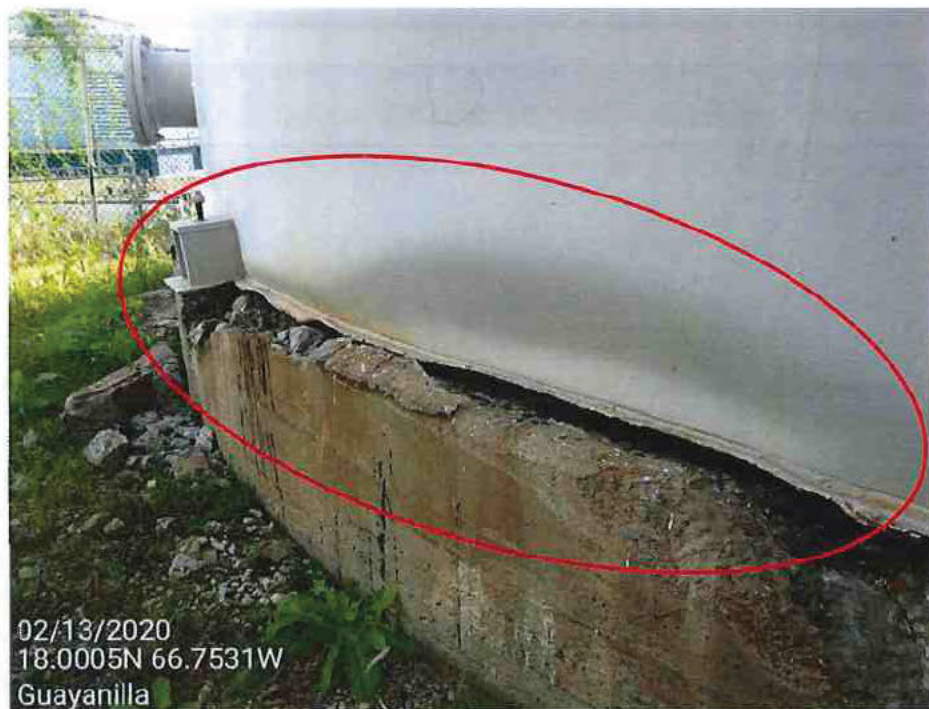
Picture 34 – Foundation concrete shell support ring crushed and tank shell has elephant foot buckling areas at first ring, due to seismic overturning moment.

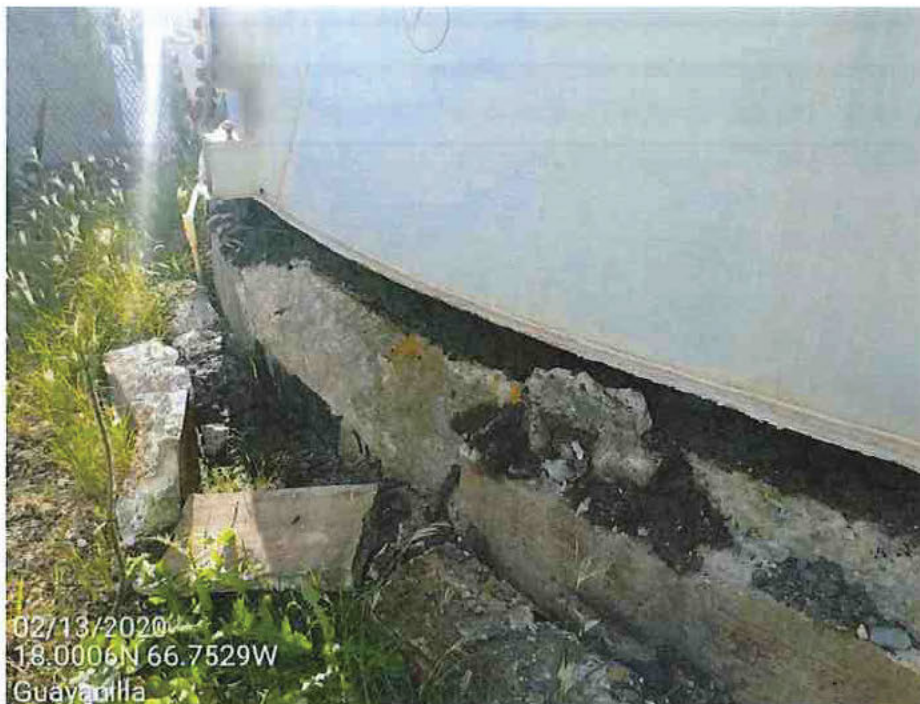
Picture 36 – Foundation concrete base shell support ring crushed, due to seismic overturning moment.

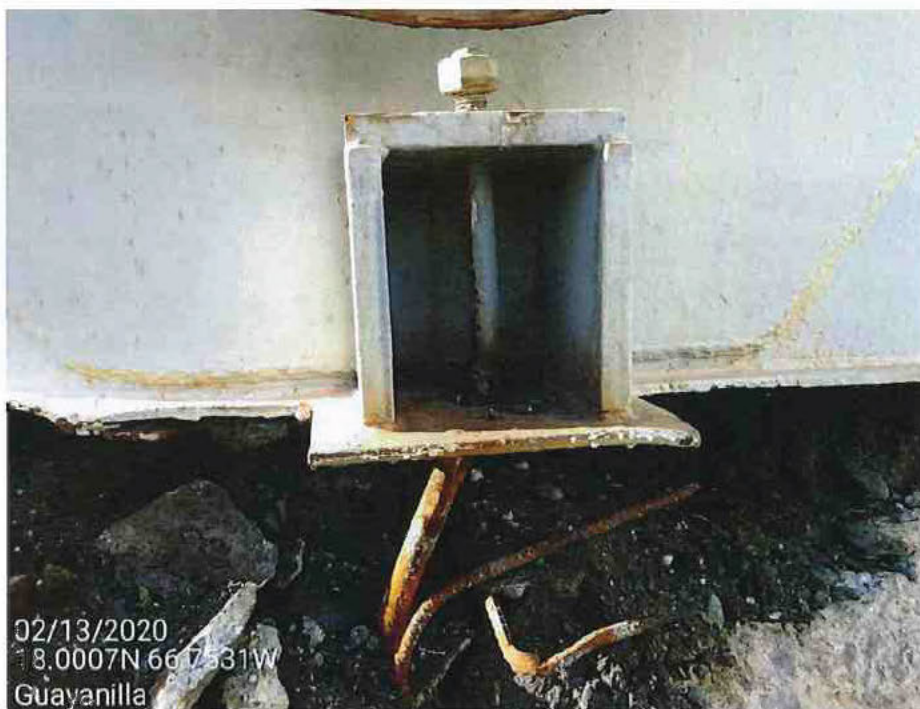
Picture 37 – Anchor bolt ripped off from concrete base, due to seismic overturning moment.

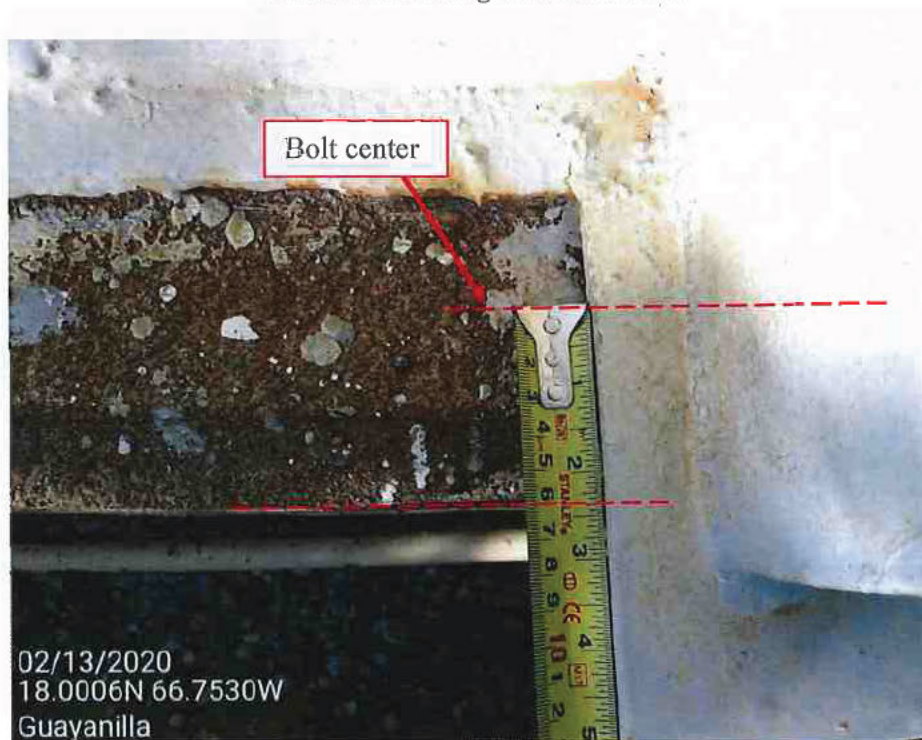
Picture 39 – Anchor bolt center is about 2.25" to 2.5" clear cover, from foundation exterior face.

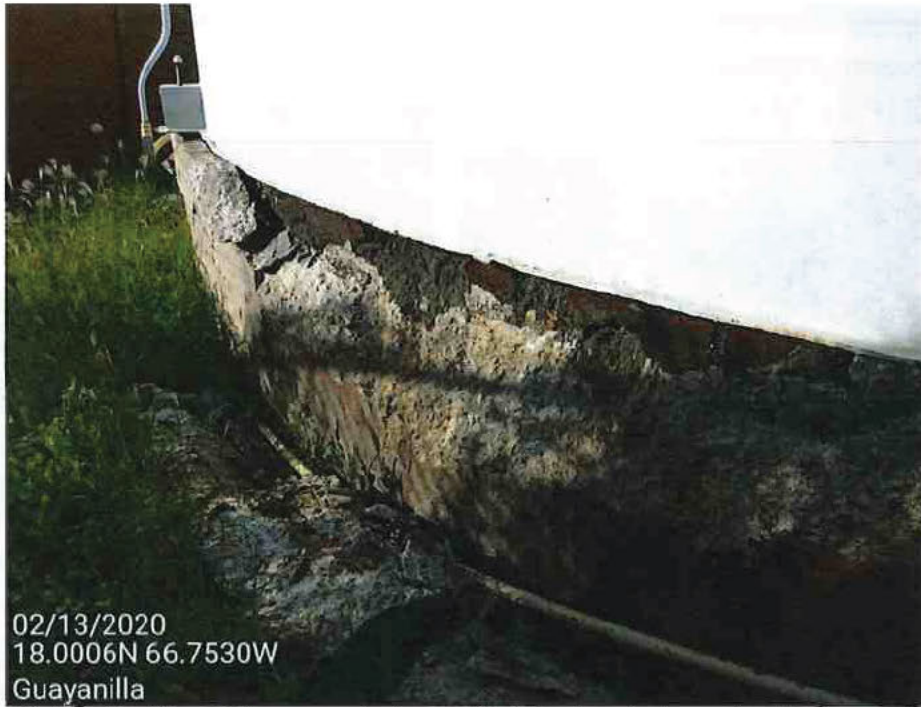
Picture 40 – Foundation concrete ring crushed, due to seismic overturning moment.

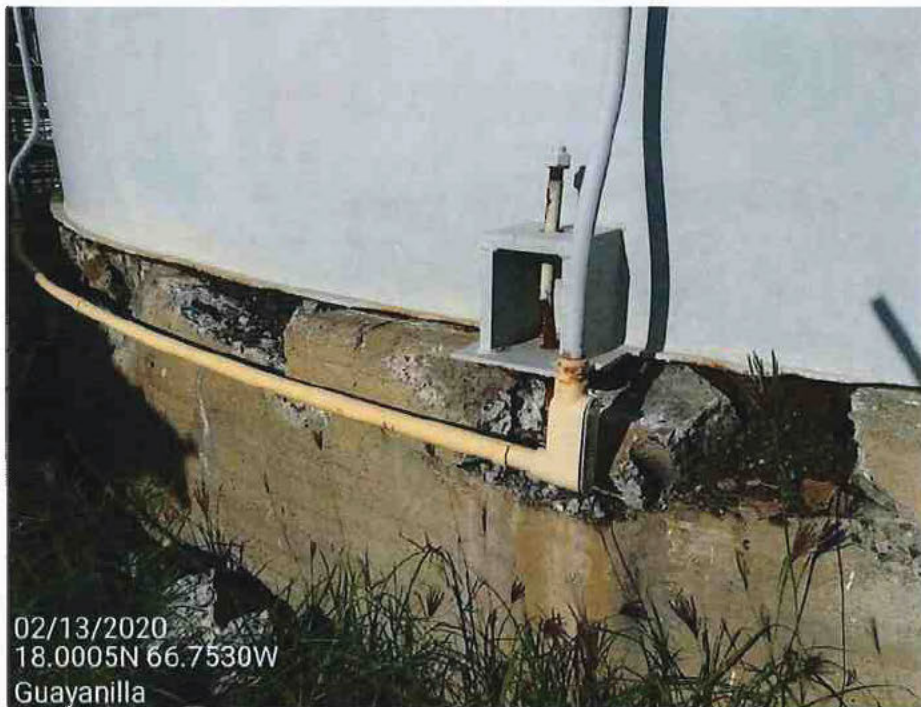
Picture 41 – Foundation concrete ring crushed, due to seismic overturning moment.

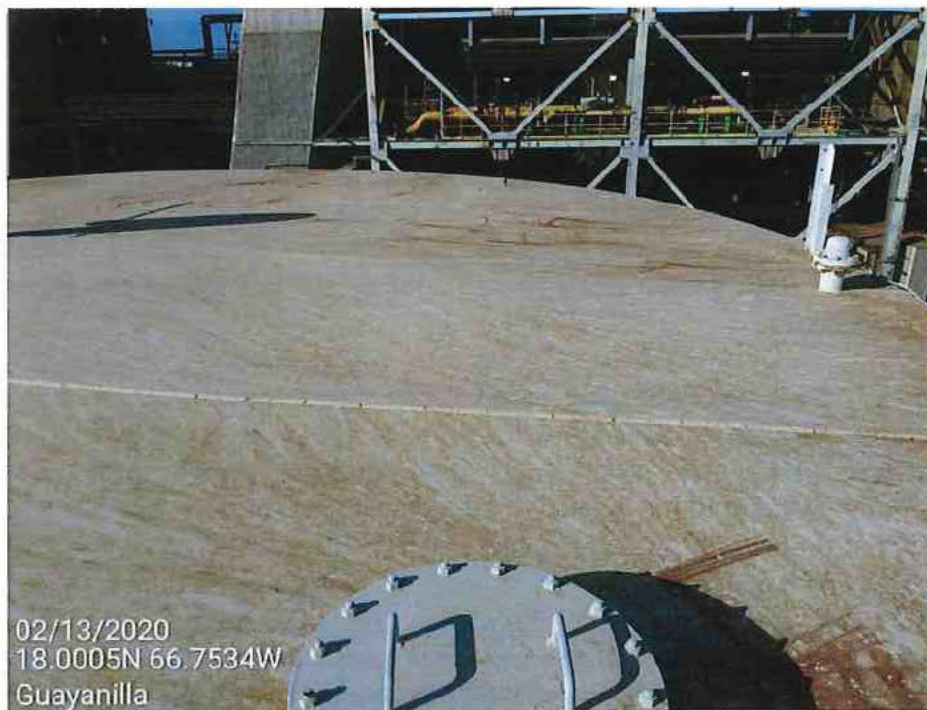
Picture 50 – Condensate Tank 6 roof have paint deterioration and corrosion signs.
