**REQUEST FOR PROPOSALS FOR
TEMPORARY EMERGENCY
GENERATION**

NEPR-AP-2020-0001

**SUPPLEMENT TO NOTIFICATION AND URGENT REQUEST
FOR APPROVAL OF REQUEST FOR PROPOSALS FOR
TEMPORARY EMERGENCY GENERATION**

COSTA SUR RECOVERY PROJECT REPORT

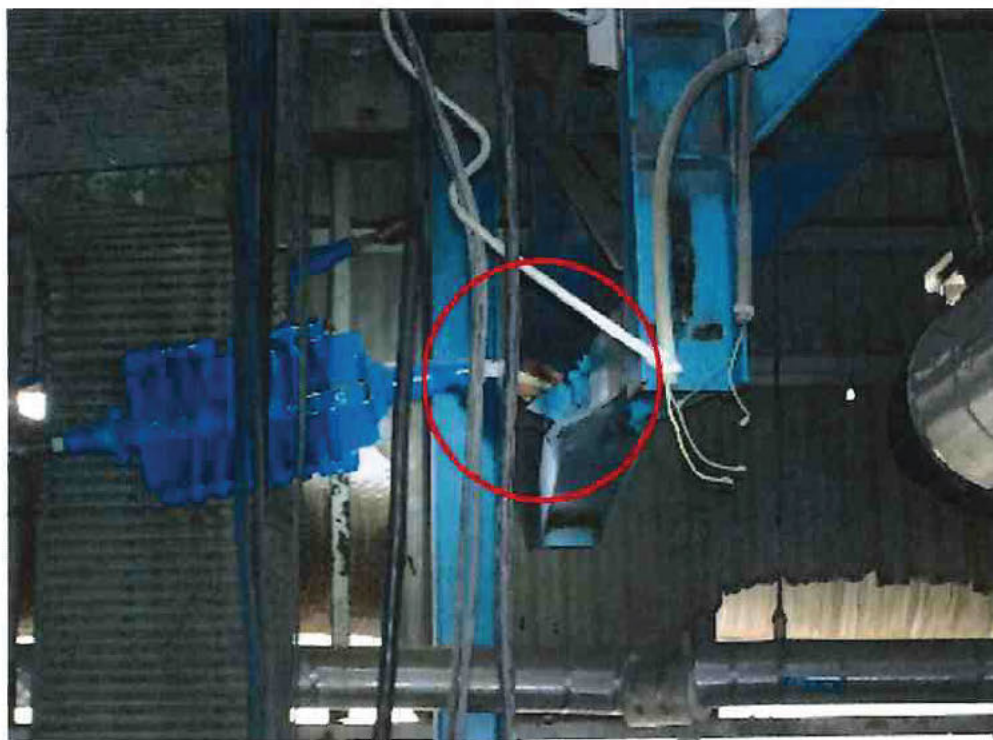
**Bent WEAR Restraint rod and I-beam.
Risk of damage to MS pipe supports
and added stress of MS pipe during
major wind or seismic event.**

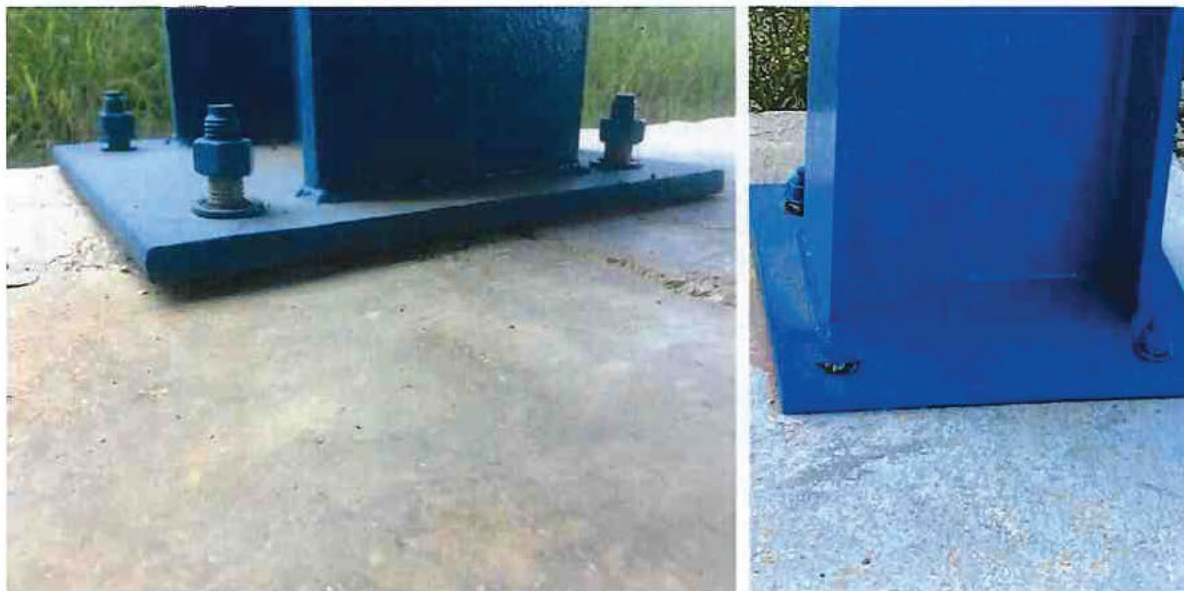
**Building columns base plates
footings anchor bolts up-lifted
and damaged**

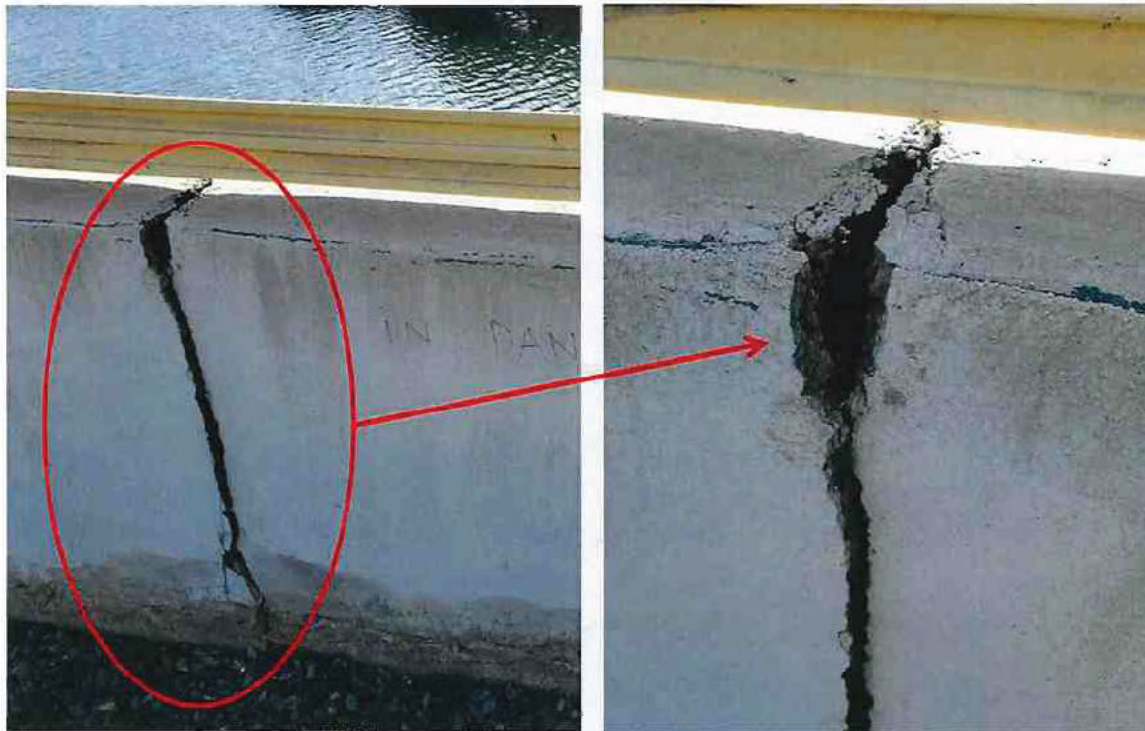
20 ft wall segment with structural damage. Structural cracks form top to bottom on cold joints at both ends.

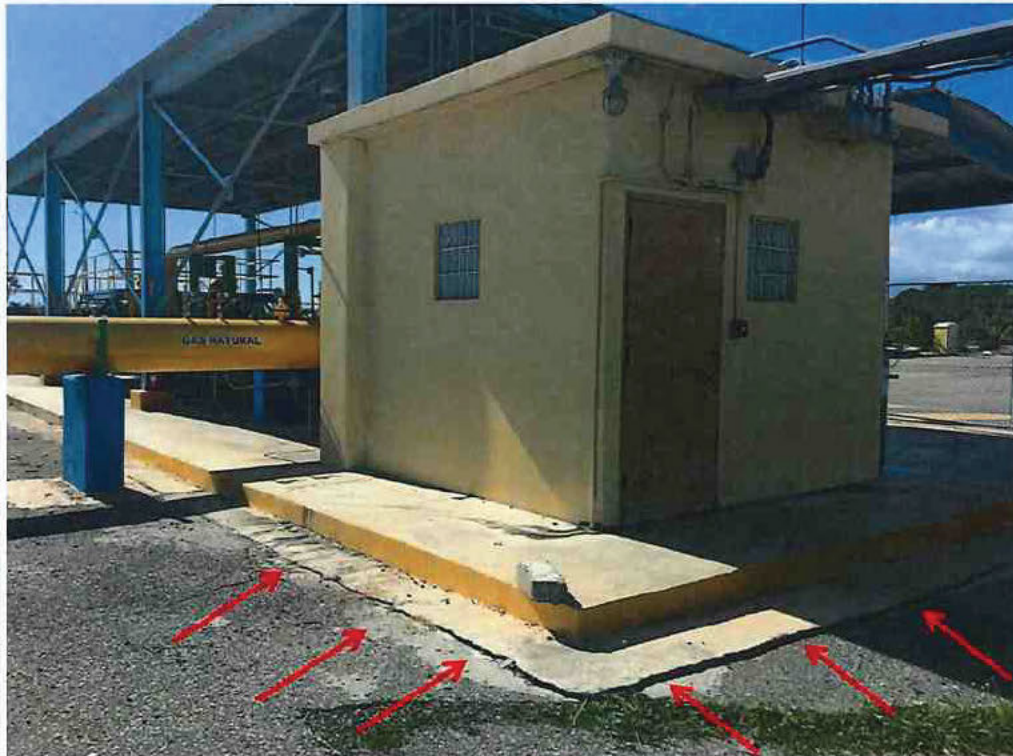
Major crack under gas metering station area

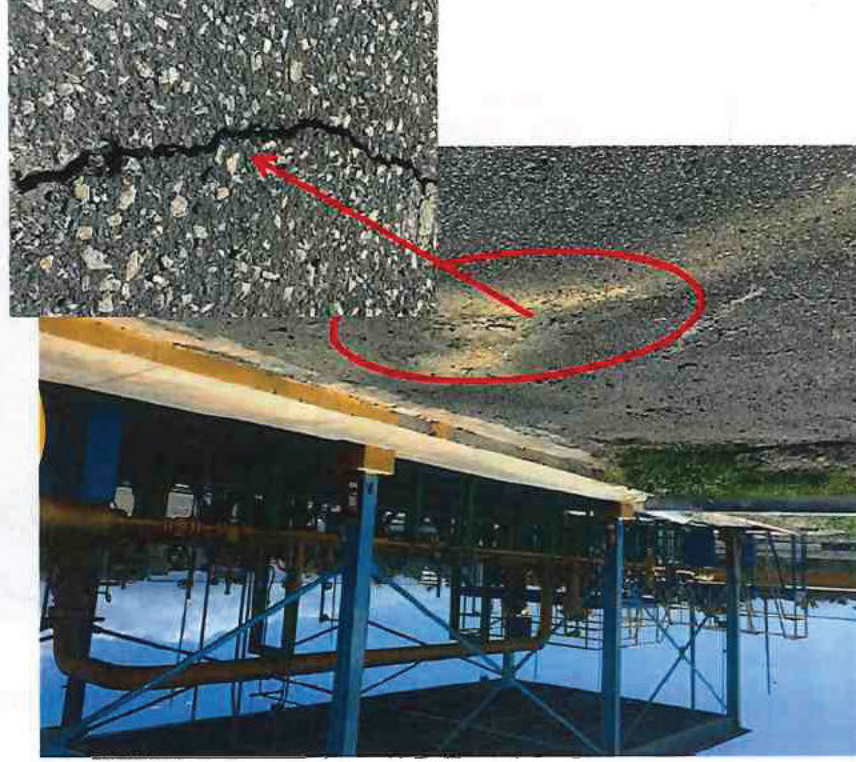
Major crack under gas metering station area

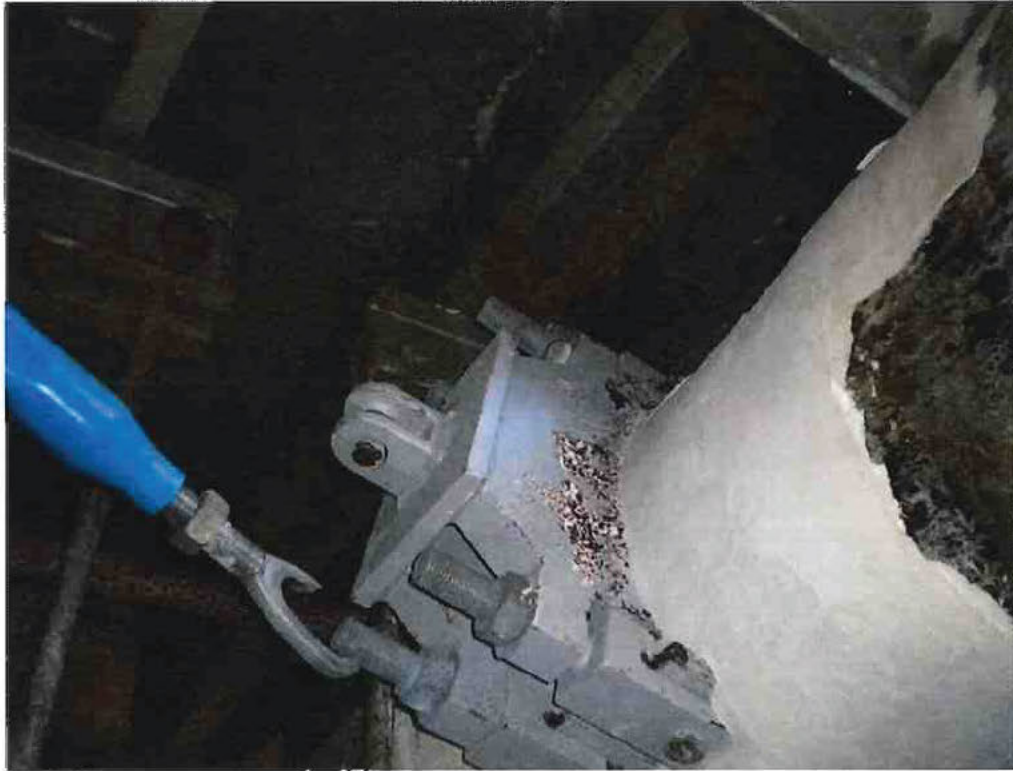
Photo 1 - U-5 Failed WEAR Restraint Rod End

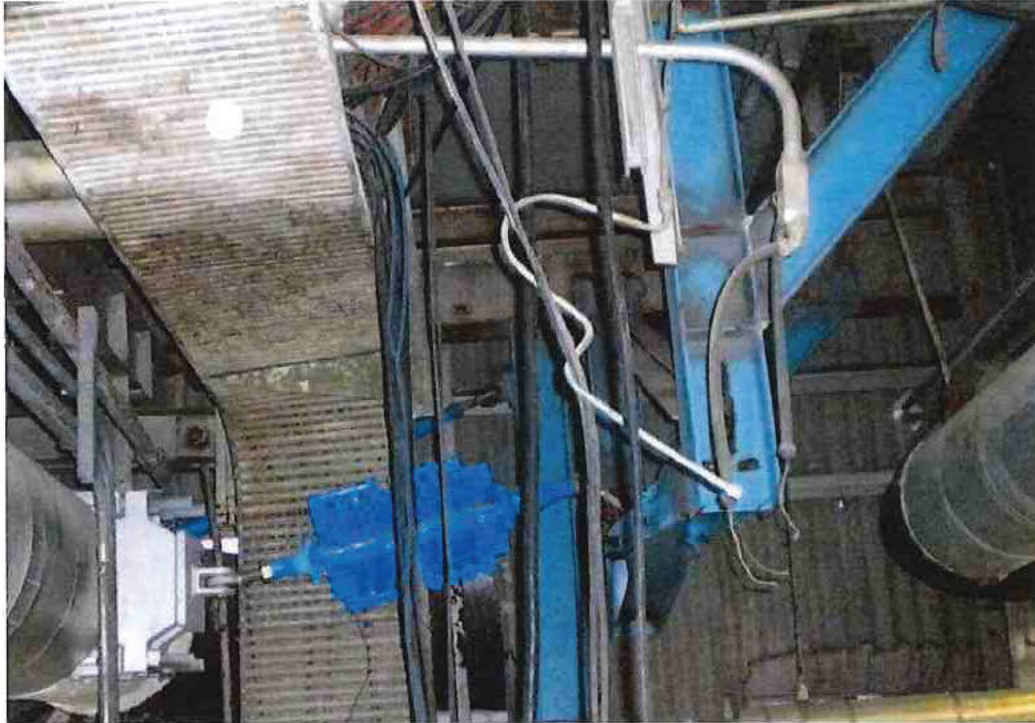
Photo 2 - U-5 Failed WEAR Rod End and Structure

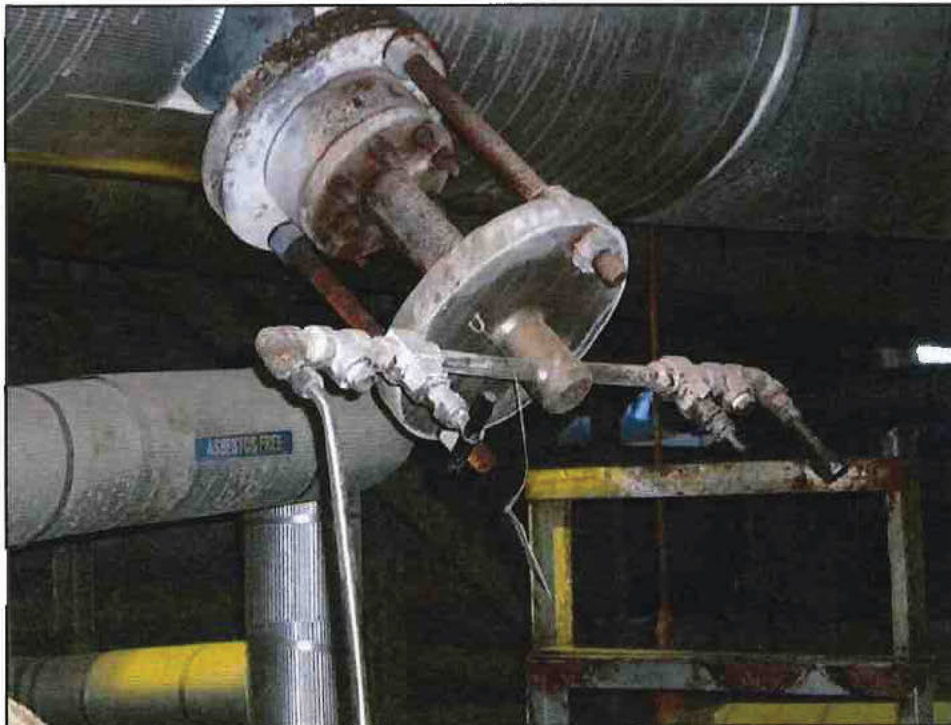
Photo 5 - U-5 Failed Main Steam Annubar Tubing

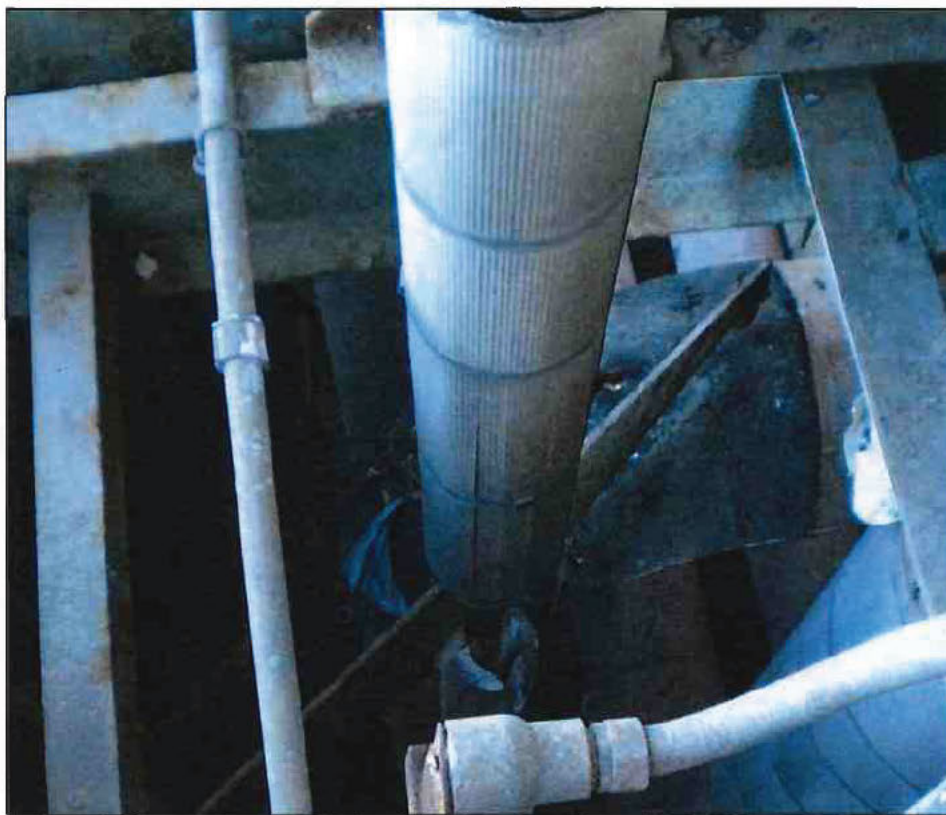
Photo 8 - U-5 Failed CR Attenuator Spray Hanger

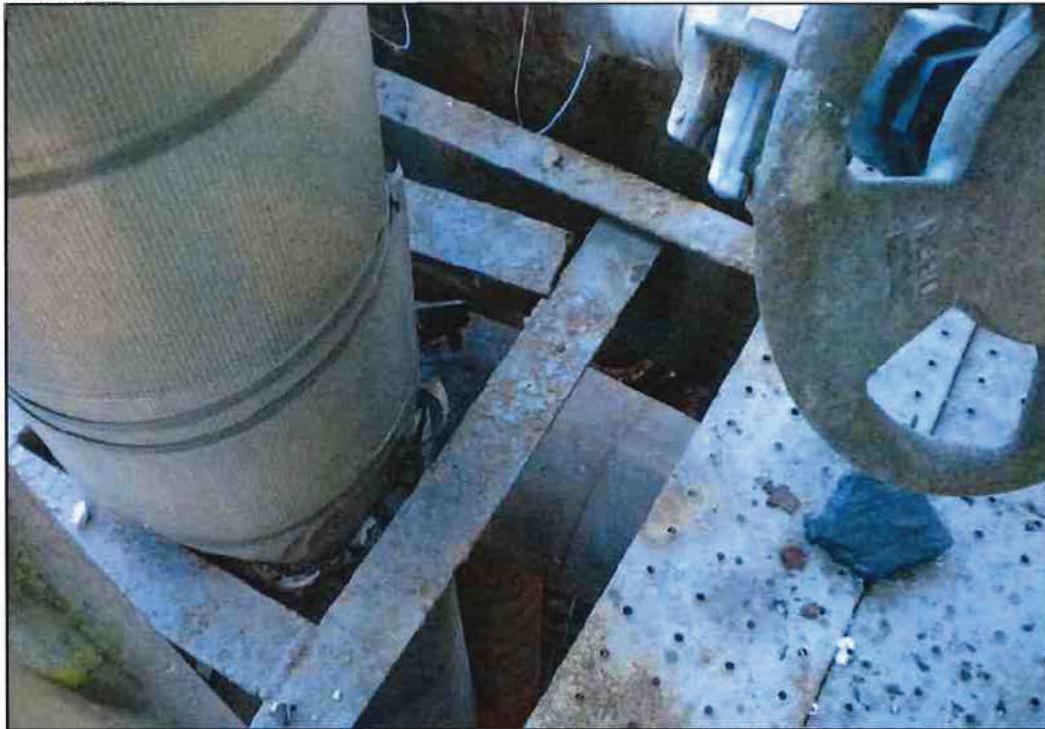
Photo 12 - U-5 Failed L-3 Boiler Feed Guide

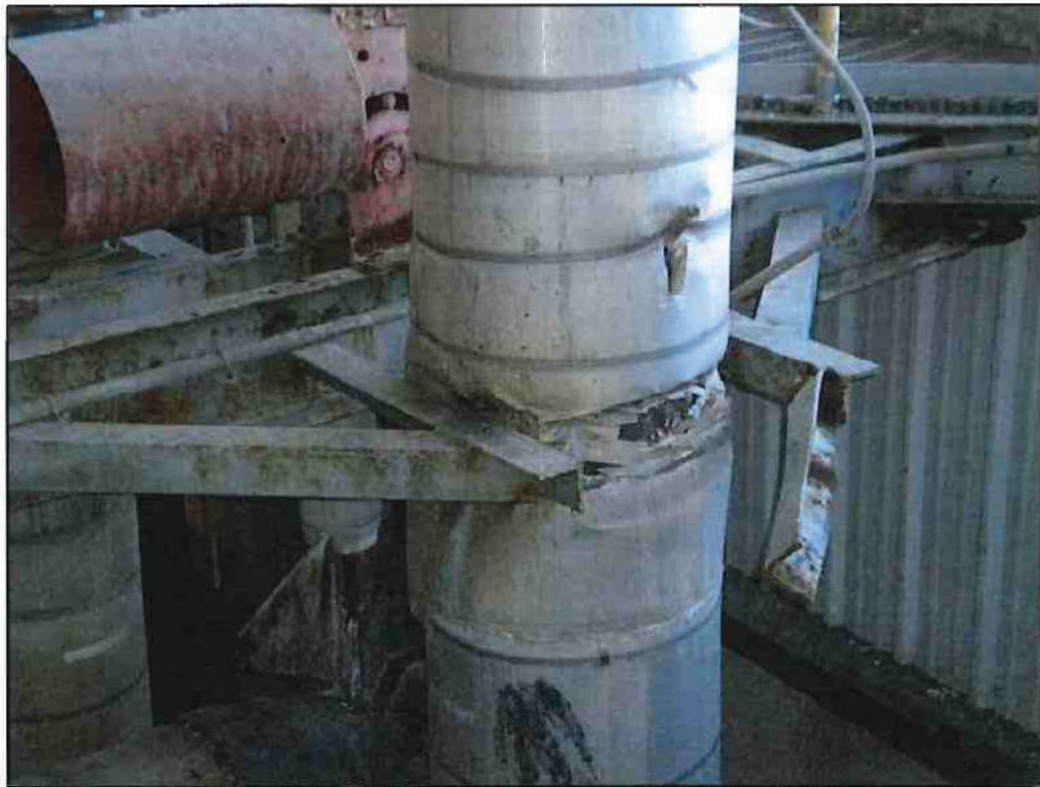
Photo 13 - U-5 Failed Guide on the Hot Suction Line

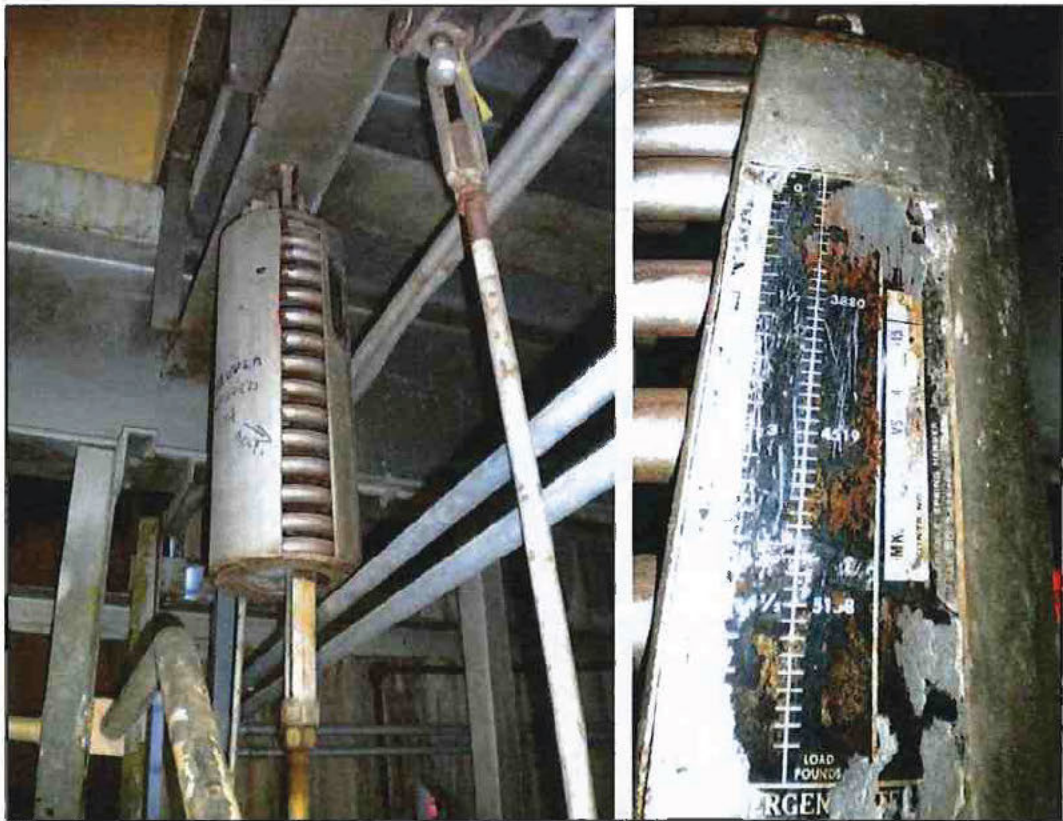
Photo 15 - U-5 Condensate to Deaerator Failed Spring Hanger

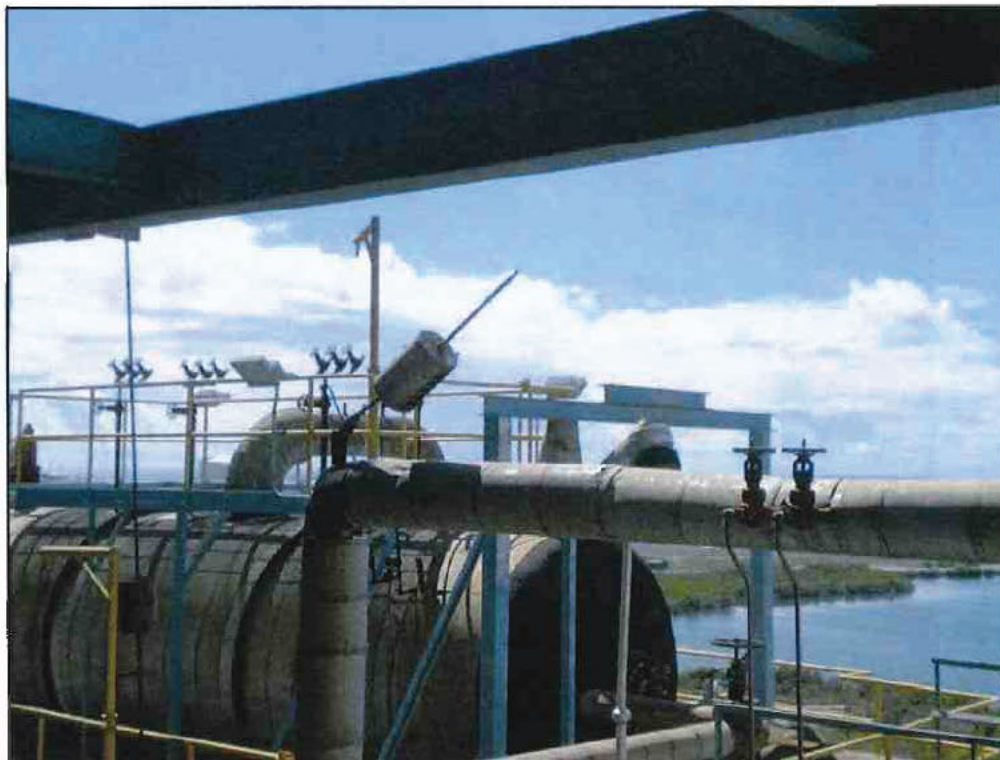
Photo 18 - U-5 Failed Spring Hanger Rod on Blow-down Line

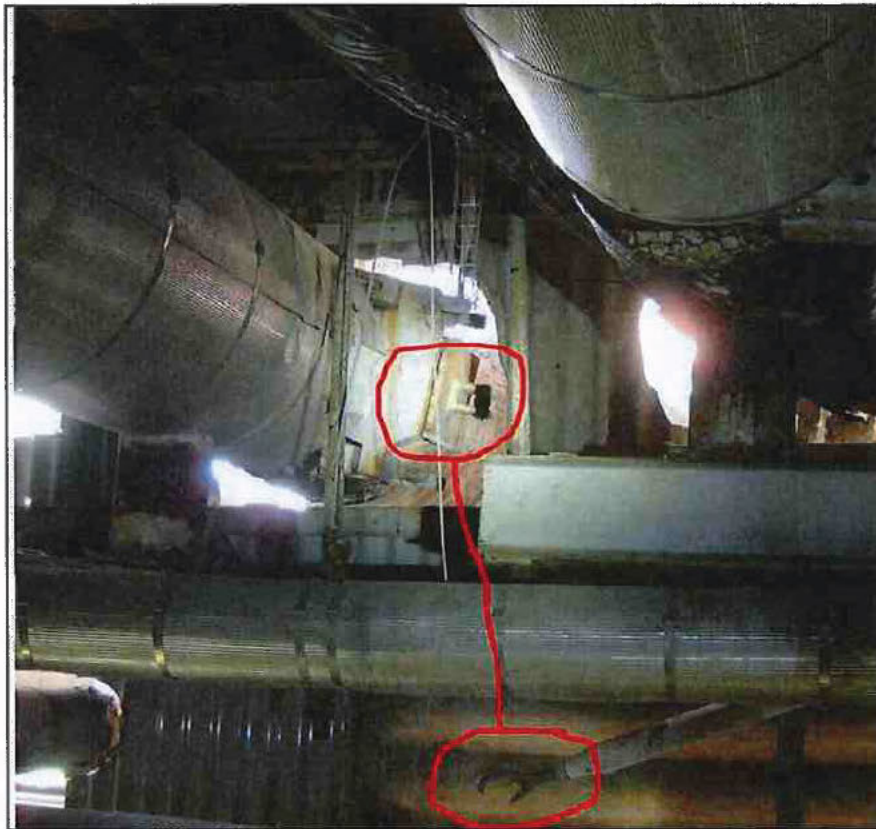
Photo 22 - U-6 Failed WEAR Restraint WR-10

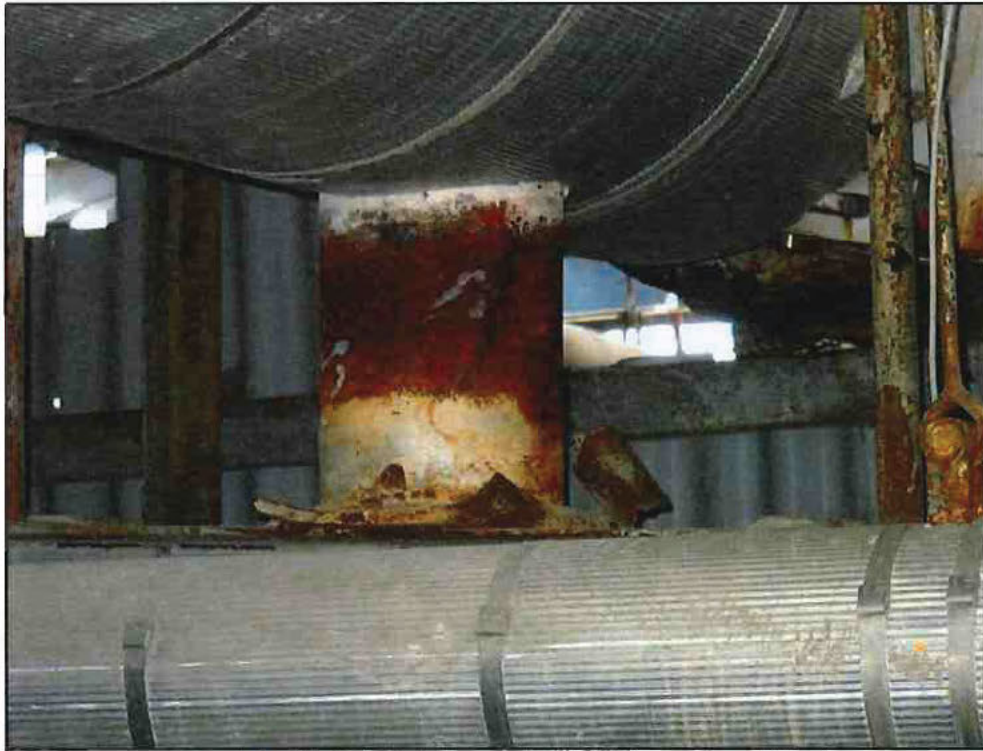
Photo 23 - U-6 Failed Support S-16 Stanchion Clip Angle

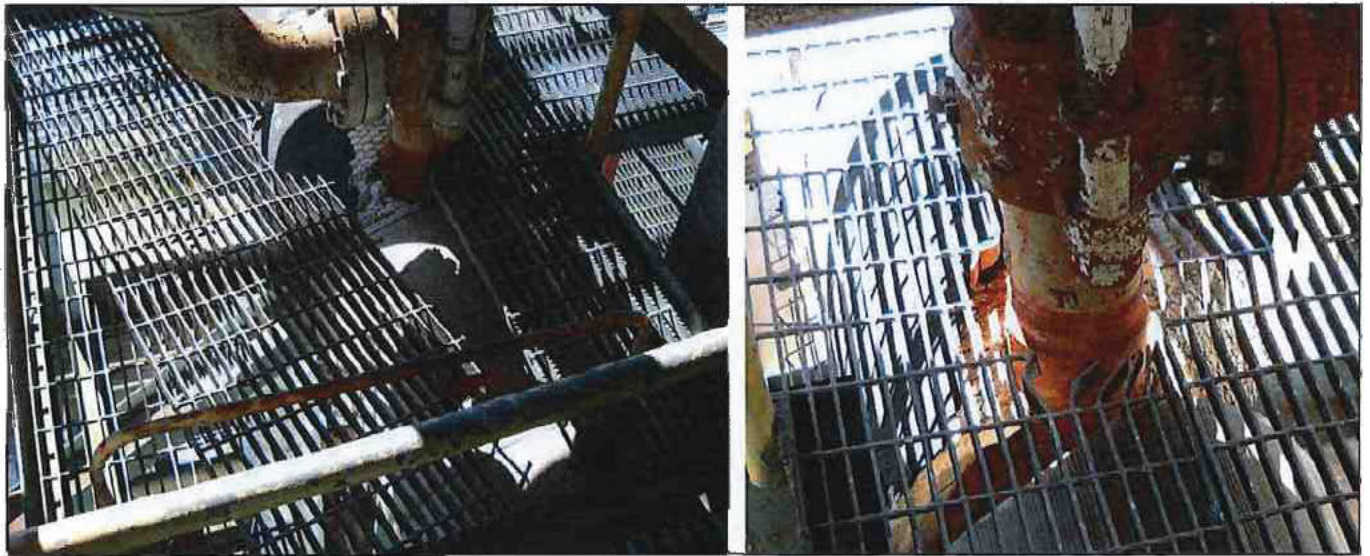
Photo 24 - U-6 Dislodged Grating and Bent Grating at the two Main Steam SRV Locations

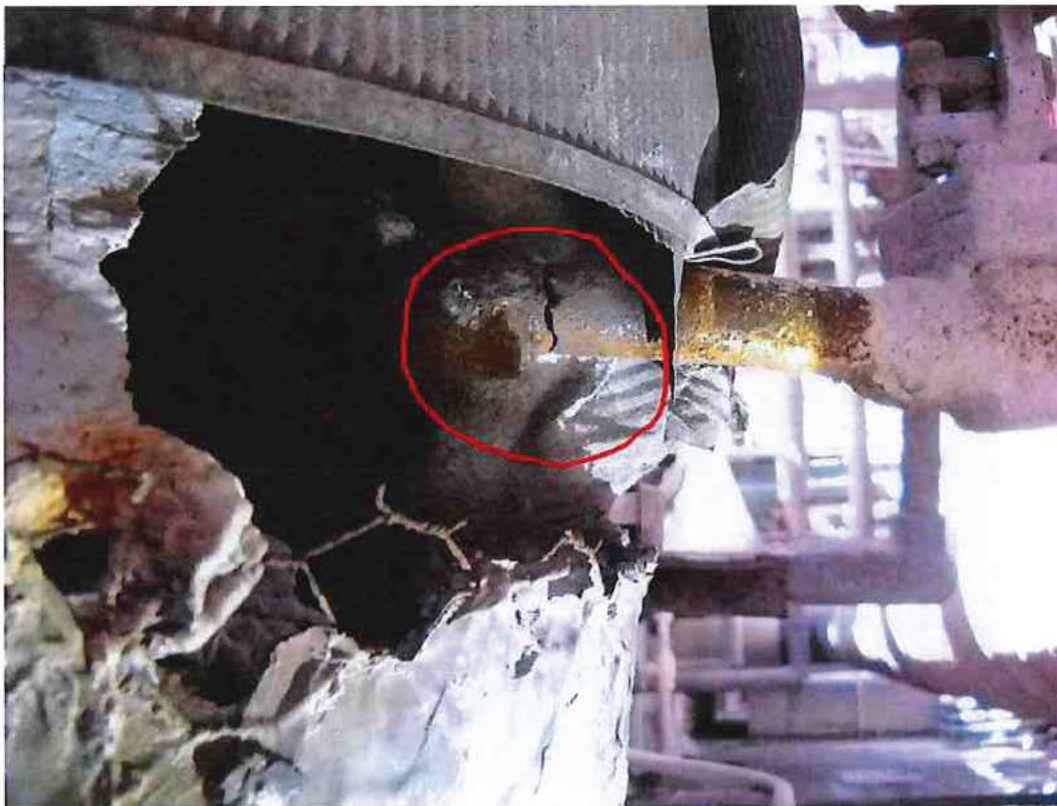
Photo 25 - U-6 Failed Pressure Tap

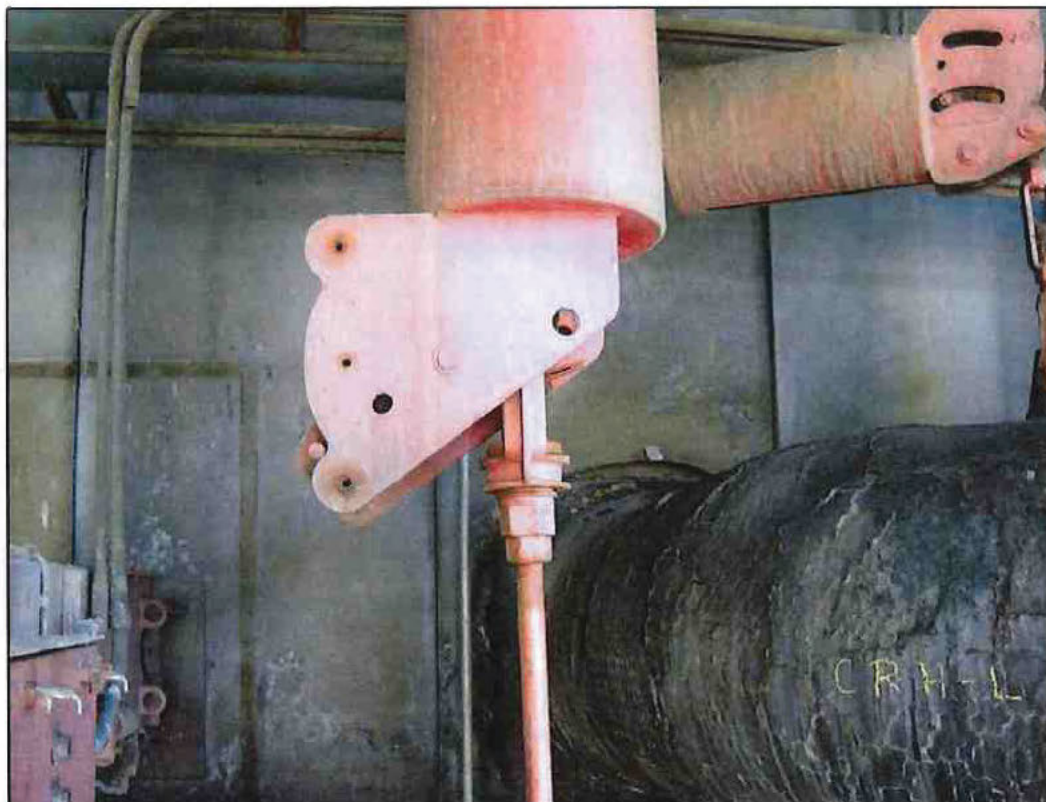
Photo 26 - U-6 Topped Out BF Hanger BF-2

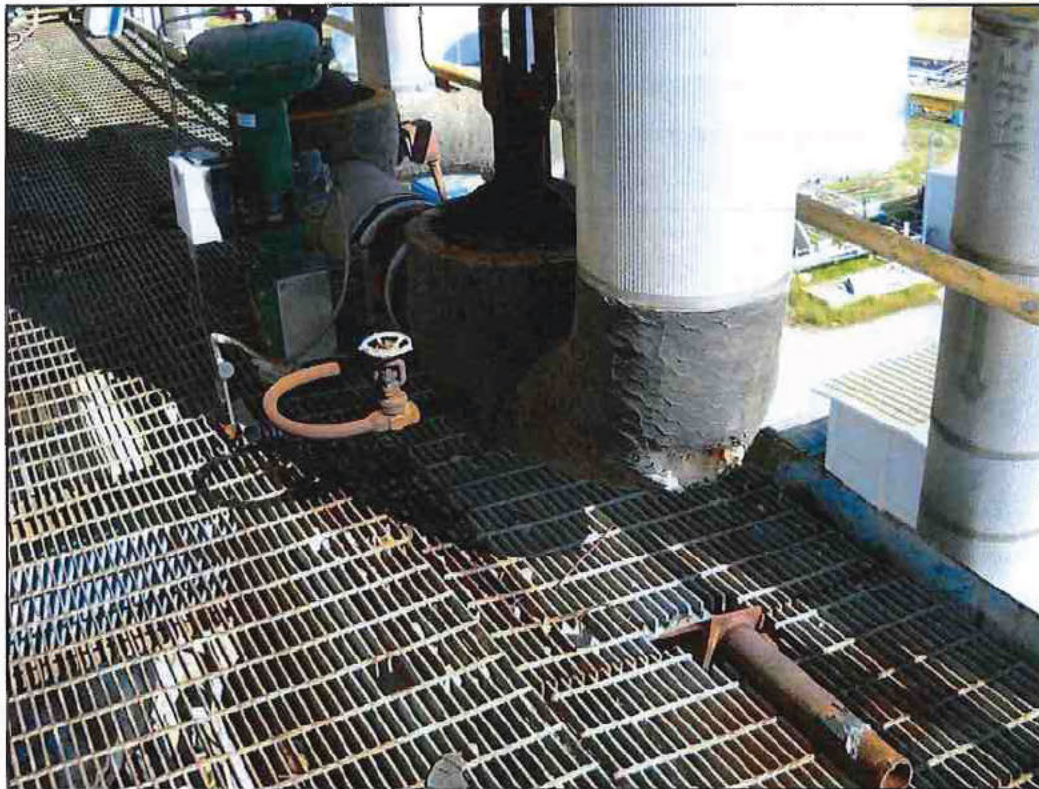
Photo 31 - U-6 Failed Heater 5 Drip Elbow Stanchion

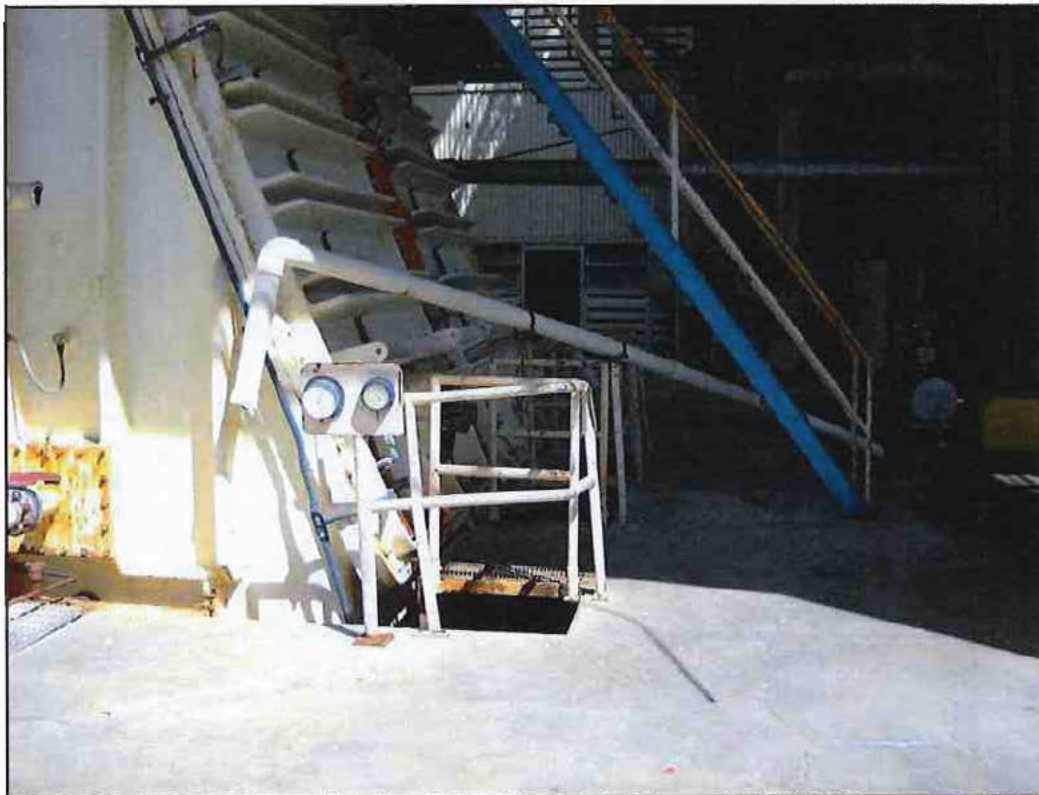
Photo 32 - U-6 Failed Condenser PVC Piping

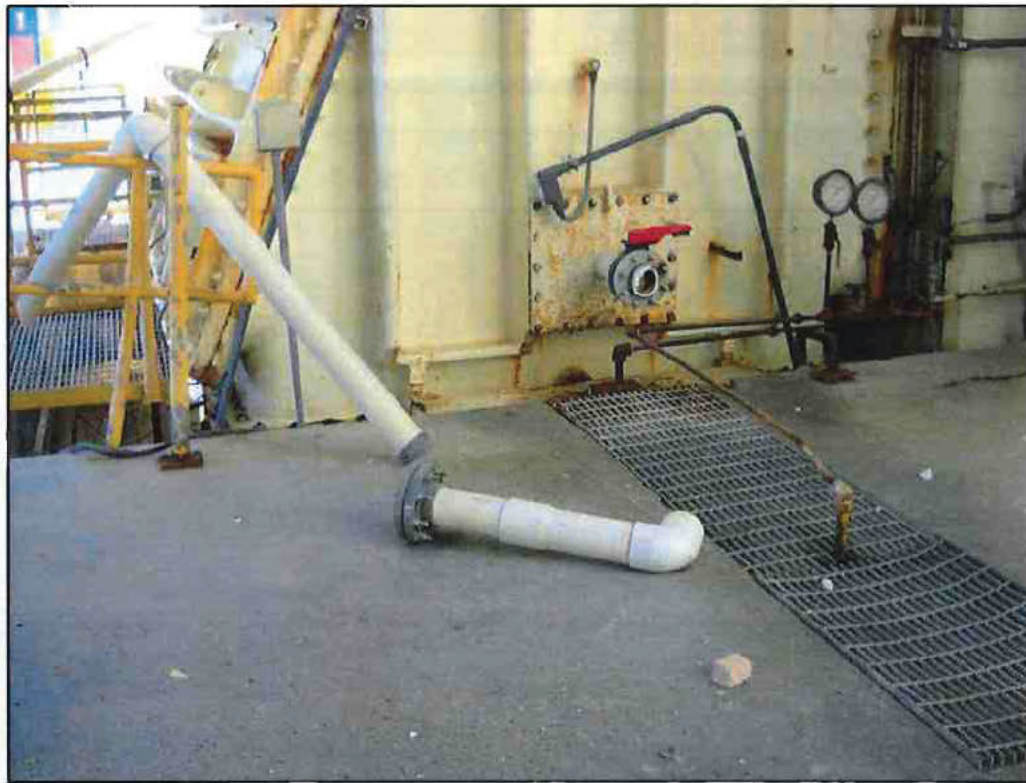
Photo 33 - U-6 Failed Condenser PVC Piping

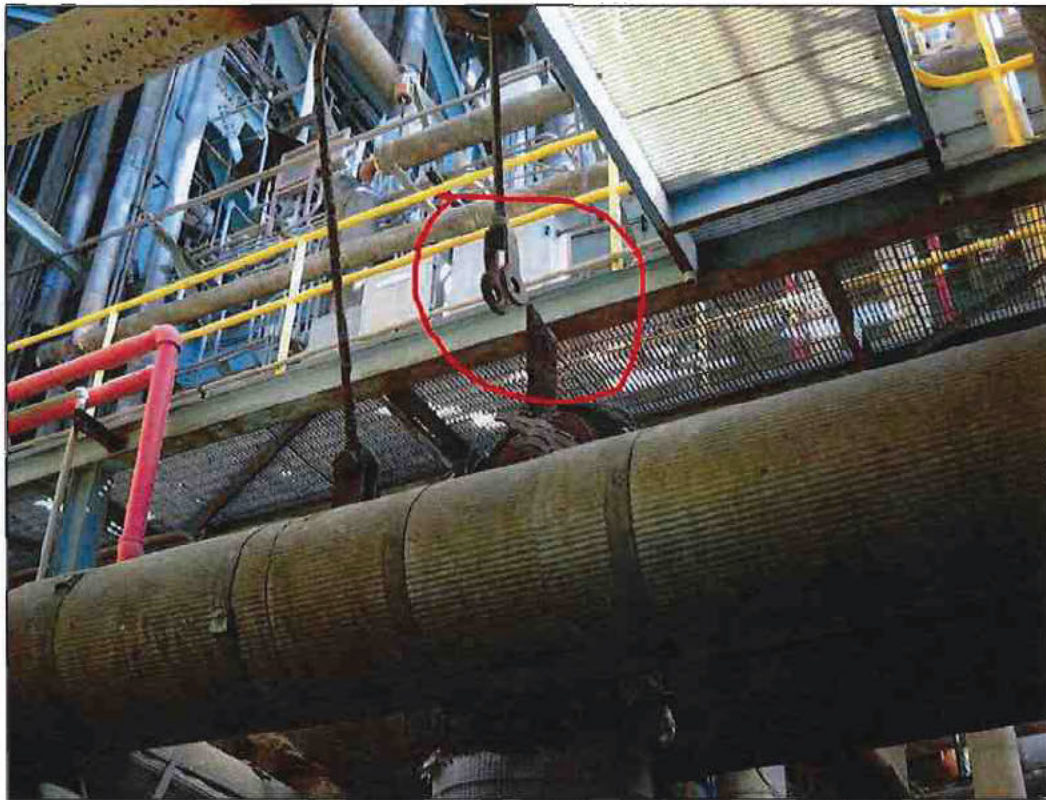
Photo 34 - U-6 Missing Hanger Pin from Unidentified Line

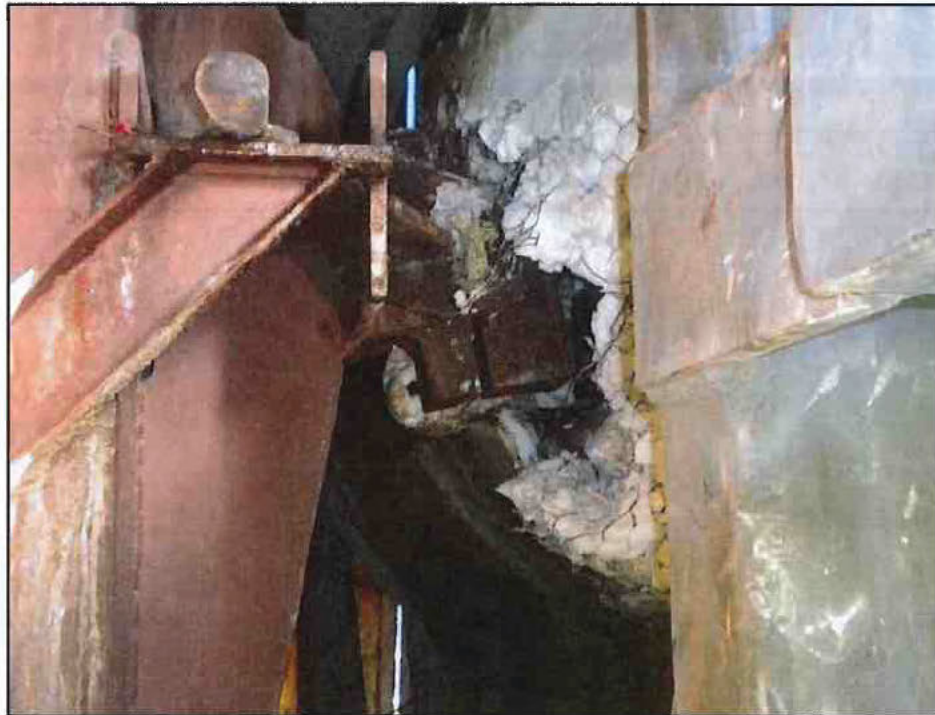
Photo 42 - U-6 Failed Control Valve Actuator Assembly Connection

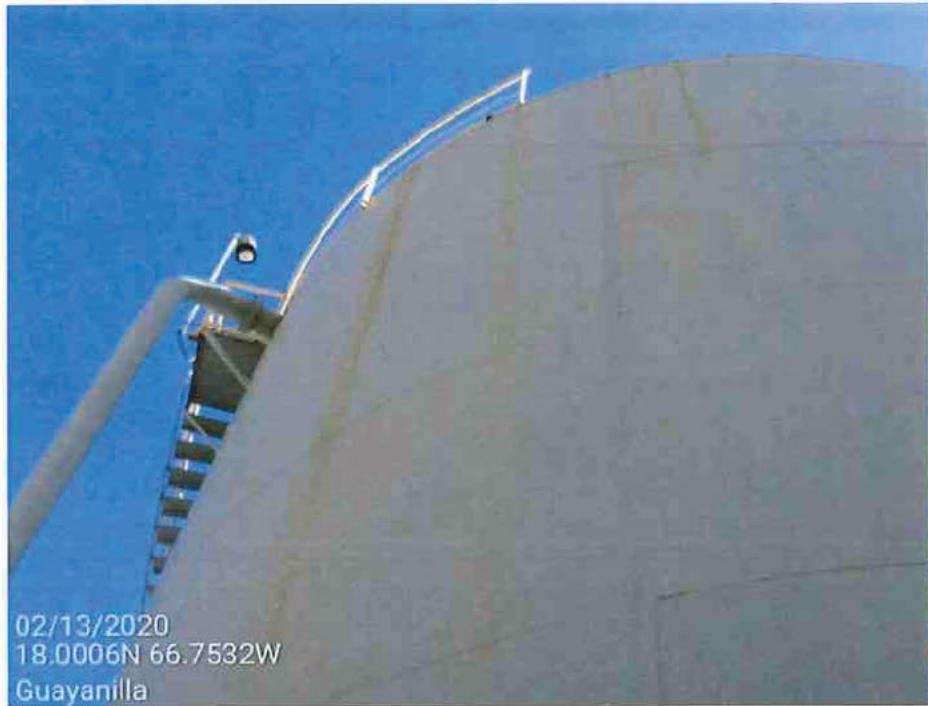
Picture 6 – Condensate Tank 5 shell paint deterioration.

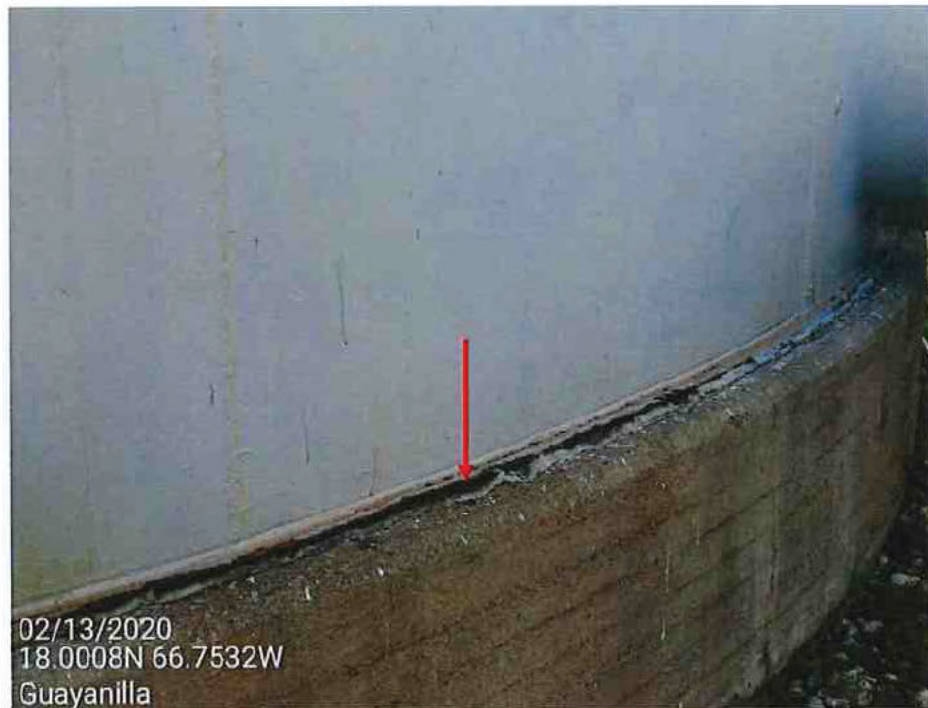
Picture 7 – Tank bottom seal joint cracked.

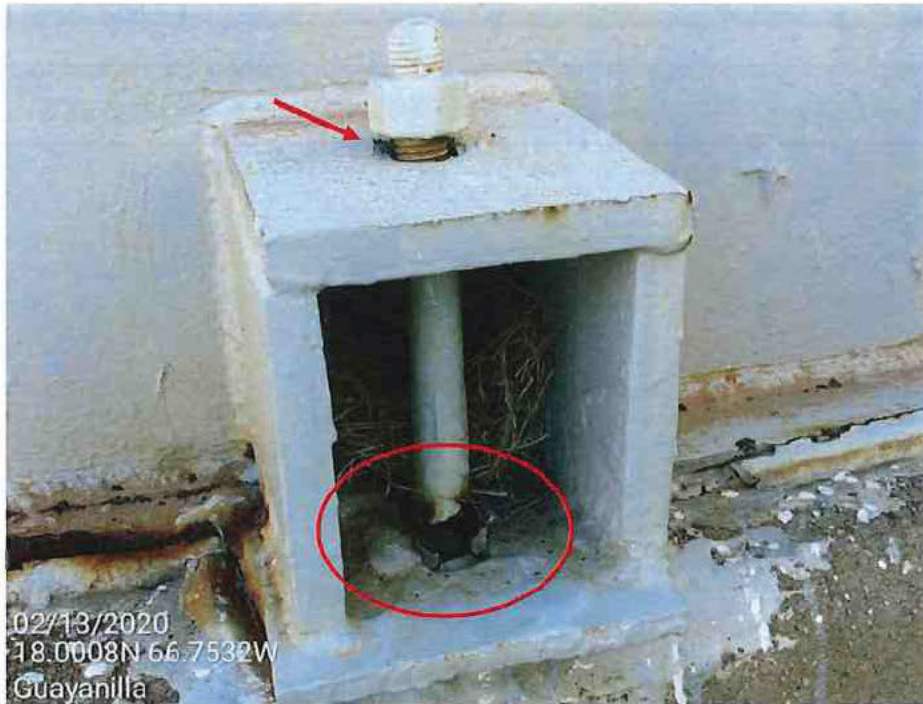
Picture 8 – Anchor bolt with severe corrosion at bottom and loose anchor bolt nut from anchor chair assembly.

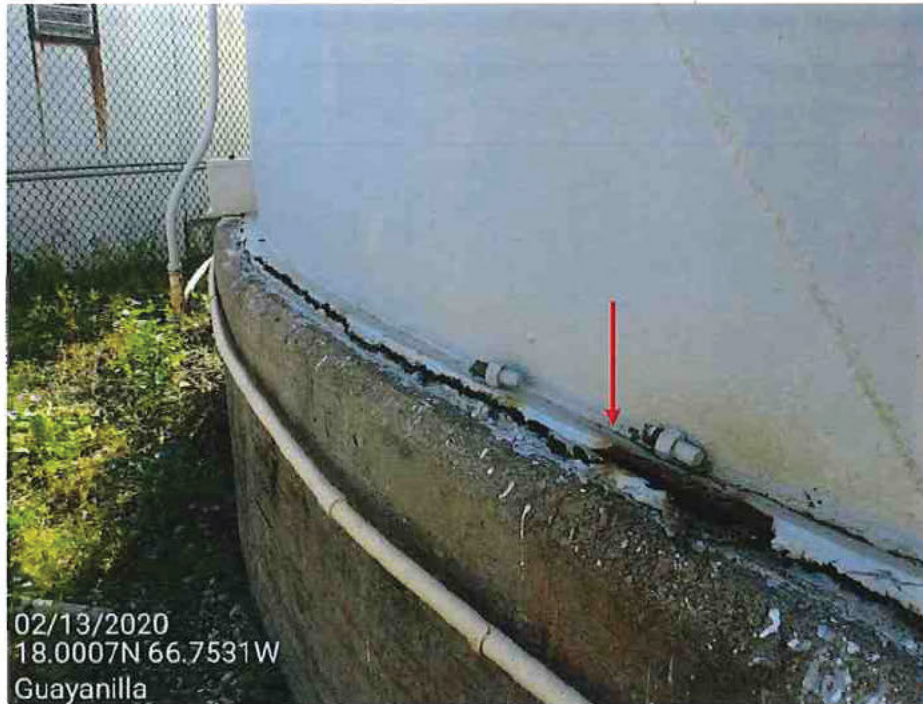
Picture 12 – Tank bottom seal joint cracked.

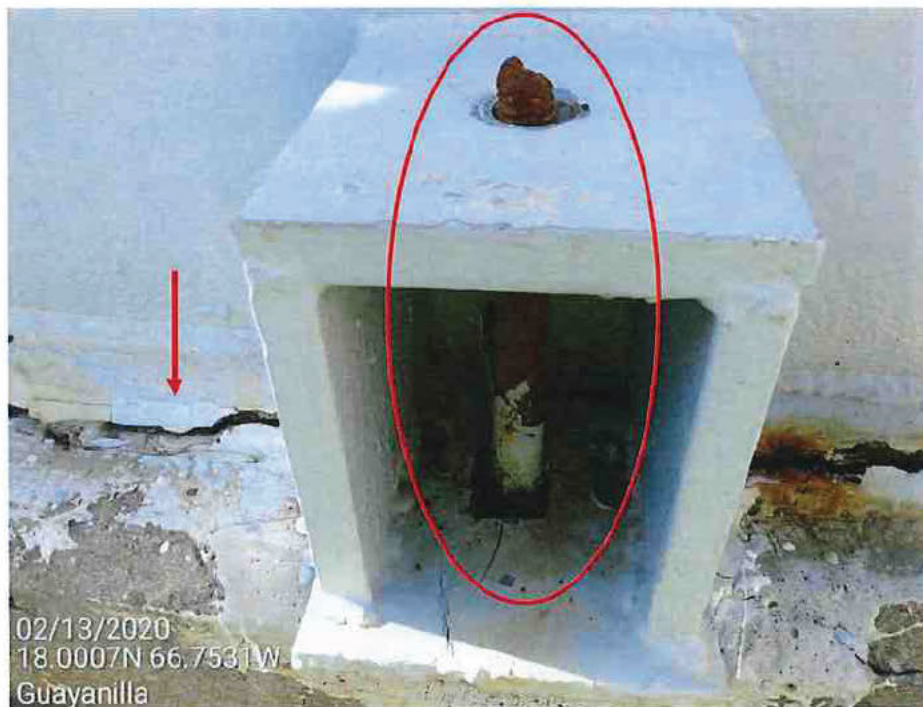
Picture 13 – Anchor bolt nut failure due to seismic overturning moment.

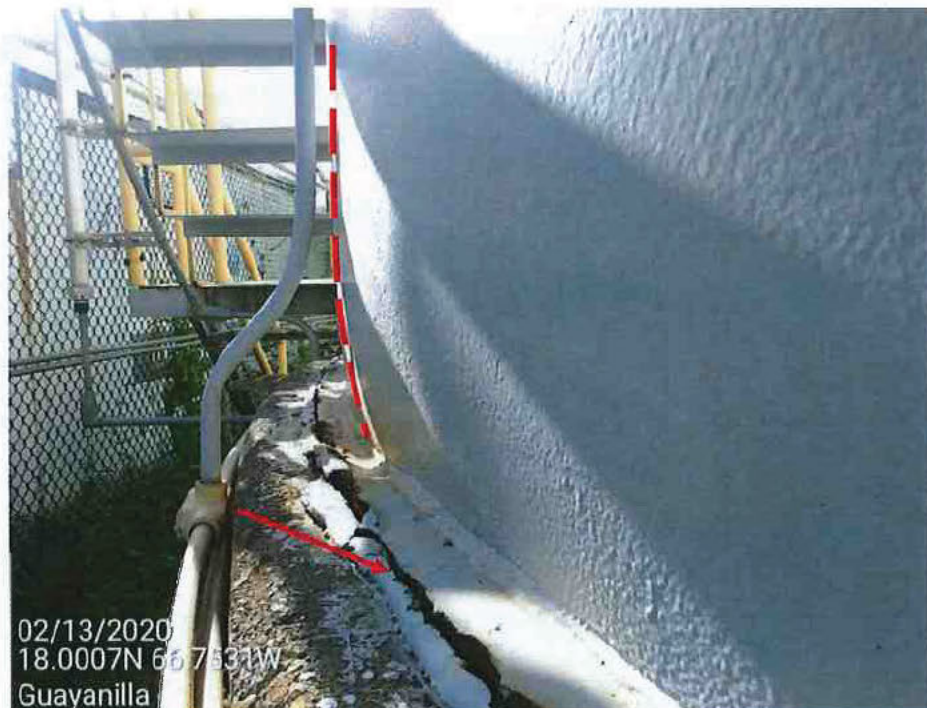
Picture 15 – Tank bottom seal joint cracked and tank shell has elephant foot buckling areas at first ring, due to seismic overturning moment.

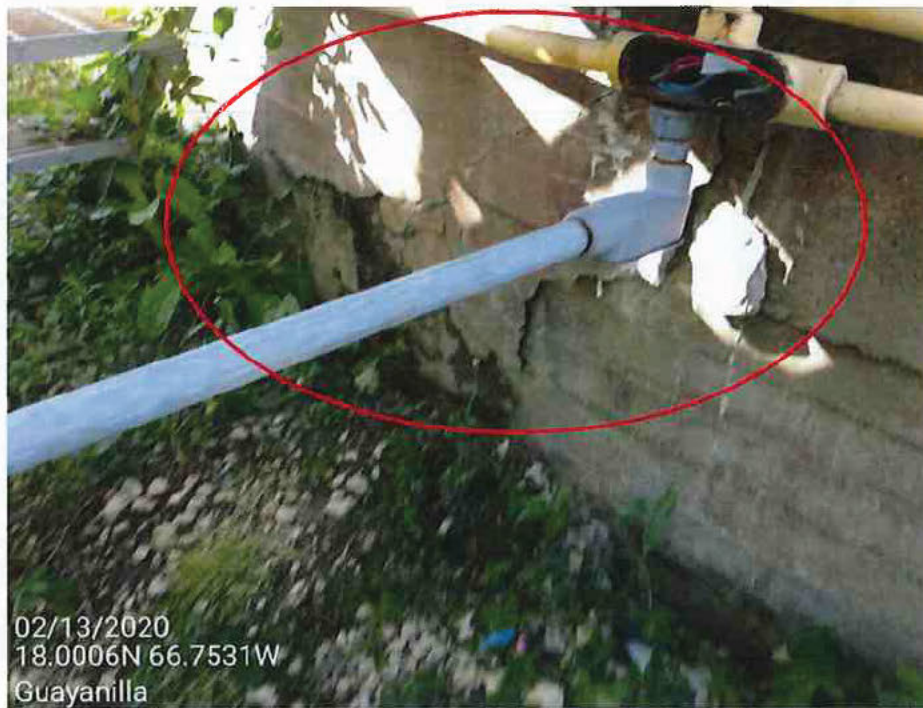
Picture 16 – Concrete foundation base crushed, due to seismic overturning moment.
