**REQUEST FOR PROPOSALS FOR
TEMPORARY EMERGENCY
GENERATION**

NEPR-AP-2020-0001

**SUPPLEMENT TO NOTIFICATION AND URGENT REQUEST
FOR APPROVAL OF REQUEST FOR PROPOSALS FOR
TEMPORARY EMERGENCY GENERATION**

COSTA SUR RECOVERY PROJECT REPORT

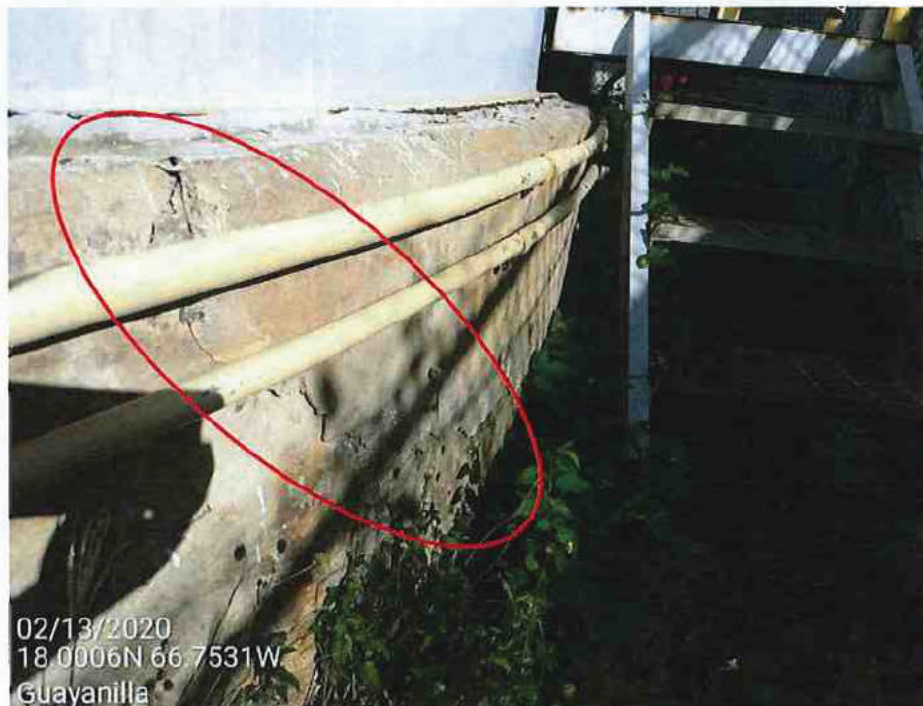
Picture 17 – Concrete foundation base cracked.

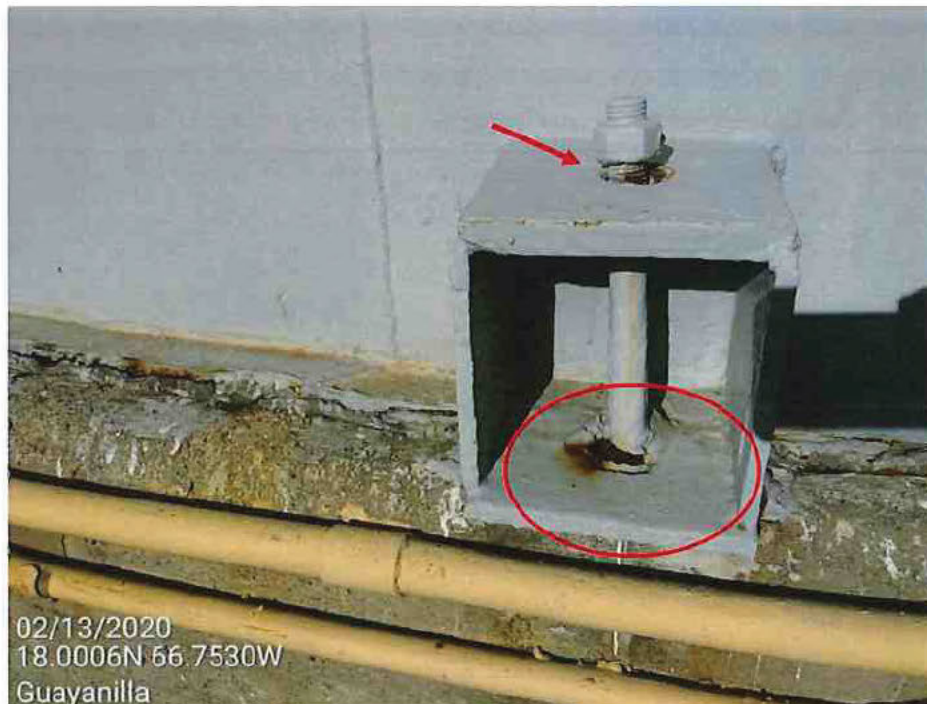
Picture 18 – Anchor bolt corrosion signs and loose anchor bolt nut from anchor chair assembly. Anchor appeared to have elongated due to tension forces.

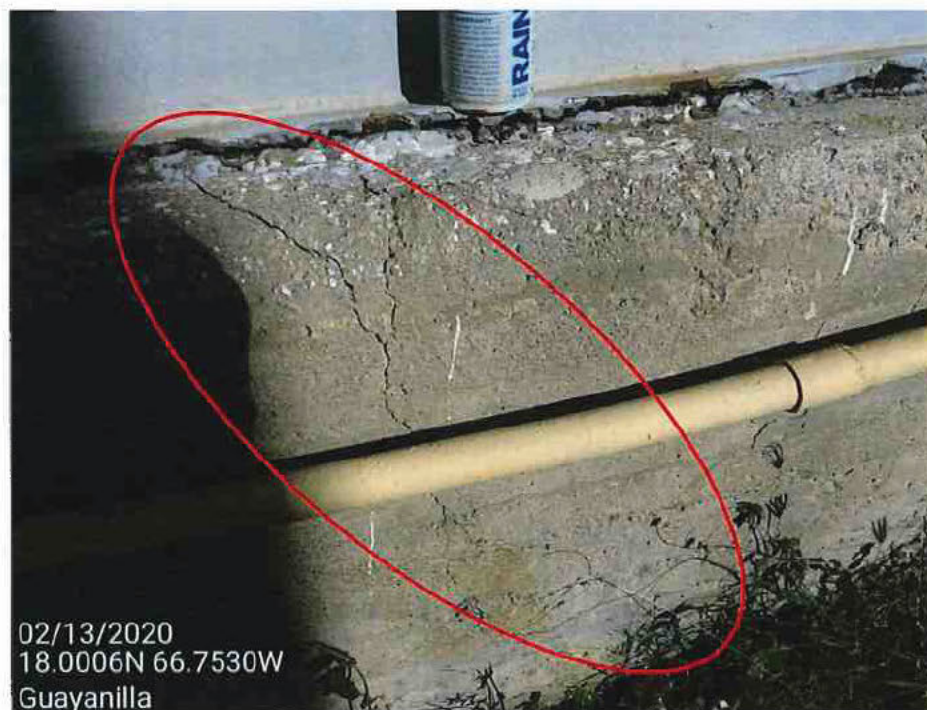
Picture 19 – Concrete foundation base cracked.

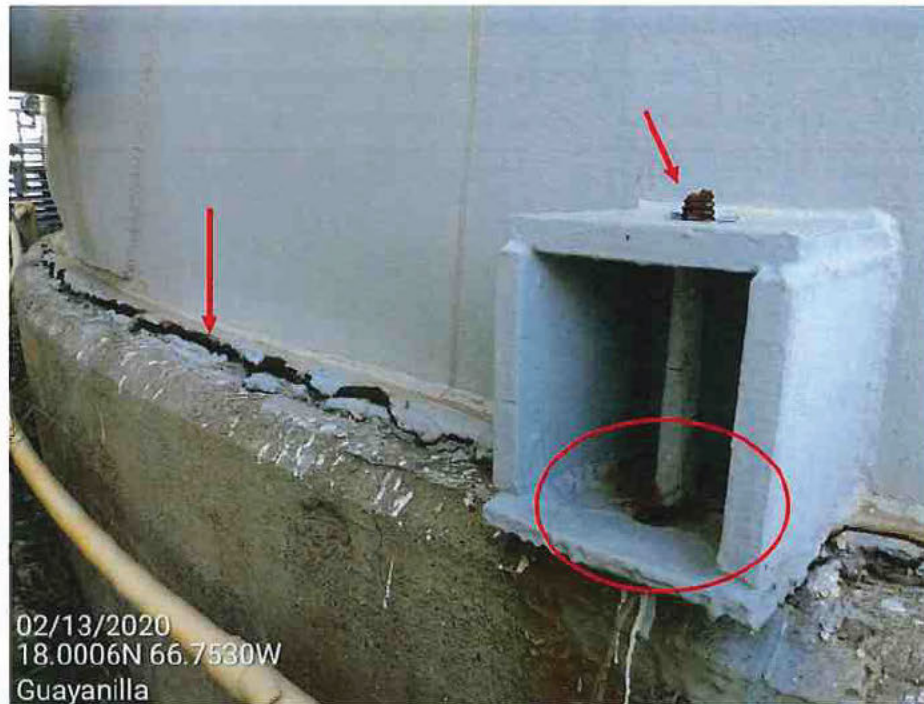
Picture 20 – Tank bottom seal joint cracked, anchor bolt nut ripped off due to seismic overturning moment. Anchor bolt has corrosion.

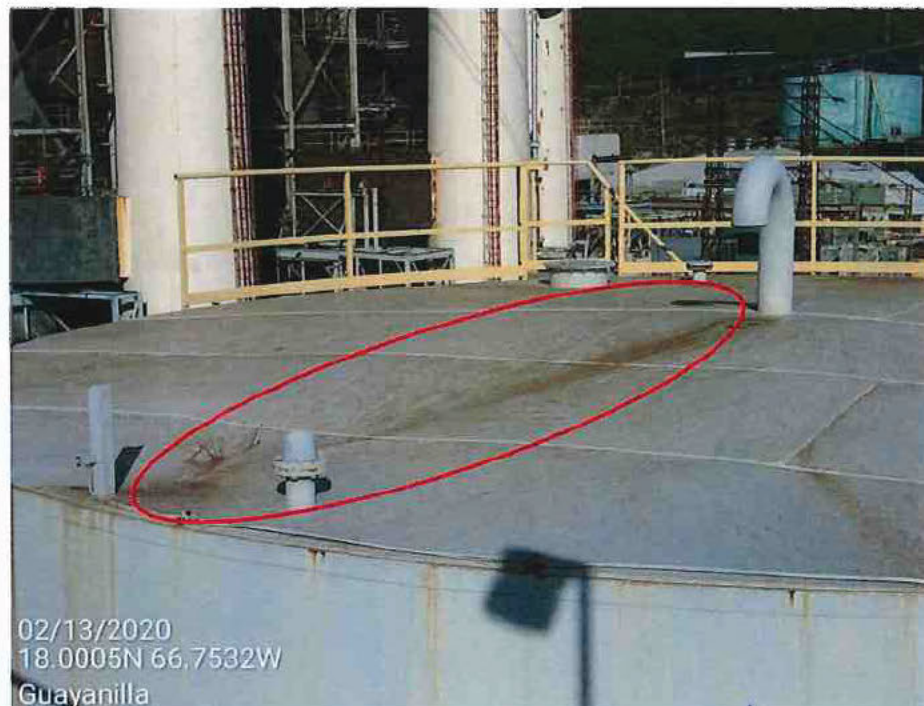
Picture 21 – Condensate Tank 5 roof paint deterioration, corrosion signs and partial roof collapse.

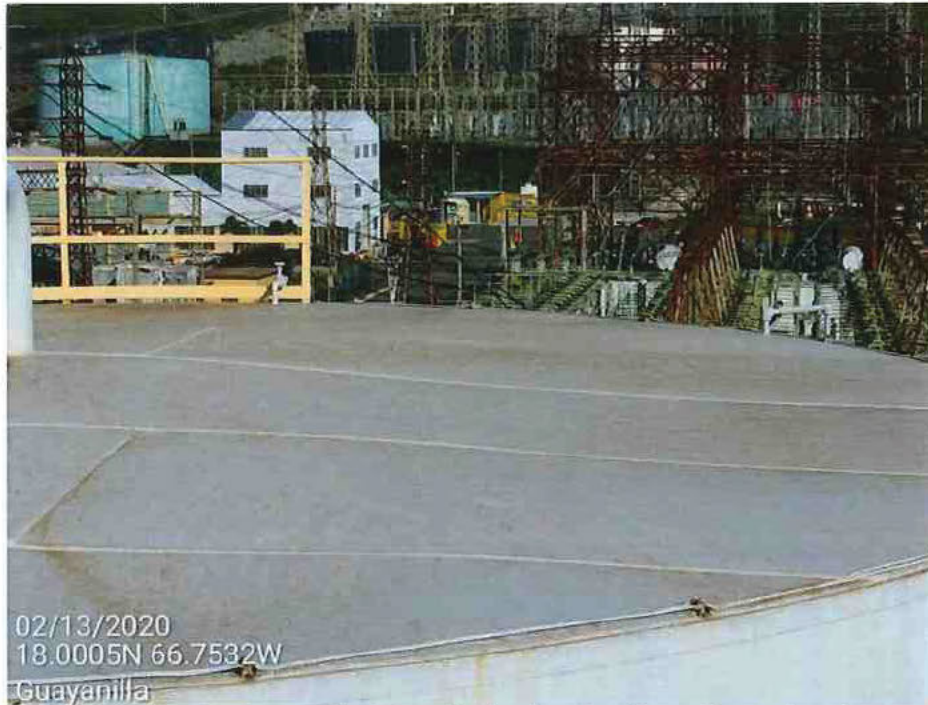
Picture 22 – Condensate Tank 5 roof paint deterioration and corrosion signs.

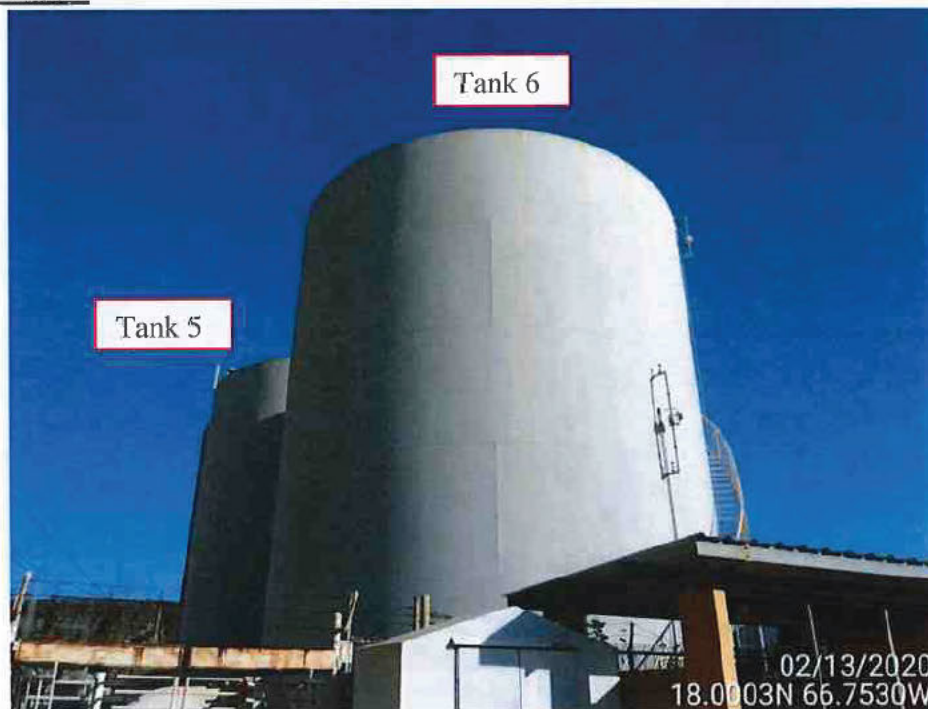
Picture 23 – Condensate Tank 6 shell paint deterioration.

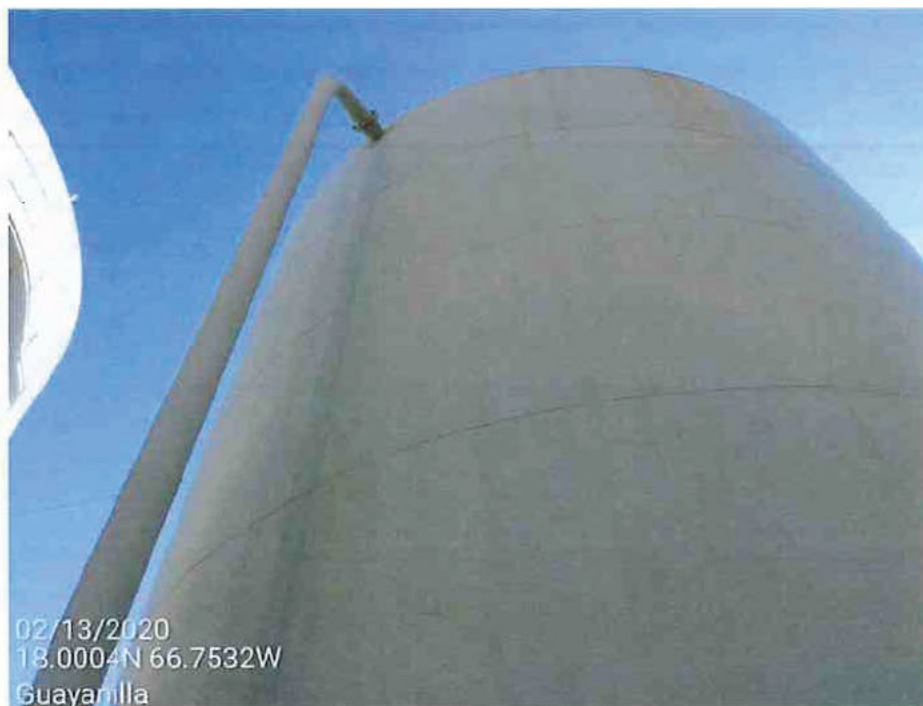
Picture 24 – Condensate Tank 6 shell paint deterioration.

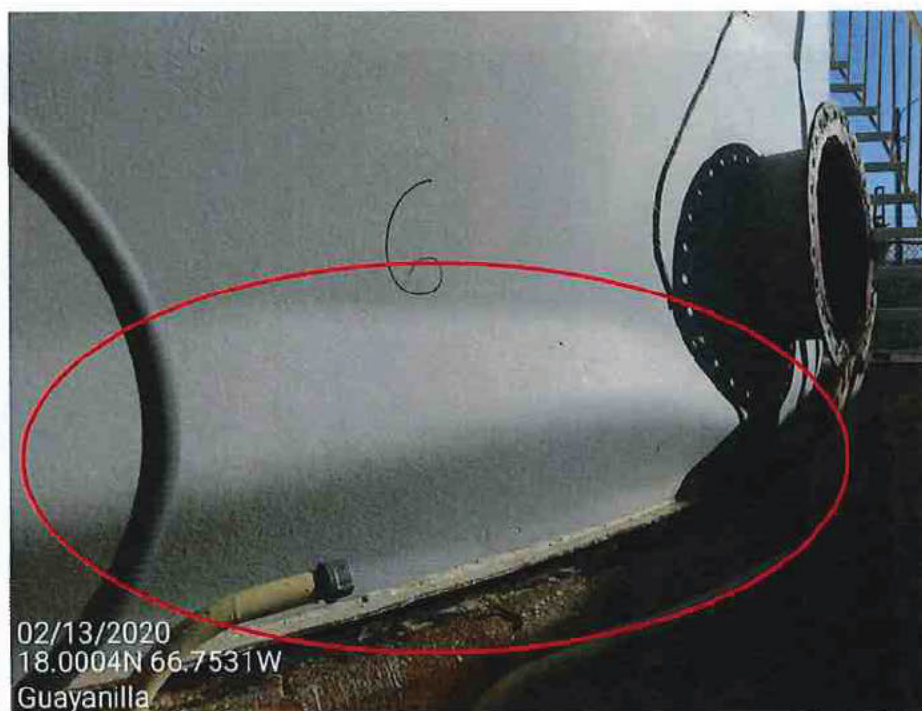
Picture 25 – Tank shell has elephant foot buckling areas at first ring, due to seismic overturning moment.

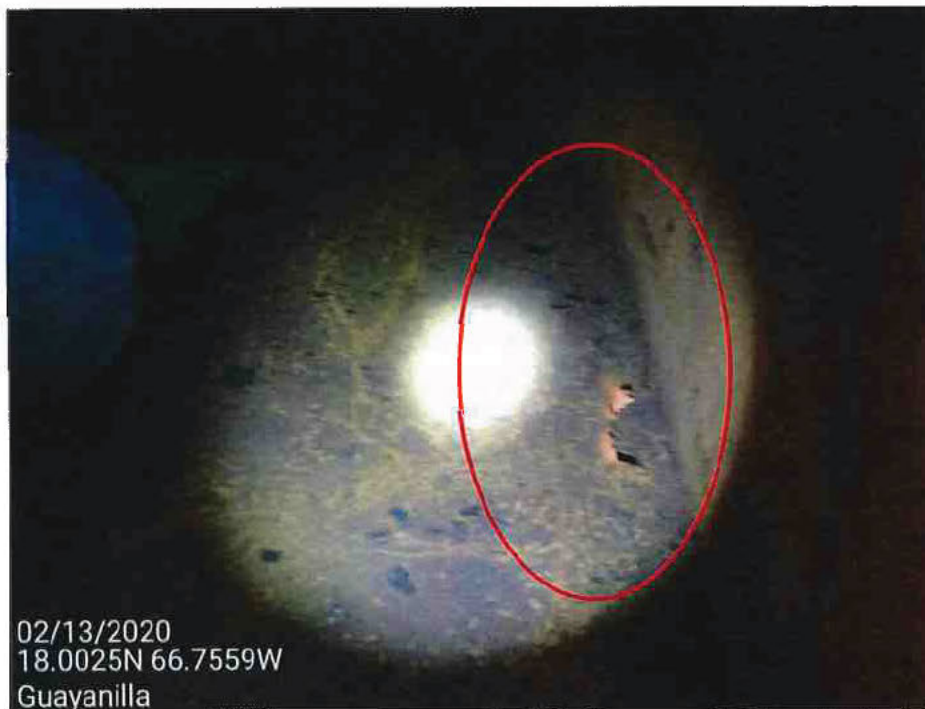
Picture 27 – Tank floor has corrosion sings and is broken at weld joint with shell.

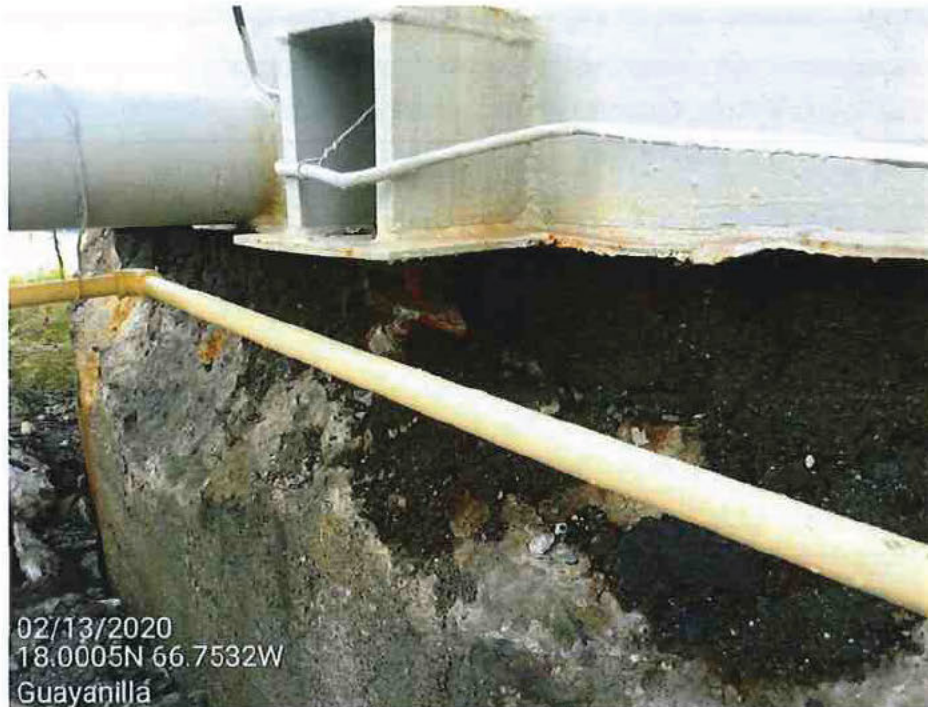
Picture 30 – Foundation concrete base crushed and anchor bolt ripped off from concrete base, due to seismic overturning moment.

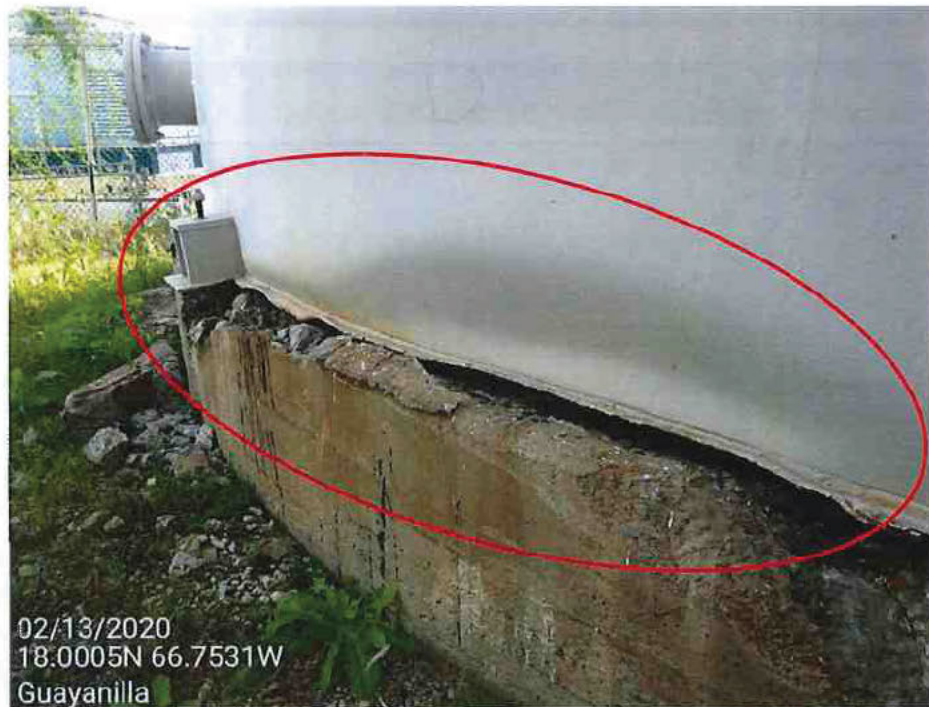
Picture 34 – Foundation concrete shell support ring crushed and tank shell has elephant foot buckling areas at first ring, due to seismic overturning moment.

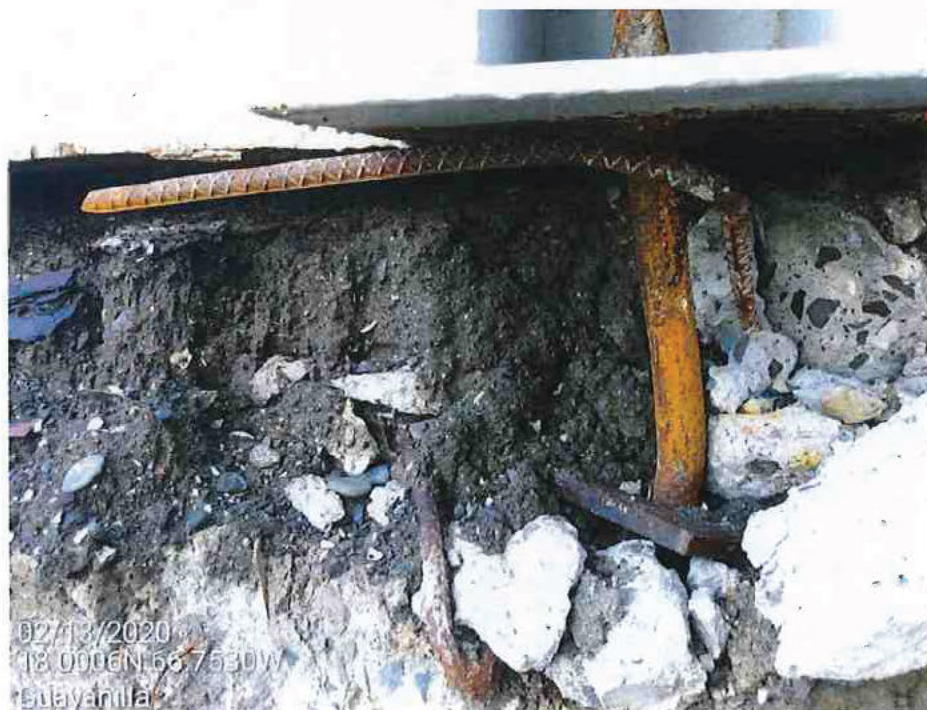
Picture 35 – Anchor bolt ripped off from concrete base, due to seismic overturning moment.

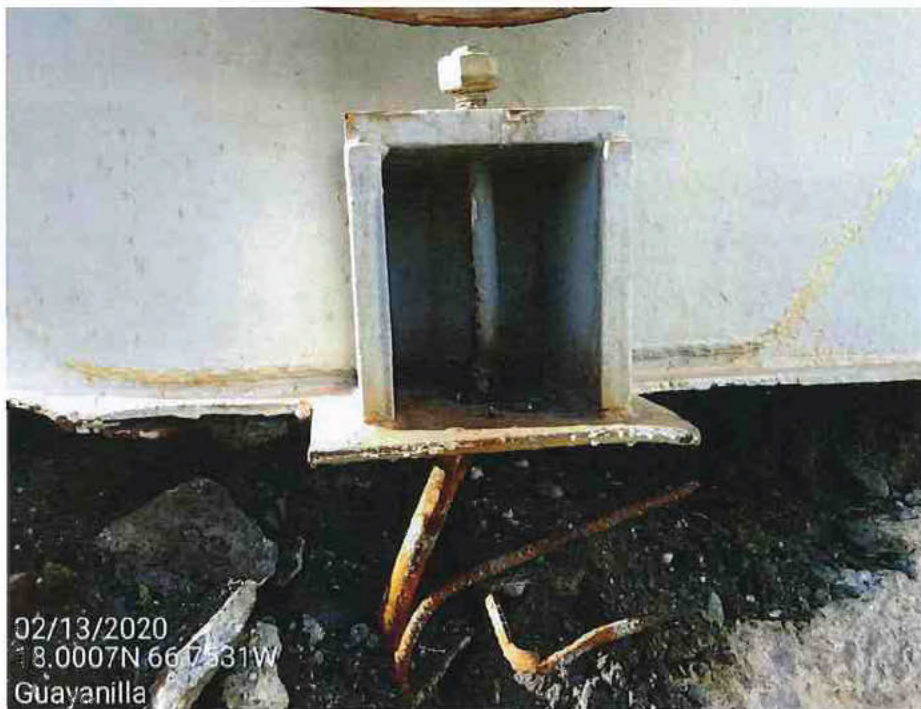
Picture 37 – Anchor bolt ripped off from concrete base, due to seismic overturning moment.

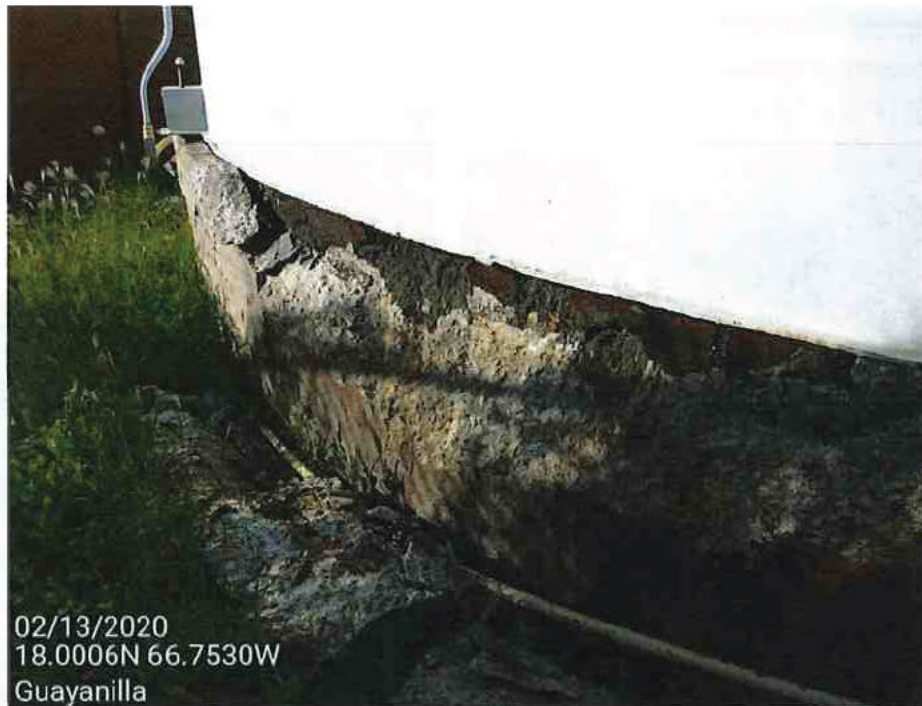
Picture 40 – Foundation concrete ring crushed, due to seismic overturning moment.

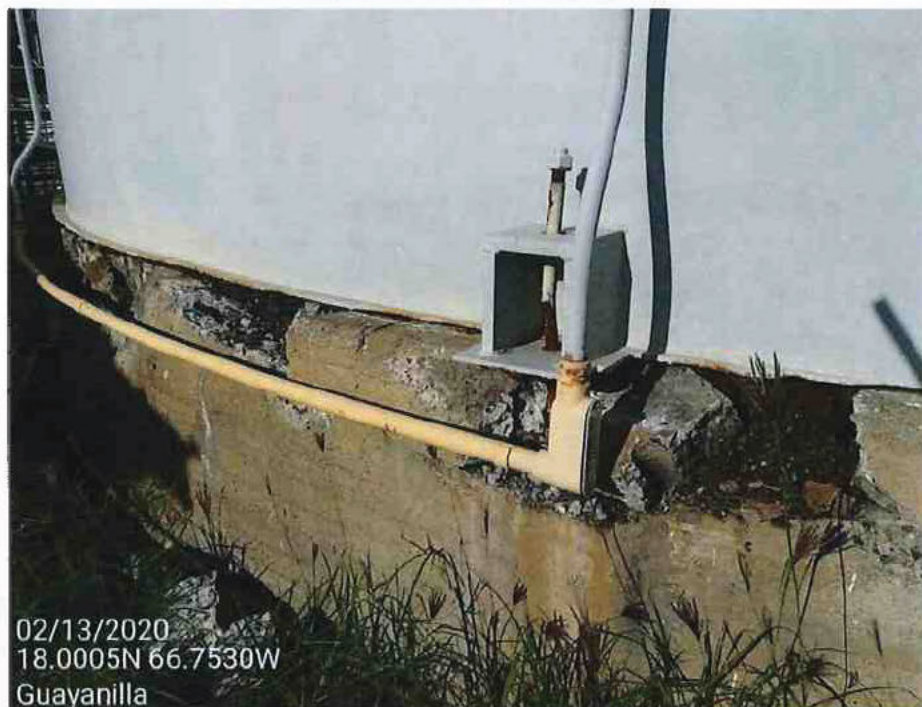
Picture 41 – Foundation concrete ring crushed, due to seismic overturning moment.

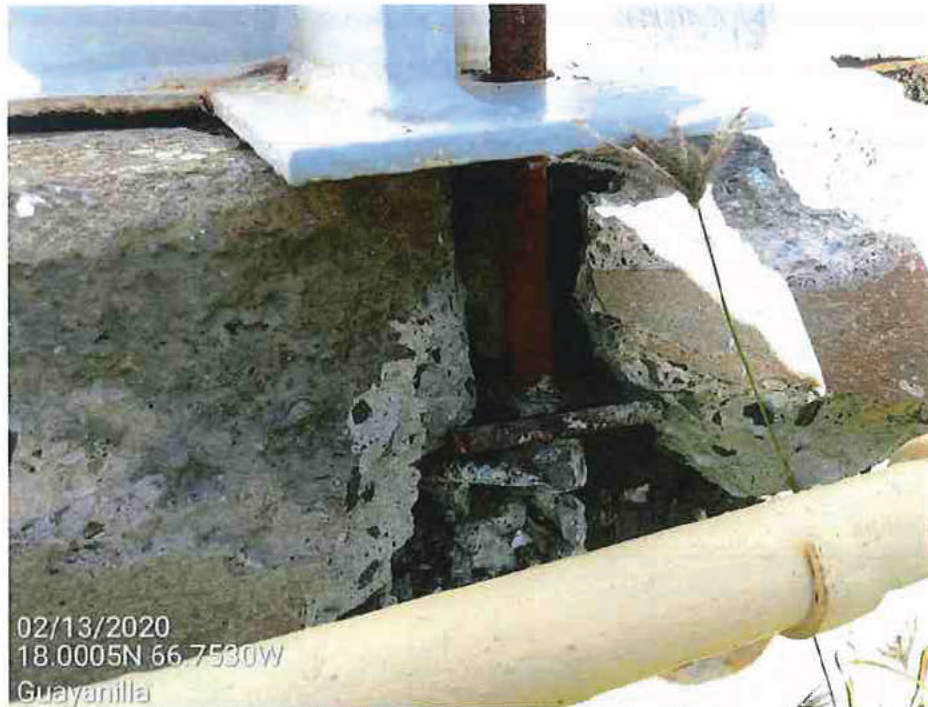
Picture 42 – Anchor bolt ripped off from concrete base, due to seismic overturning moment.

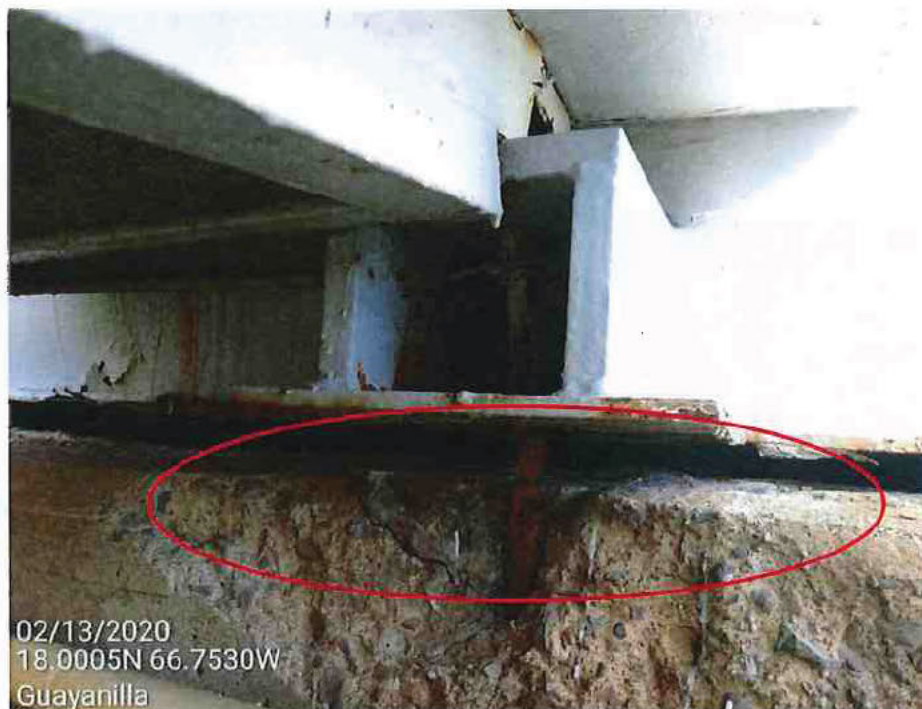
Picture 45 – Anchor bolt ripped off and broken at concrete base, due to seismic overturning moment.

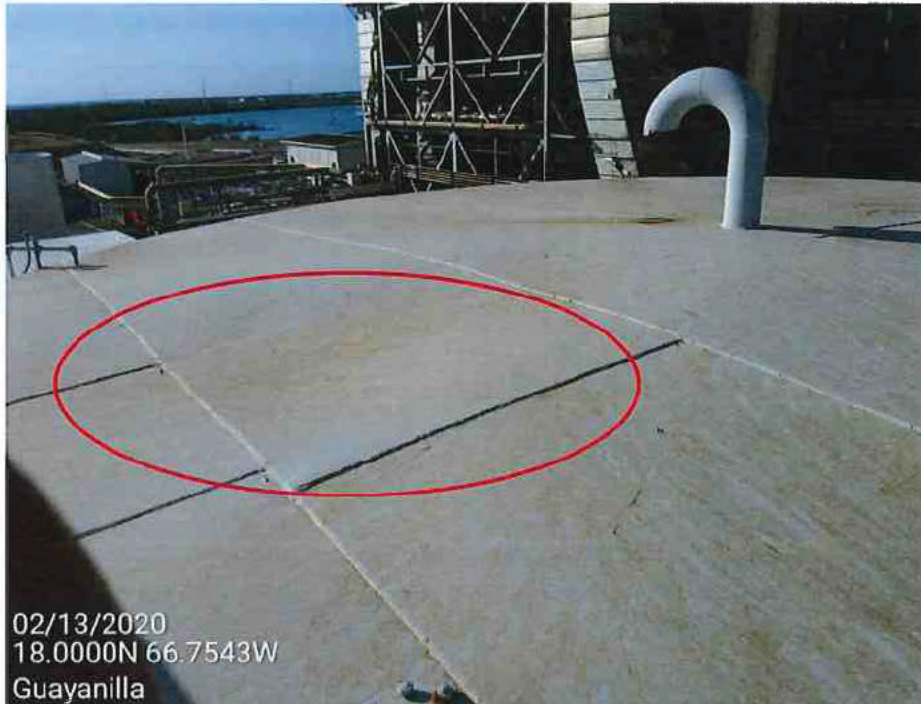
Picture 48 – Condensate Tank 6 roof have paint deterioration, corrosion signs and partial roof collapse.

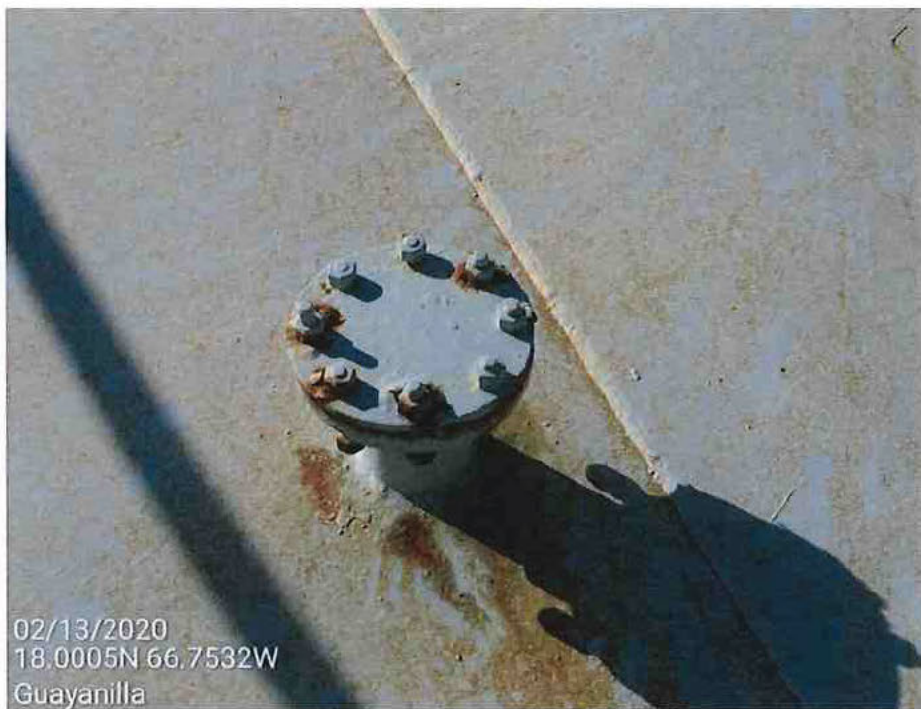
Picture 49 – Condensate Tank 6 roof have paint deterioration and corrosion signs.

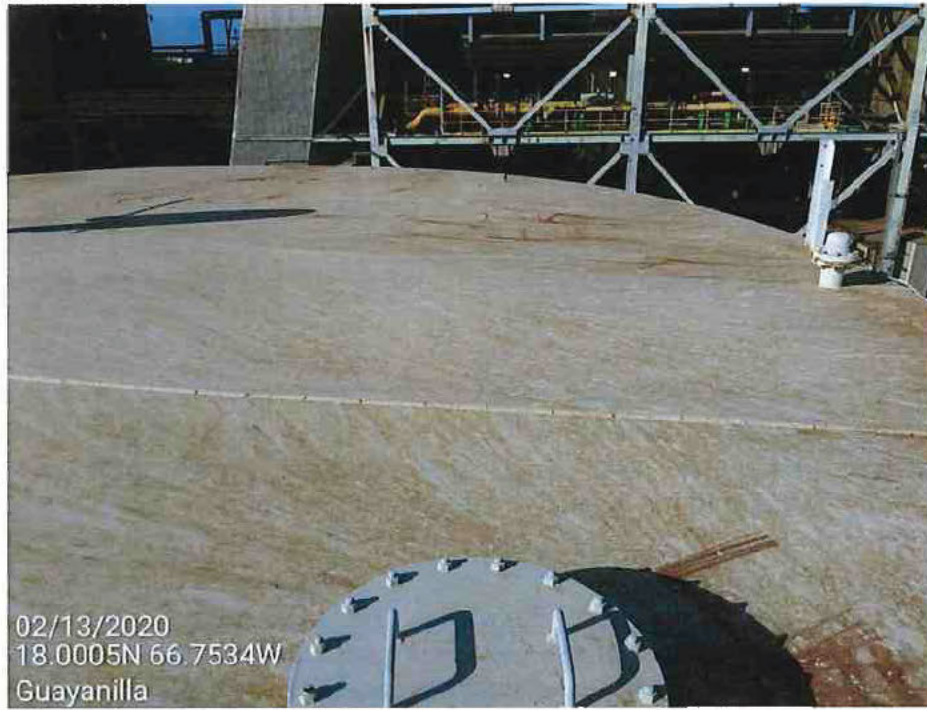
Picture 50 – Condensate Tank 6 roof have paint deterioration and corrosion signs.
