**GOBIERNO DE PUERTO RICO
JUNTA REGLAMENTADORA DE SERVICIO PÚBLICO
NEGOCIADO DE ENERGÍA DE PUERTO RICO**

May 29, 2020

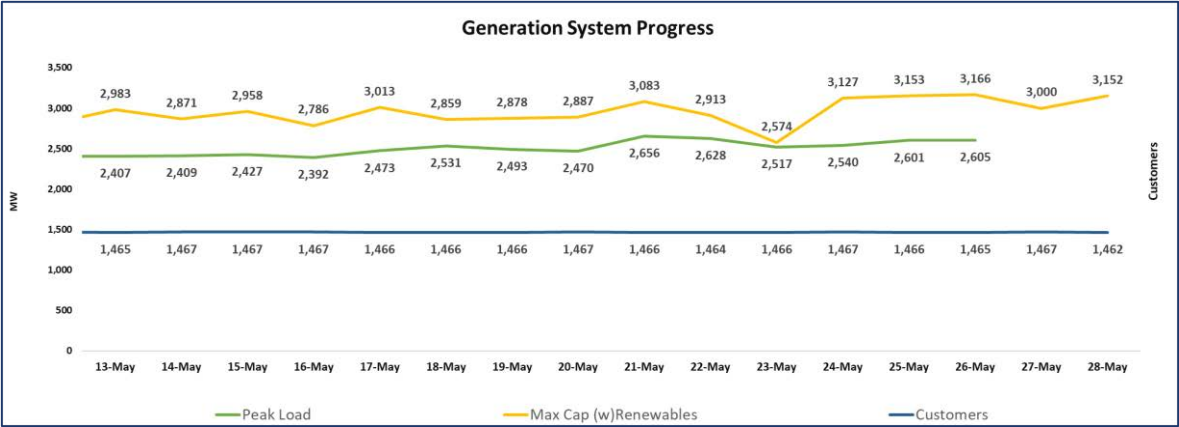
Project Team and Roles and Responsibilities Matrix

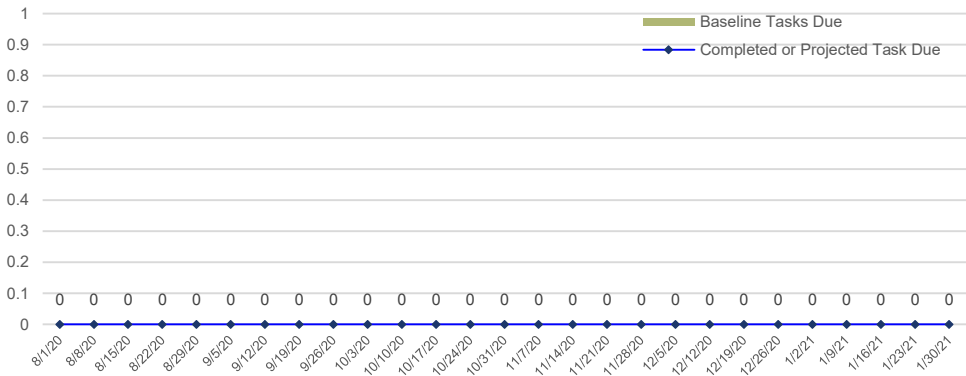
Scope and Metrics by Workstream

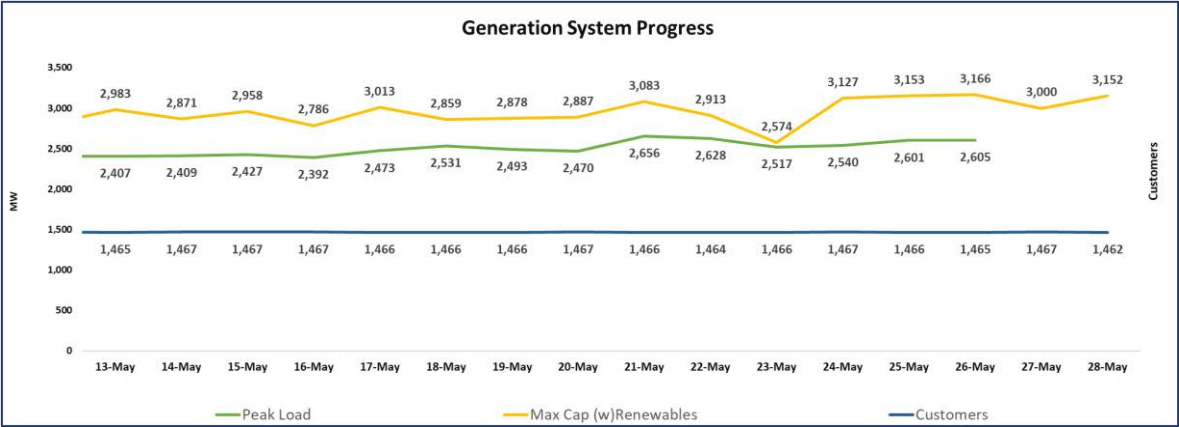
Project Team and Roles and Responsibilities Matrix
