CASE NO. NEPR-IN-2022-0002

Exhibit 1
Incident Preliminary Report

Costa Sur Substation Initial Facts from April 6, 2022 Incident

Name: 06APR2022 Major Outage Event – Costa Sur Substation's 230 kV Circuit Breaker Failure

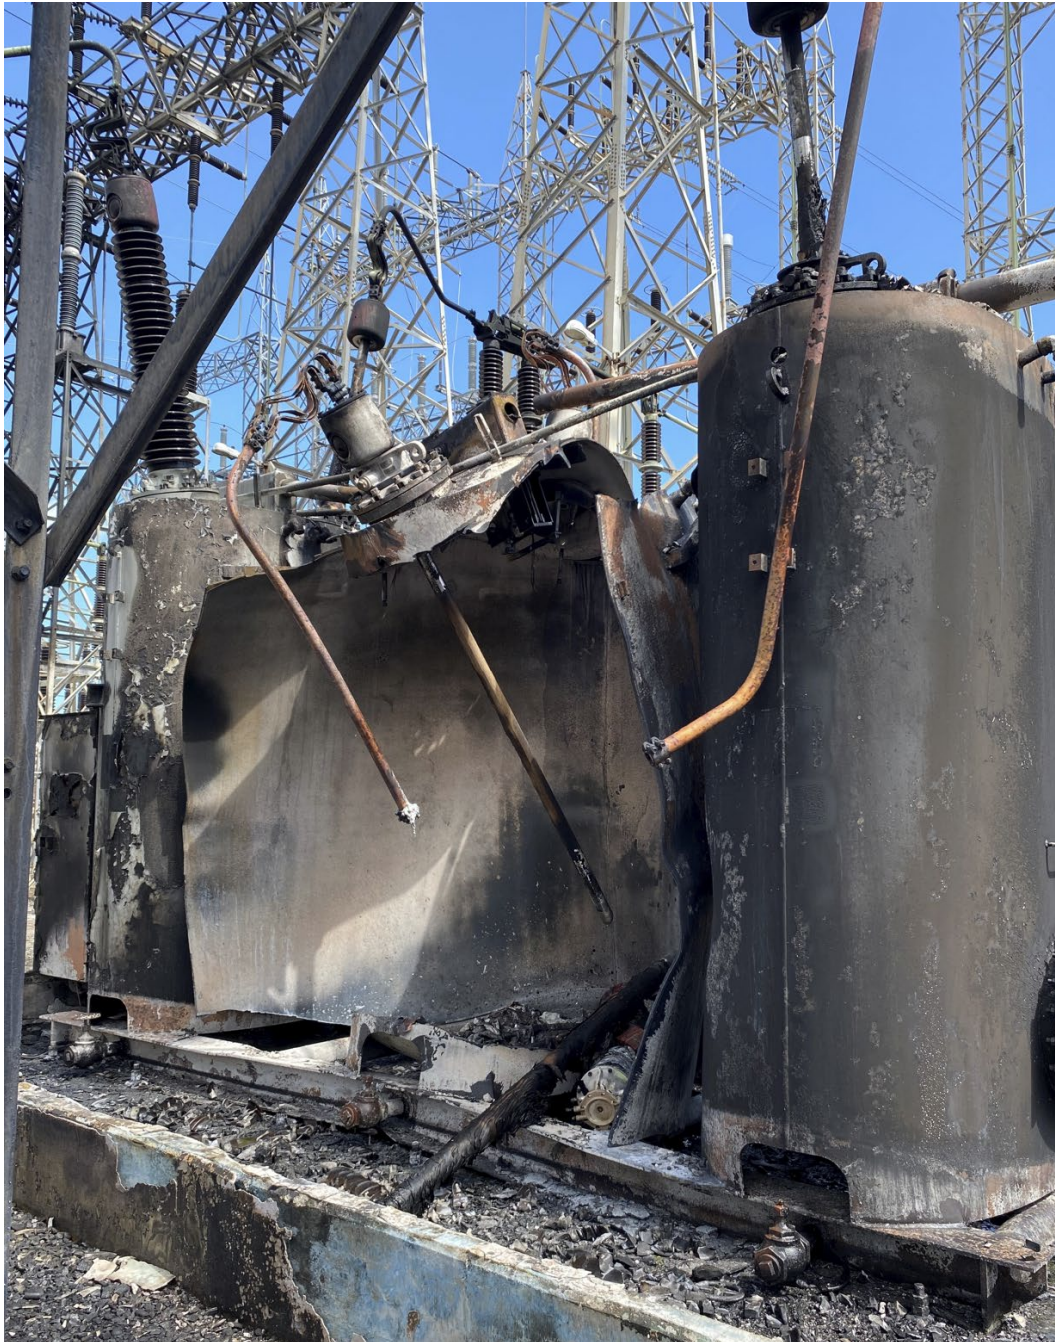
Figure 1-1 Photo of Damaged Oil-Circuit Breaker #0082

At 20:42 on Wednesday, April 6th, 2022, a fault occurred in the 230 kV switchyard of the Costa Sur Substation. Phase B of Oil-Circuit Breaker (OCB) #0082 suffered a catastrophic failure.

OCB #0082 connects to Costa Sur Steam Plant (SP) Generation Unit #5. While synchronizing Unit #5 to the grid and during the circuit breaker's closing operation, the circuit breaker experienced a failure followed by a ball of fire and flying debris that damaged Bus #6. The failure affected three adjacent circuit breakers and several portions of the substation's lattice structures.

The failure of OCB #0082 damaged the structure of Bus #6 and three additional circuit breakers.

Item	How Many?	Spare Available?	Target Date
230 kV OCB #0082 (failed device)	1	Yes	06-10-2022
230 kV OCB #0074 (collateral damage)	1	Yes	06-10-2022
Potential transformers (synchronism) on Bay #6	2	Yes	04-14-2022
Potential transformers (bus bar)	3	Yes	06-10-2022
230 kV insulators	30 approximately	TBD	06-10-2022
230 kV gang-operated switches	12 approximately	TBD	06-10-2022
30' of copper bus bar with hardware (confirming measurements)	1	TBD	06-10-2022

An engineering firm has provided the plan for the structural testing and engineering design for the reconstruction of the damaged bus and the replacement of OCBs #0082 and #0074.

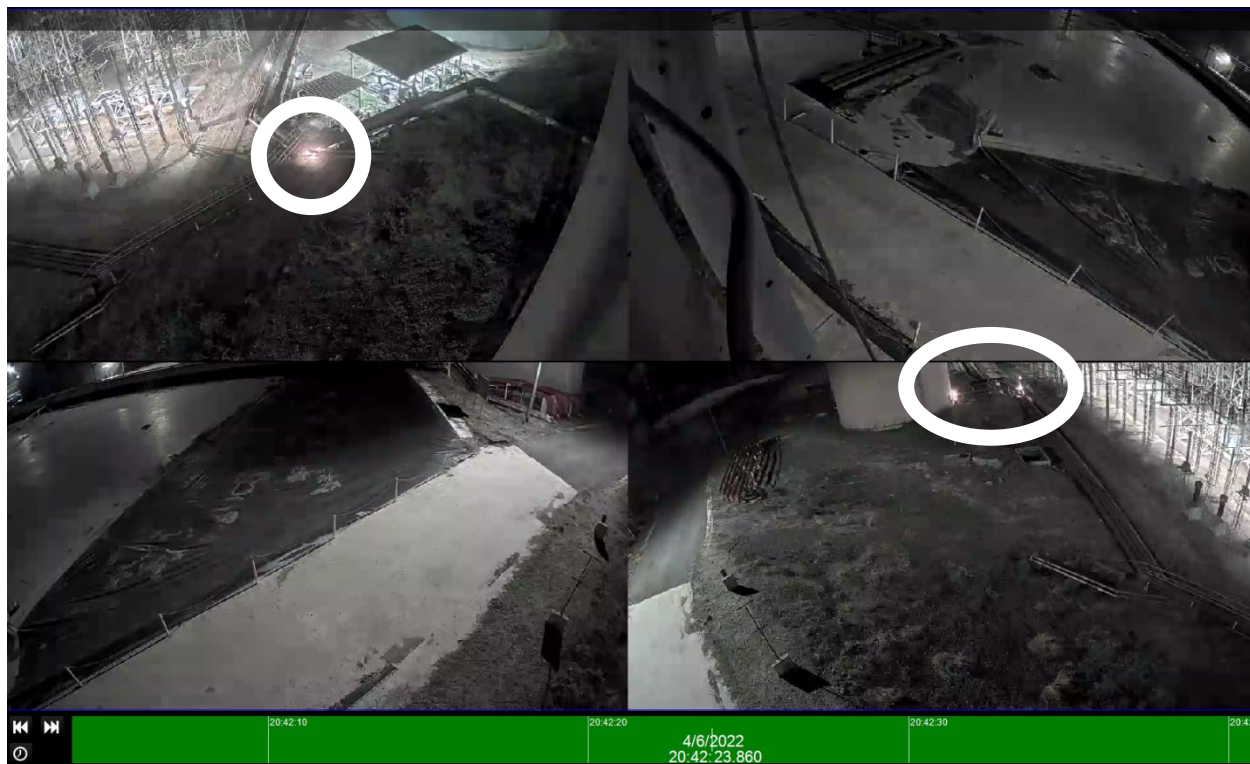
Figure 3-3 Security Cameras' Screenshots Showing Arcing Immediately Before the Failure

From the videos recorded by the security cameras, evidence of a ground fault prior to the failure is apparent. As of this moment, the source of this fault has not been identified. The Bureau of Alcohol, Tobacco and Firearms and Explosives (ATF) indicated evidence of arcing from the poles to the circuit breaker's tank on #0082.

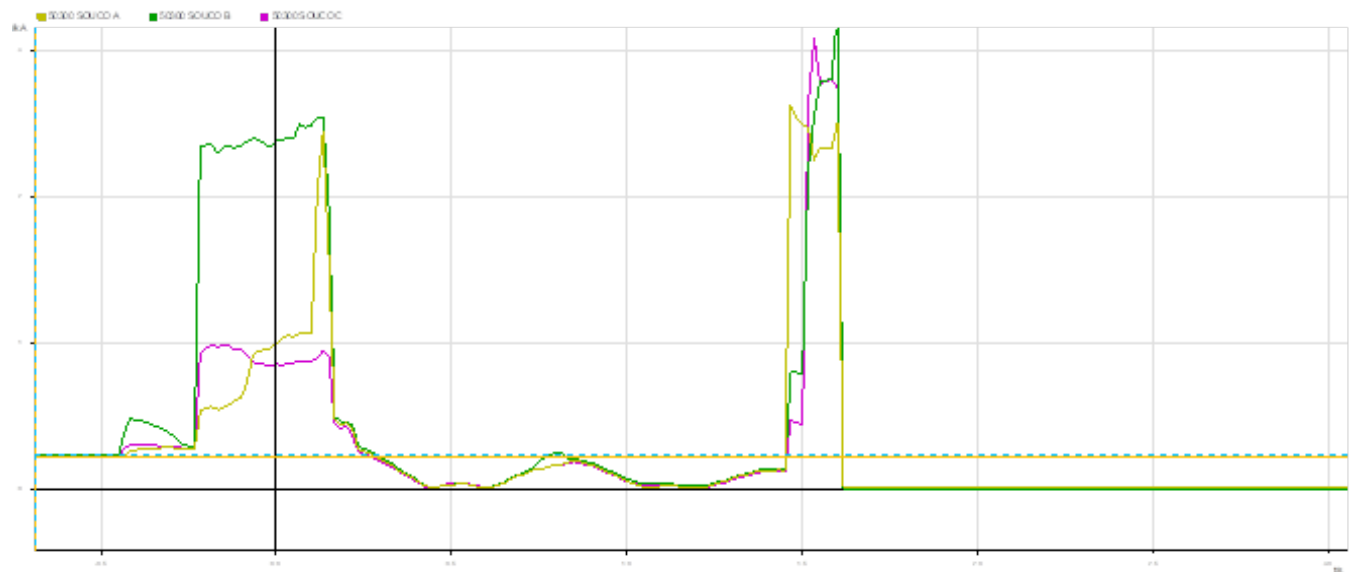
Figure 3-4 230 kV Current Readings in Line 50300 Aguirre-Costa Sur as seen by Aguirre Planta's Transient Recorder

Based on available data, the failure of the circuit breaker started after the closing of the circuit breaker. As seen in the figure below, the B-phase current showed a higher current compared to A's and C's phase currents. After approximately 230 milliseconds (ms), the current increased drastically and it can be assumed this was the moment when the circuit breaker B's phase failure occurred. This fault event lasted for about 400 ms.

About 1.7 seconds (s) after the failure happened, a second fault was visible in the recorded data and lasted for approximately 160 ms. More events occurred during this time period and detailed data is needed to confirm the sequence of events.

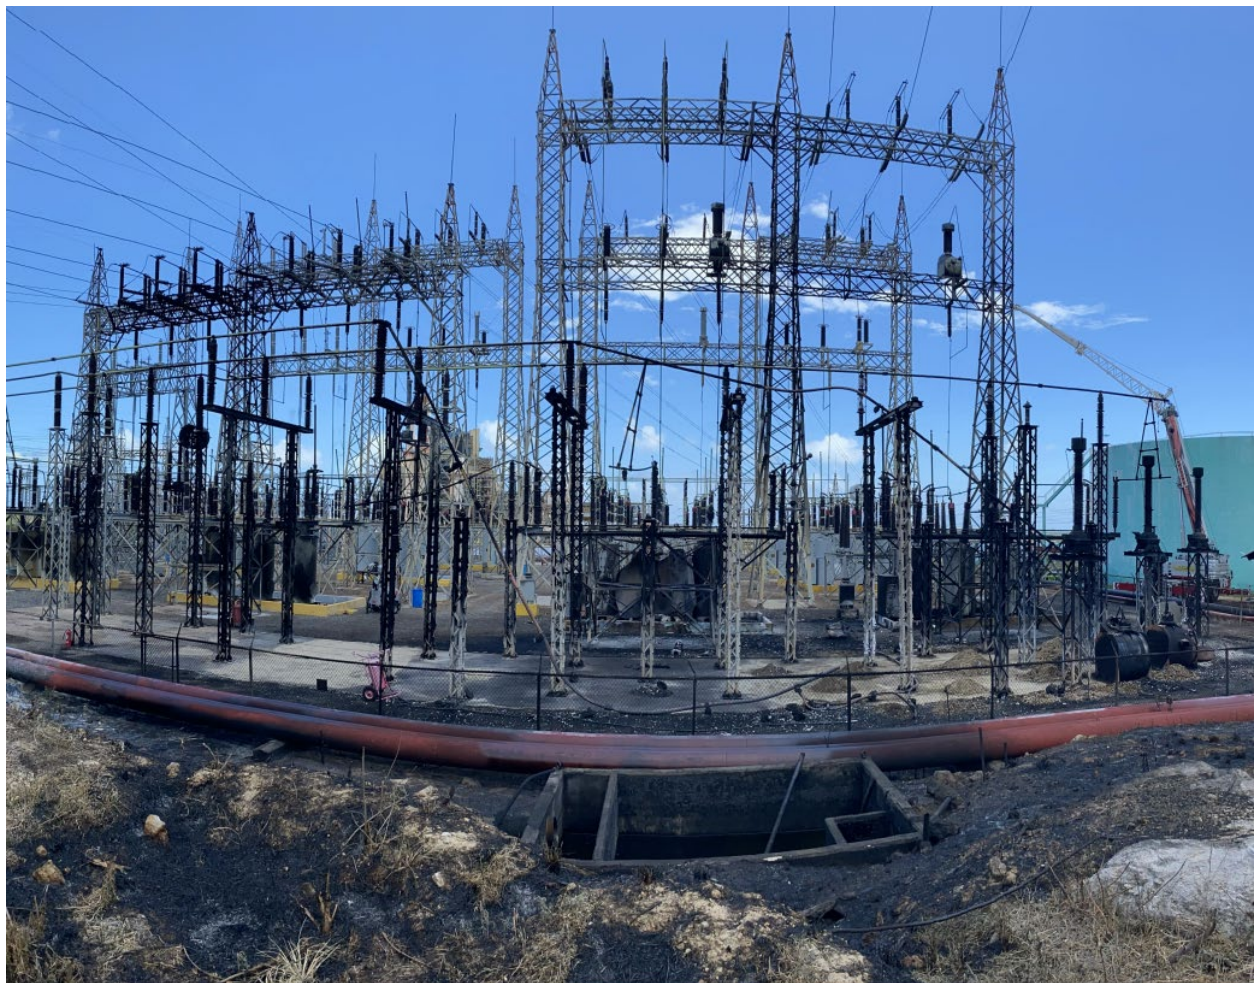
Figure 4-1 Evidence of Burned Oil Reaching Beyond Substation's Fence

The failure of OCB #0082 caused structural damages to Bus #6 and contaminated the support structures and high-voltage equipment to the left and right sides of the failure. The burning oil spill reached beyond the substation's fence, as seen in the front of the picture below.

Item	Type of Cleaning	Target Date
Structural bay #6	Completely	06-10-2022
OCB #50320	In addition to complete maintenance procedure	06-10-2022
OCB #50220	In addition to complete maintenance procedure	06-10-2022
