**CASE NO. NEPR-IN-2022-0002**

*Updates to Costa Sur Substation Incident on April 6, 2022*

April 18, 2022

**Name:** 06APR2022 Major Outage Event –  
Costa Sur Substation's 230 kV Circuit Breaker Failure

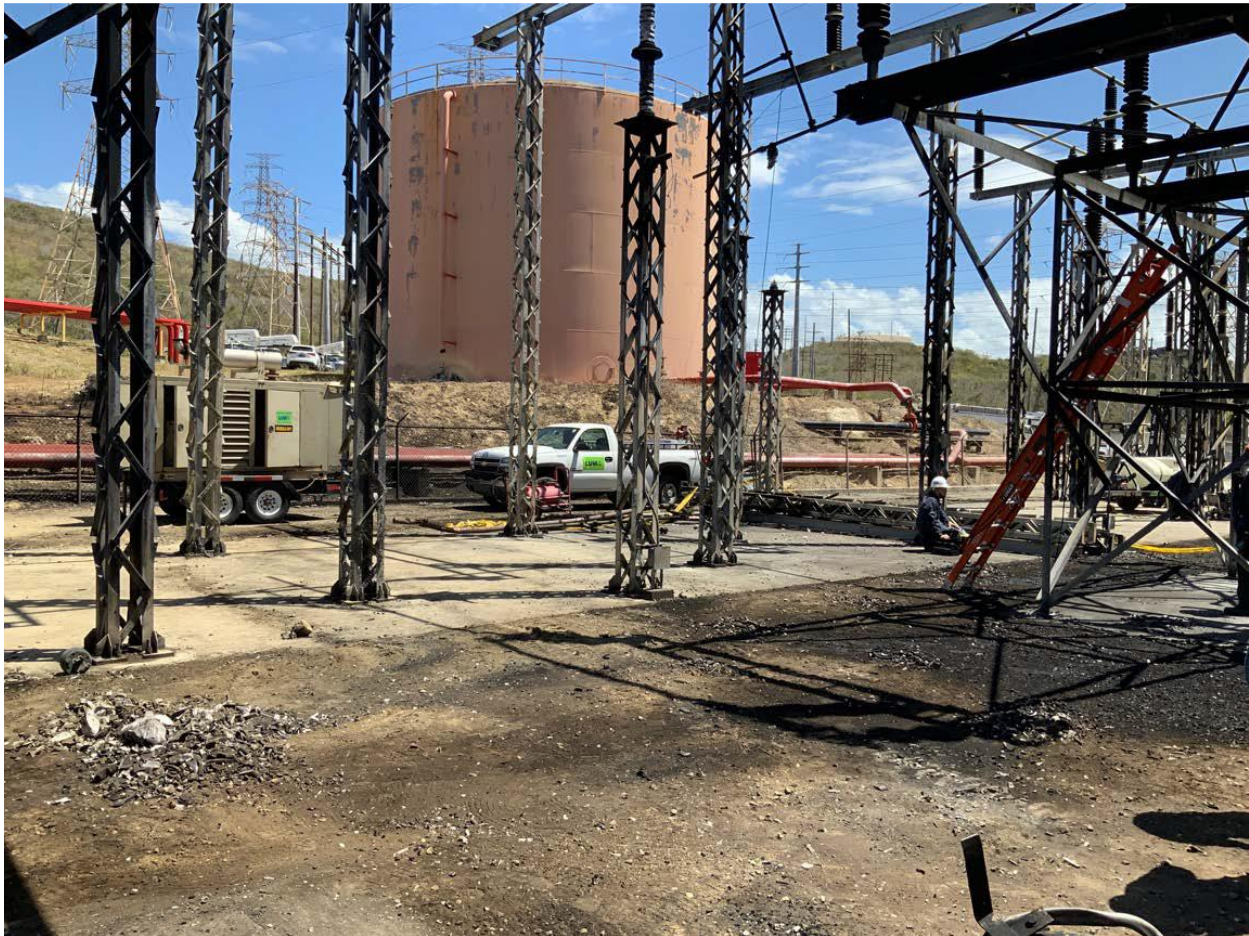
**Figure 4-2 Sample of Lattice Steel Structures Tested for Integrity**

- **The Engineering team performed a visual inspection of the damaged area and identified 20 steel lattice structures to be tested for their integrity condition prior to be returned to services.** Samplings of the steel structures as shown in Figure 4-2 Sample of Lattice Steel Structures Tested for Integrity were taken on April 13th and are being analyzed for their condition to ensure the structures integrity. The results will be available by the end of the week of April 18th. The results are being evaluated to confirm the materials' integrity due to their exposure to high temperatures as well as to verify the physical capacity or molecular behavior of the materials was not compromised.

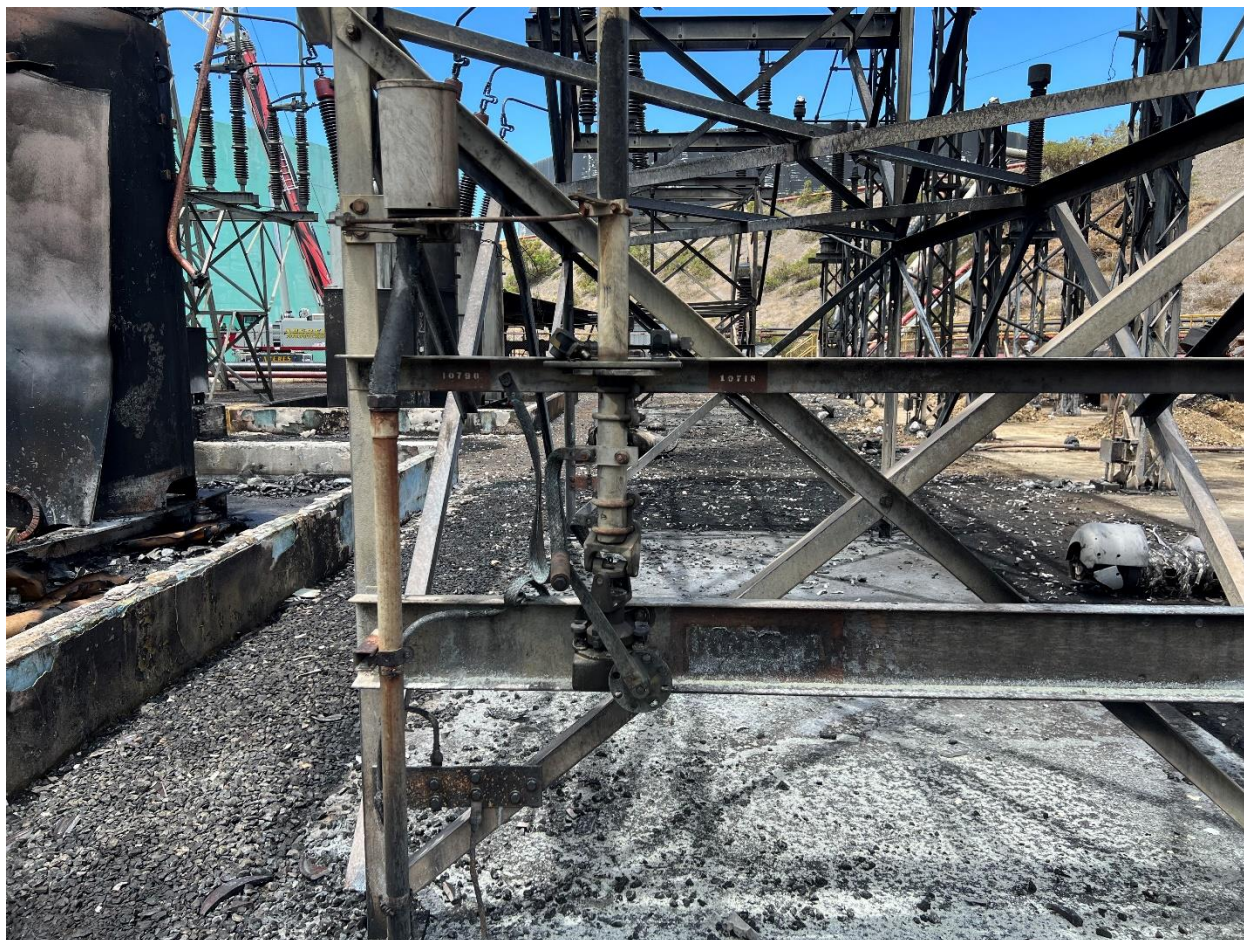
**Figure 4-3 Ground Areas to be Evaluated**

The area around the affected breakers as shown in the Figure 4-3 Ground Areas to be Evaluated has been cleaned of debris and the soil in that area is being evaluated for ground integrity. Soil and gravel requirements are being identified to bring the area to their proper condition.

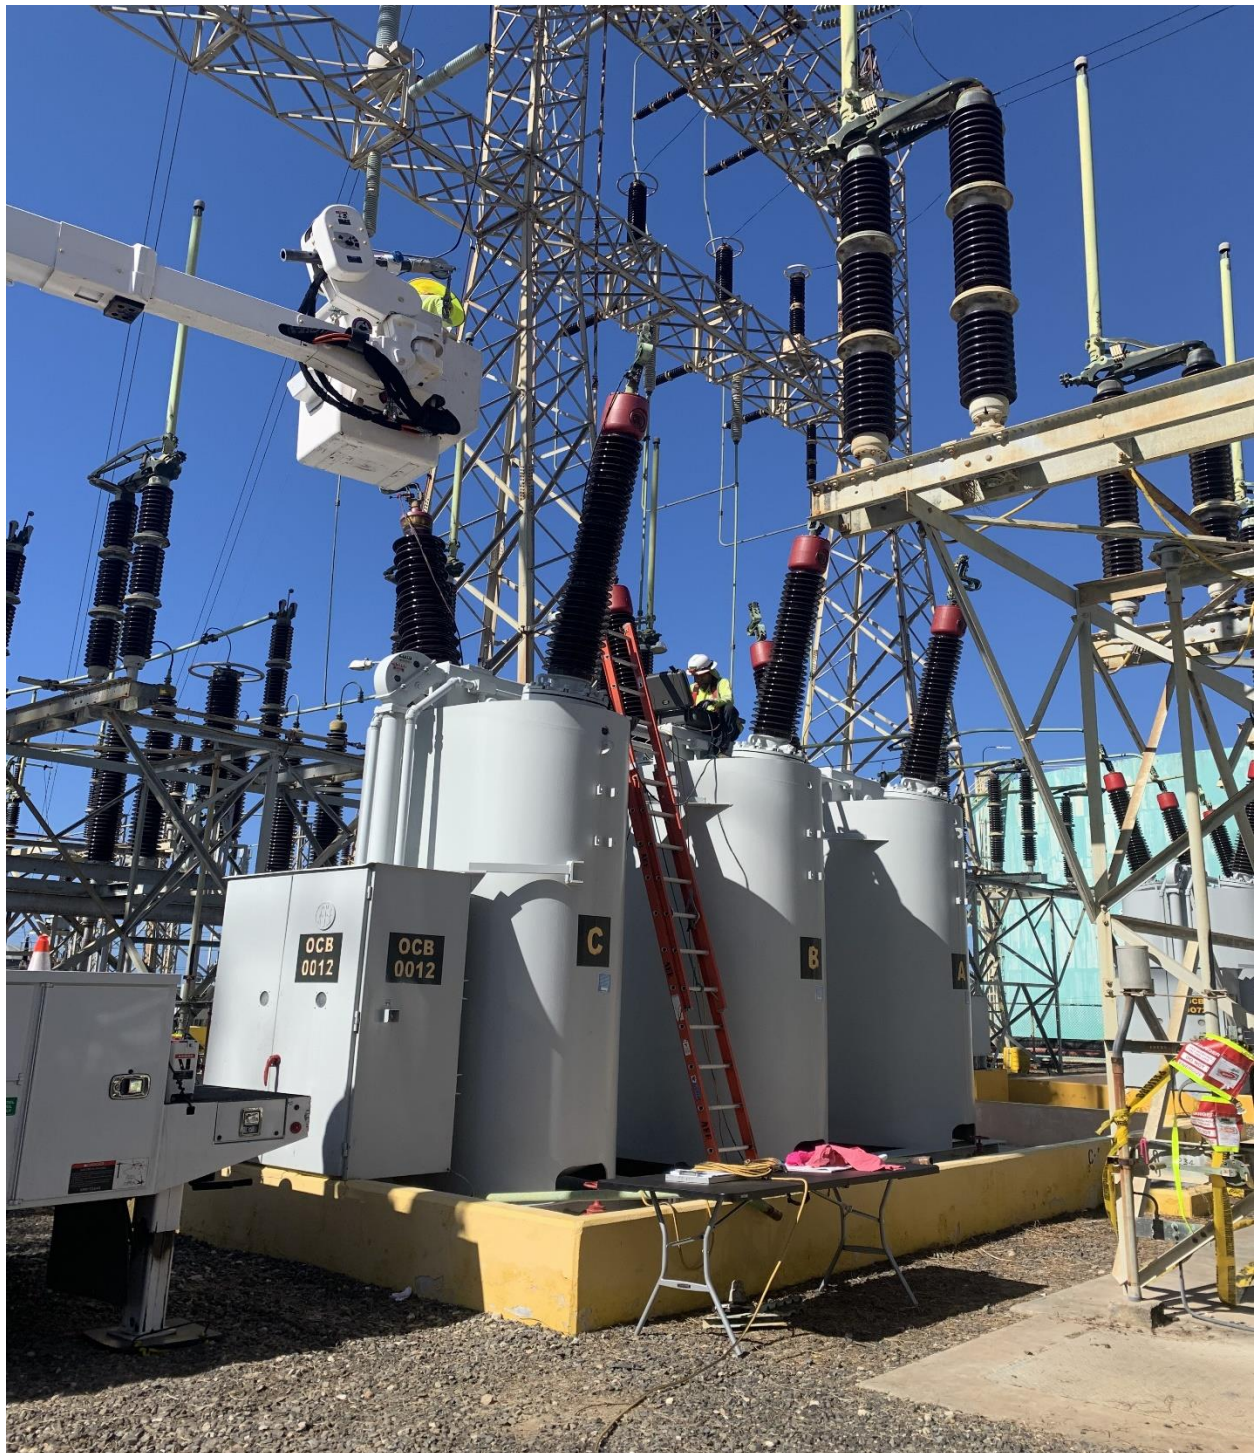
**Figure 4-4 Field Crews Testing Circuit Breaker Bushings Along with Performing a Full Circuit Breaker Maintenance Check**

Additional onsite activities include LUMA teams carrying out breaker testing including Ductor, Doble (bushing), and other maintenance activities as shown in Figure 4-4 Field Crews Testing Circuit Breaker Bushings Along with Performing a Full Circuit Breaker Maintenance Check. In Figure 4-6 LUMA Transmission Line Crews Replacing and Cleaning High-voltage Insulators, Transmission Line crews were working through the night to clean insulators where there was light contamination and replace insulators if there was significant contamination.

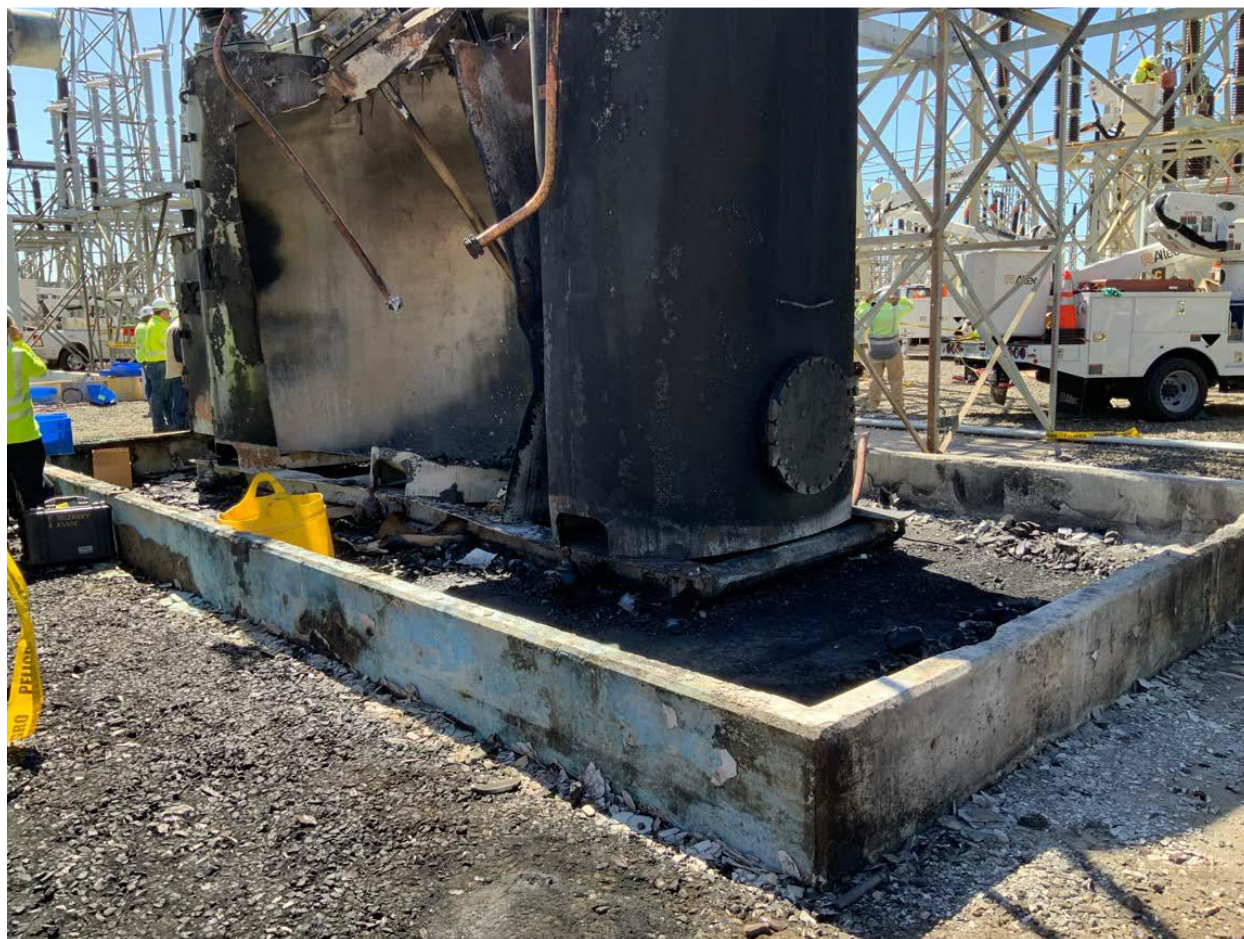
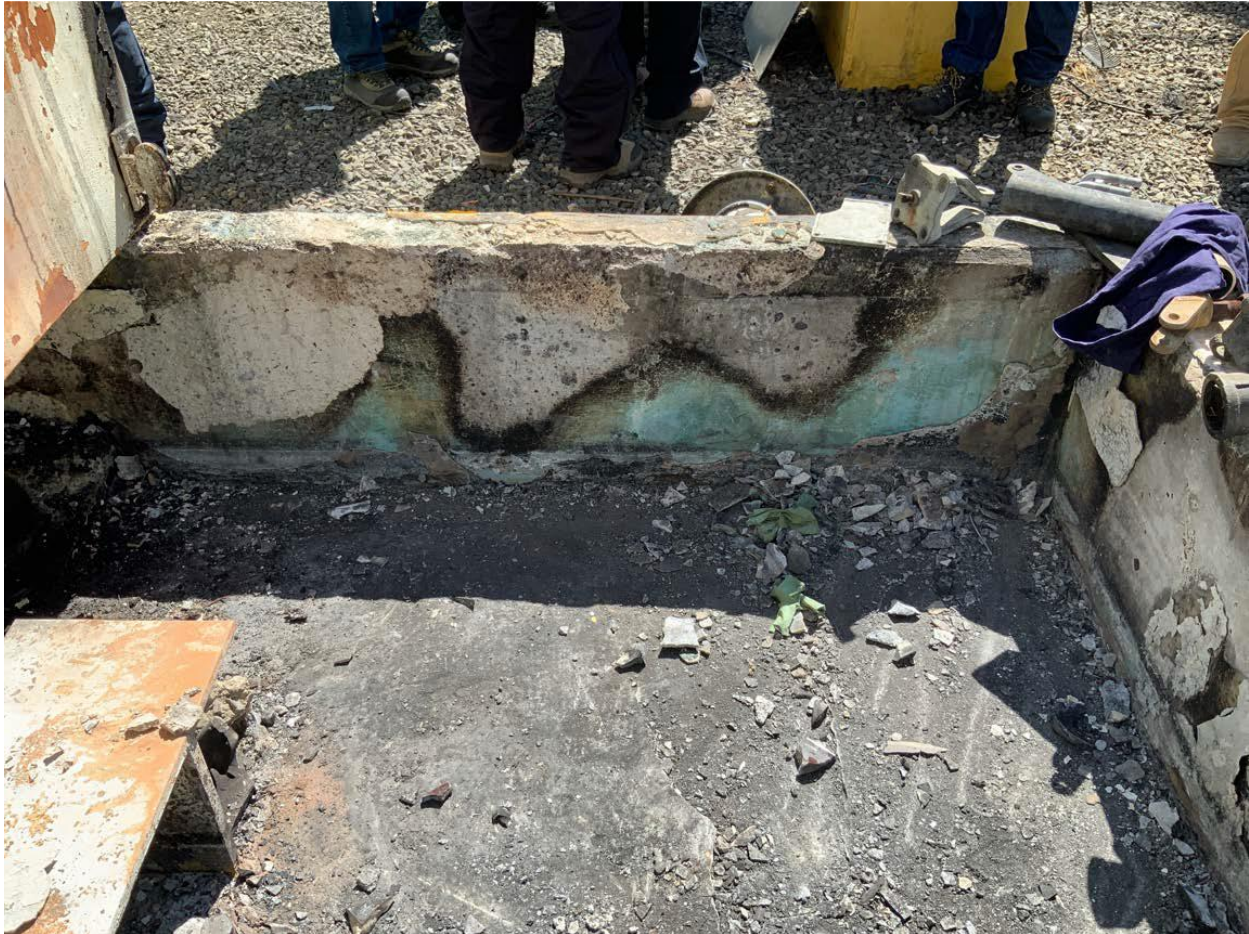
**Figure 4-7 Foundation to be Tested**

- **Take core samples from the affected foundations** as shown in Figure 4-7 Foundation to be Tested and Figure 4-8 Close-up of Foundation to be Tested. These samples will be sent to a lab on the mainland for an integrity analysis that will determine if any modifications are required. This activity is scheduled to occur on Monday, April 18th.
