Independent Engineering Report

Cambalache Power Plant

Report SL-015976.CA

September 30, 2021

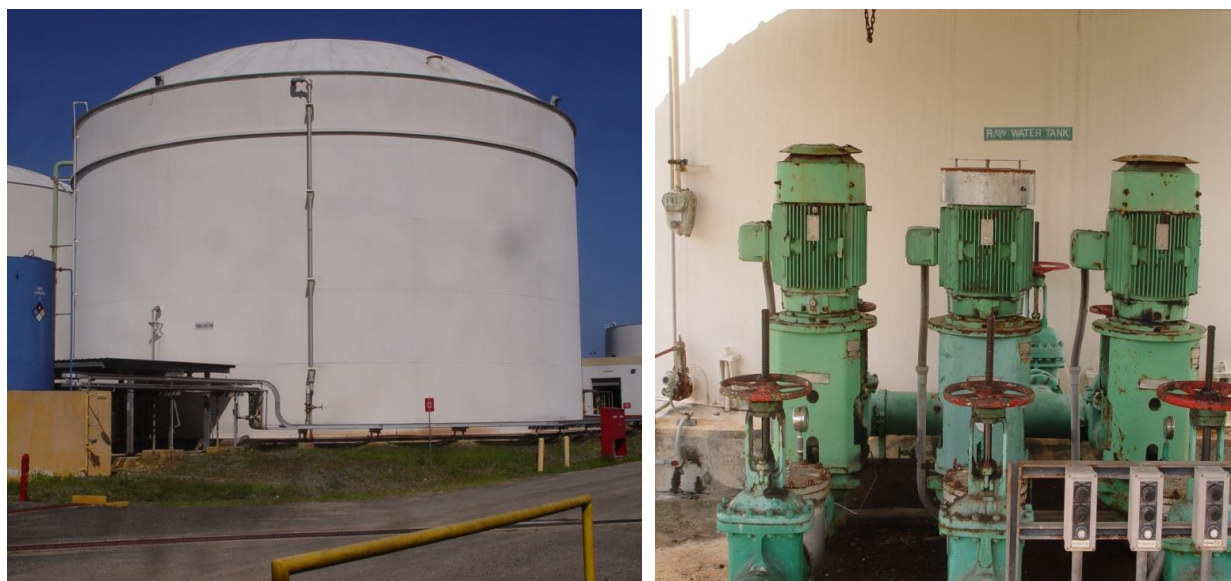
Figure 3-2 — Demineralized Water Tank and Raw Water Transfer Pumps

Like the raw-water tank, the demineralized-water tank appears to be well maintained, and the weather shroud over the raw-water transfer pumps appears to be helping to mitigate weather-related corrosion of the equipment beneath it (see Figure 3-2).

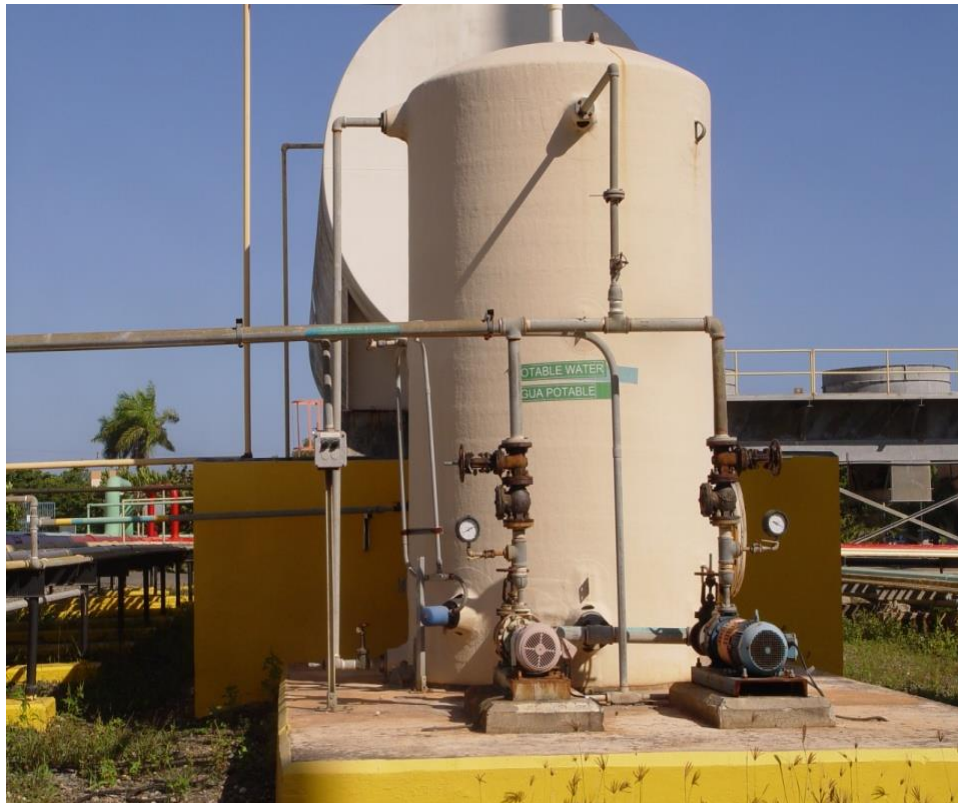
Figure 3-3 — Potable Water Storage Tank

The potable water tank and pumps are in an outdoor area exposed to the elements. The tank appears to be in good condition, but the valves and pump casings show considerable corrosion, as is the case with many unprotected systems on site.

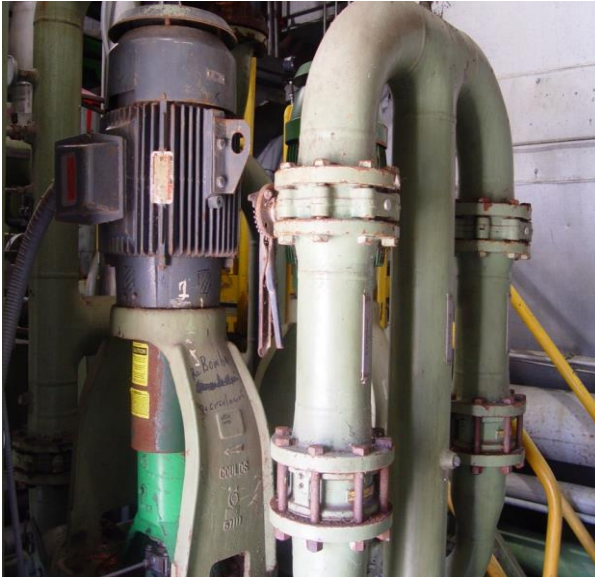
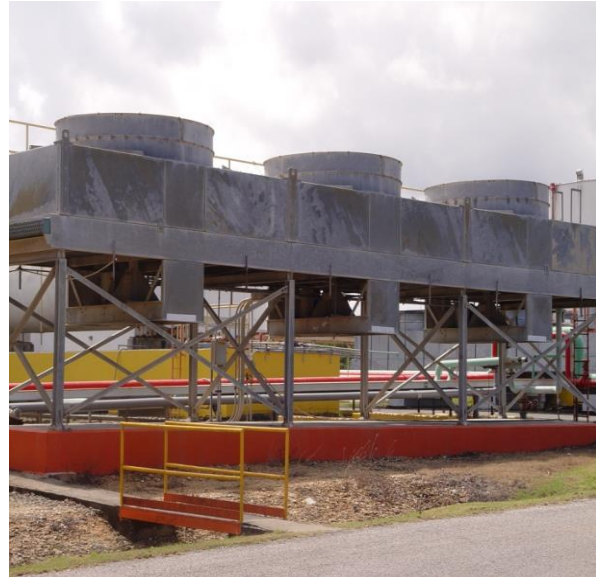
Figure 3-4 — Water Circulation Pumps and Fin Fan Cooler

The closed cooling water systems show evidence of some minor corrosion, but they generally appear to be in good serviceable condition (see Figure 3-4). The circulating water pumps are contained in an enclosure that appears to have preserved the equipment better than exposed systems on site of the same vintage.

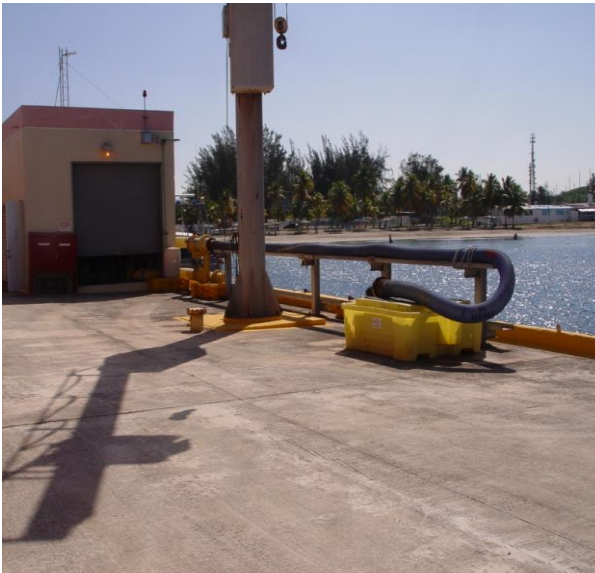
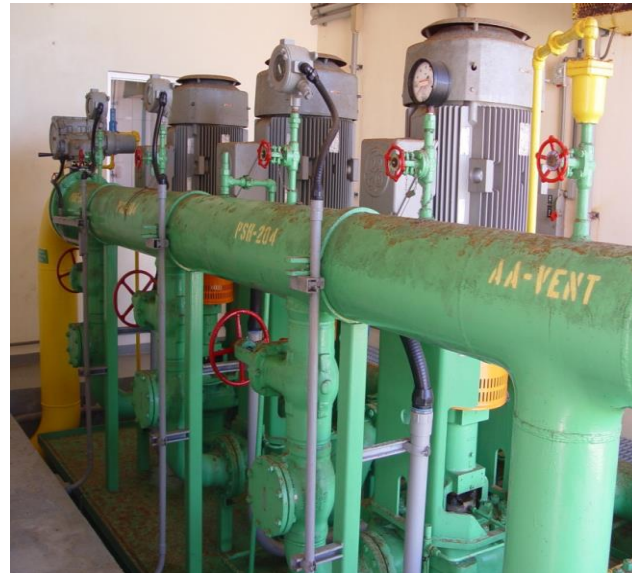
Figure 3-5 — Barge Unloading Area and Barge Unloading Pumps

The fuel transfer station located at Arecibo Port (Figure 3-5) is in good condition, thanks largely to the weather-proof enclosure housing the pumps. Based on recent interviews, Plant staff did not make note of any recent maintenance issues or concerns with the system.

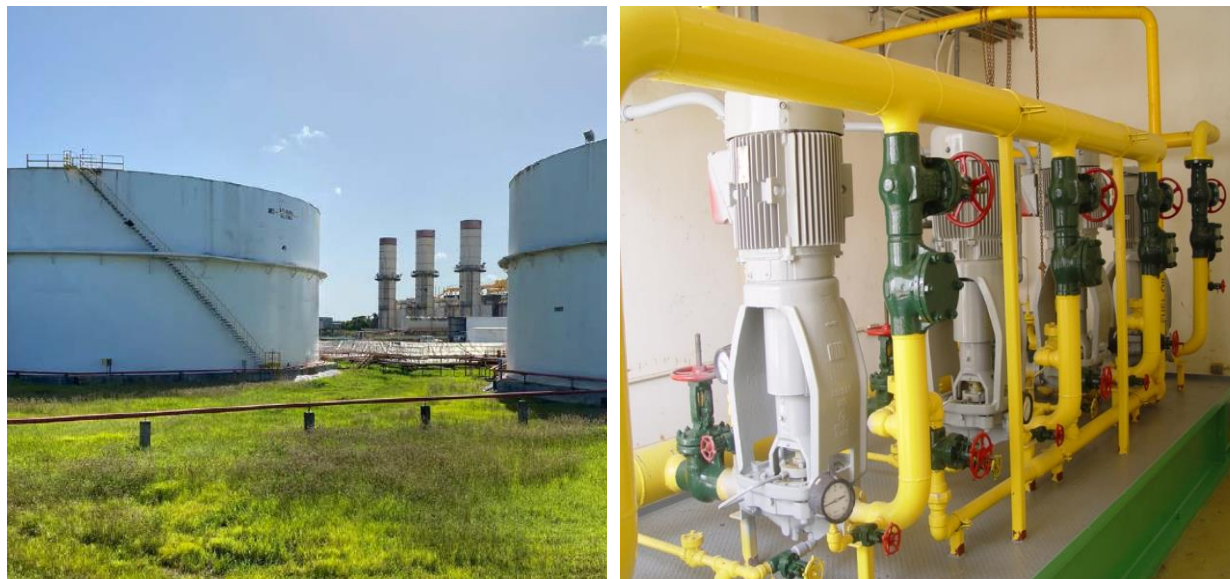
Figure 3-6 — Fuel Oil Storage Tanks (1 and 2) and Fuel Oil Forwarding Pumps

Several of the fuel storage tanks have begun to show rust streaks, indicating that their coating systems are no longer providing complete corrosion protection. The fuel forwarding pumps, however, appear to be well

maintained and well protected by a weatherproof enclosure. Figure 3-6 includes a photograph of two of the three fuel storage tanks from August 2020 as well as a photo of the three fuel forwarding pumps in their enclosure and the truck unloading pump obscured at the far end of the row.

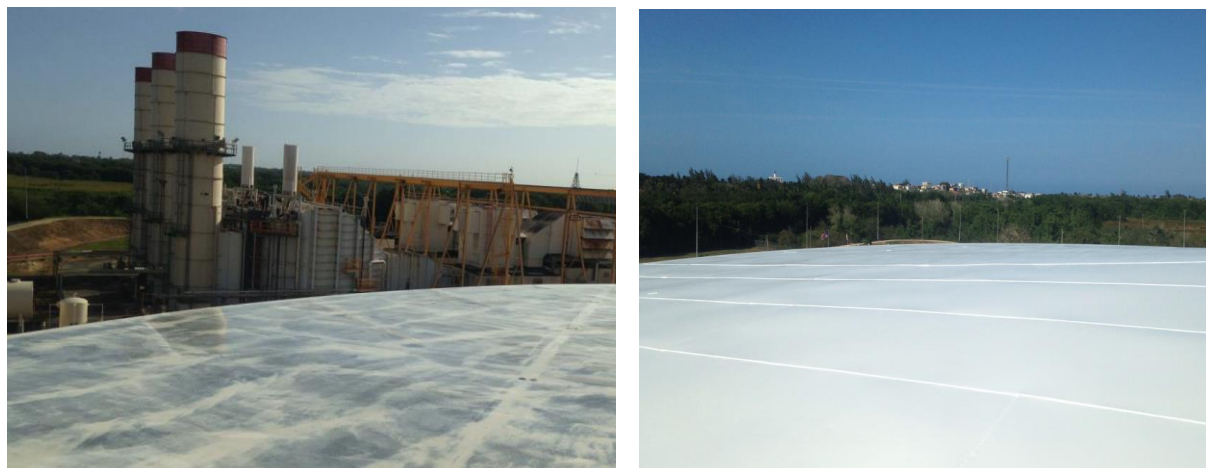
Figure 3-7 — Fuel Storage Tank R1 Roof

Pictured is the Fuel Storage Tank R1 roof before (left) and after refurbishing (right).

Plant staff recently completed repairs to the fuel forwarding pump shelter, which had been damaged in the 2017 hurricane. The interior and exterior of Fuel Storage Tank R1 were also recently refurbished, and the tank has been returned to service. Figure 3-7 provides a visual of the Fuel Storage Tank R1 roof before and after this work was performed.

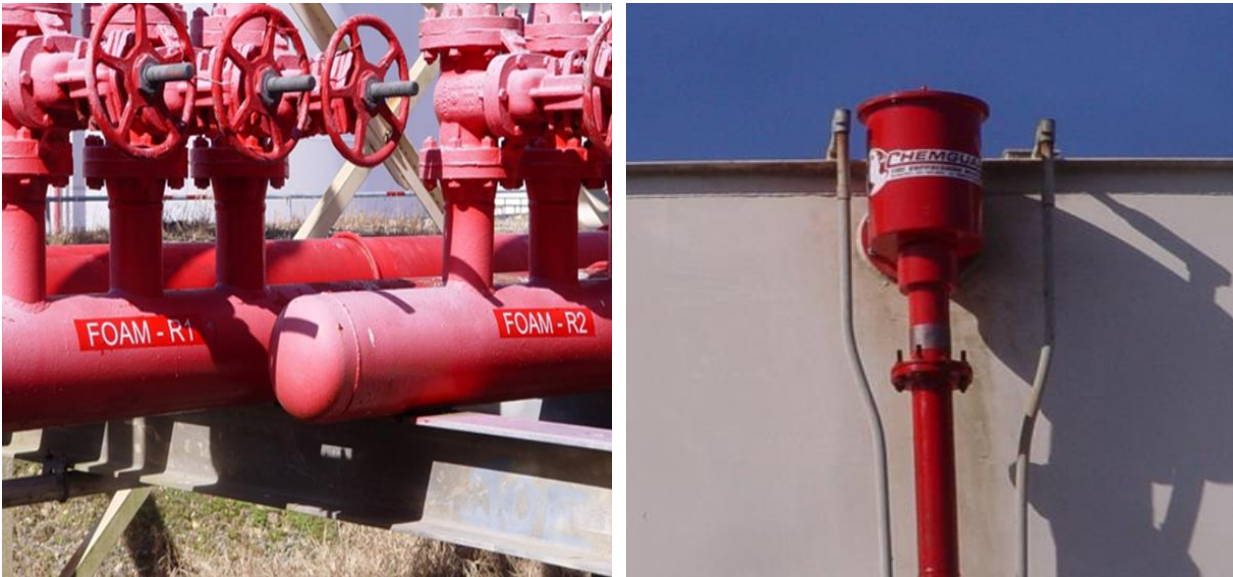
Figure 3-9 — Foam System Isolation Valves and Foam Chamber

The fire foam system that protects the fuel oil tanks and fuel oil forwarding pumps also appears to be in serviceable condition. The photo on the left in Figure 3-9 shows minor chalking of the pipe coating system; this is not uncommon for systems that remain exposed to the elements. Over time the coatings degrade, releasing the binder's hold on the pigment and resulting in the chalky white appearance. These and other coatings on outdoor equipment and piping should be monitored for further degradation and regularly recoated to protect the substrate from corrosion.

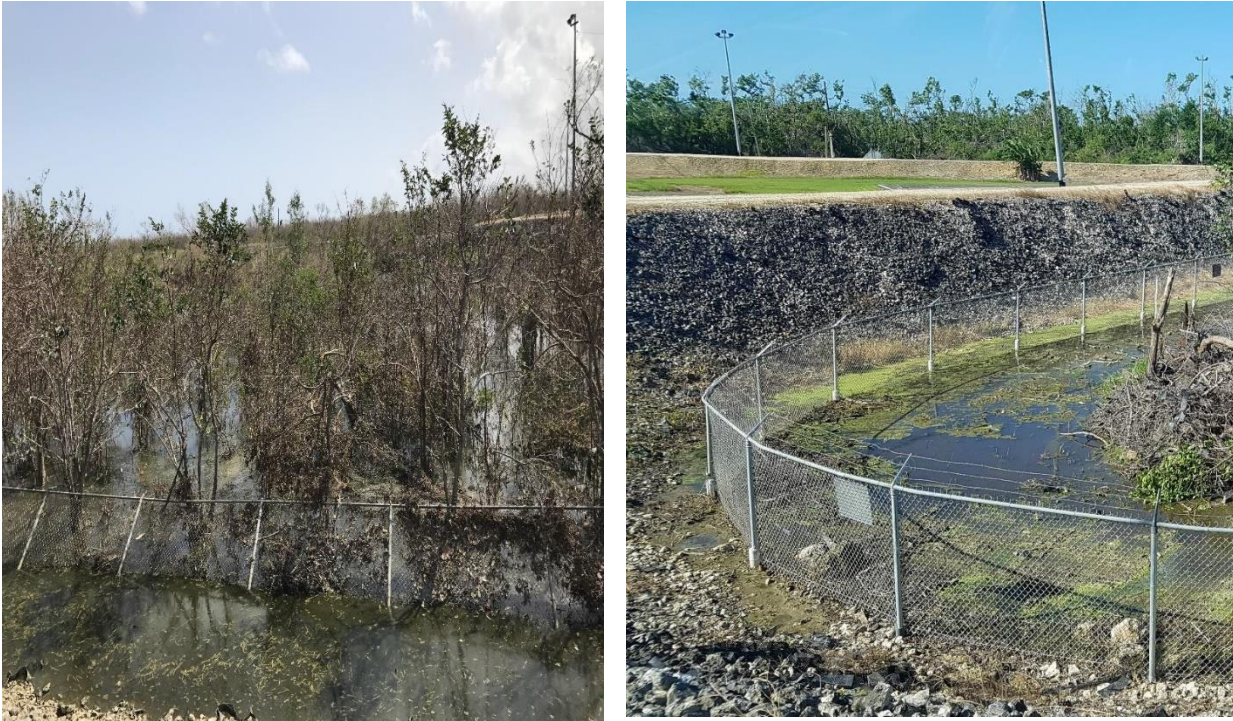
Figure 3-10 — Cambalache Perimeter Fence Damage and Repair

Pictured are portions of the perimeter fence that were damaged (left) in 2017 and repaired (right) as part of the Hurricane Maria Recovery Project.

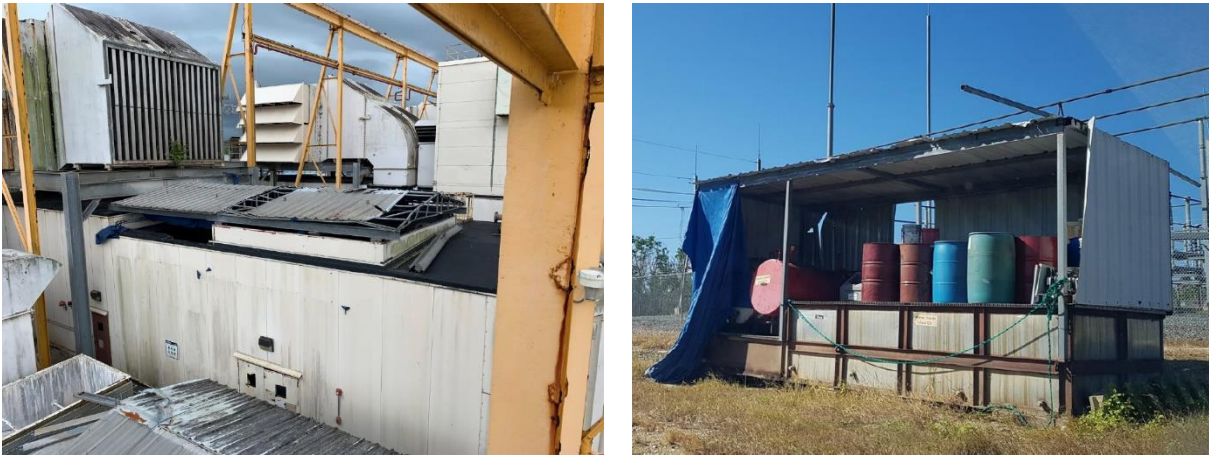
Figure 3-11 — Unit 1 Main GT Enclosure and Oil Storage Shelter

Pictured are portions of the Unit 1 GT enclosure that were damaged in 2017 (left) and a 2018 photo of the old oil storage shelter (right), which has since been replaced.
