O&M Concession  
**Independent Engineering  
Report**  
Central Hidro Gas Mayagüez Plant

**Puerto Rico Electric Power Authority**

**Report SL-015976.MG**

**August 31, 2021**

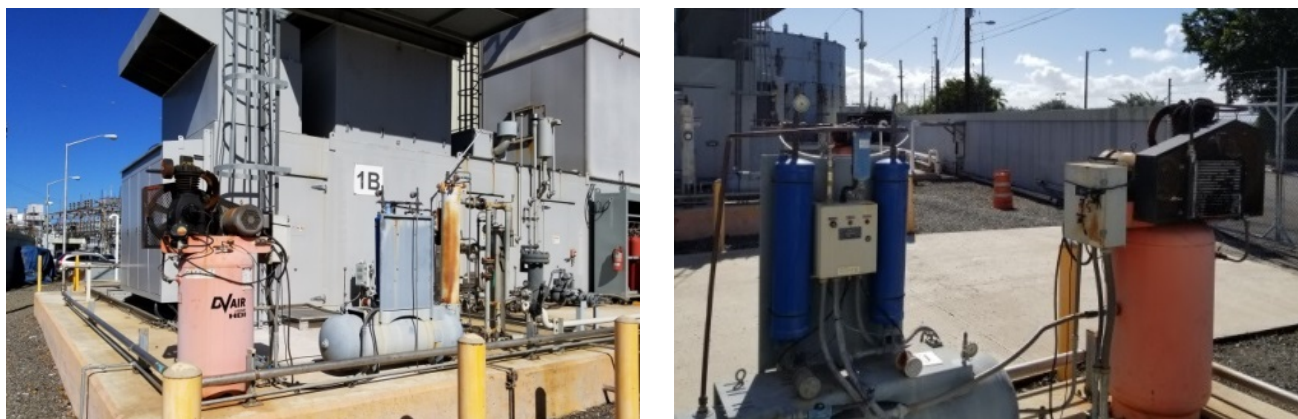
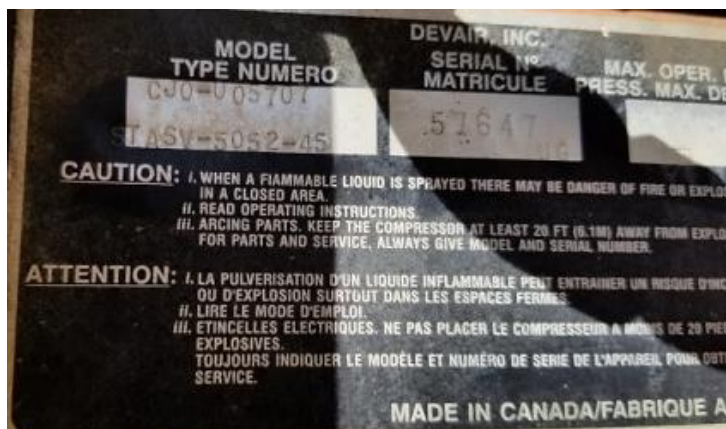
**Figure 2-4 — Air Compressor (Typical) with Nameplate**

The original air compressors (Figure 2-4) were incorrectly sized and not configured for the marine operating environment; they have since been replaced for additional capacity and weather hardening. The Plant staff notes that all units have new compressors as of May 2019.

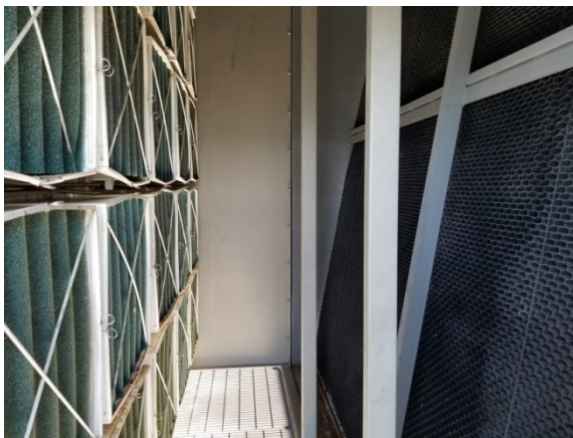
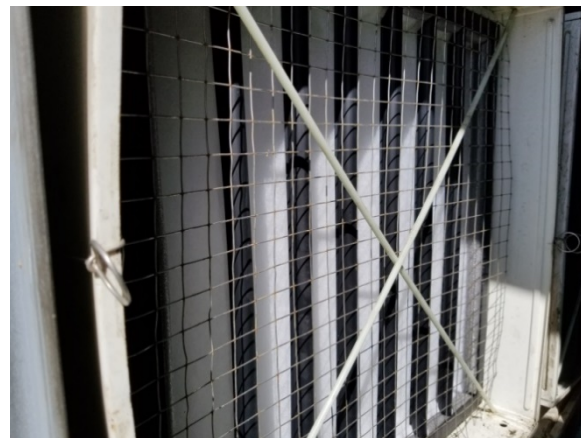
**Figure 3-1 — Inlet Air Moisture Coalescing Section (Right) and Pre-Filter (Left)**

Static inlet air filters of the Mayagüez GTs incorporate a moisture-coalescing section, pre-filter stage, and final-filter stage. These filters are shown in Figure 3-1 and were observed to be in good condition.

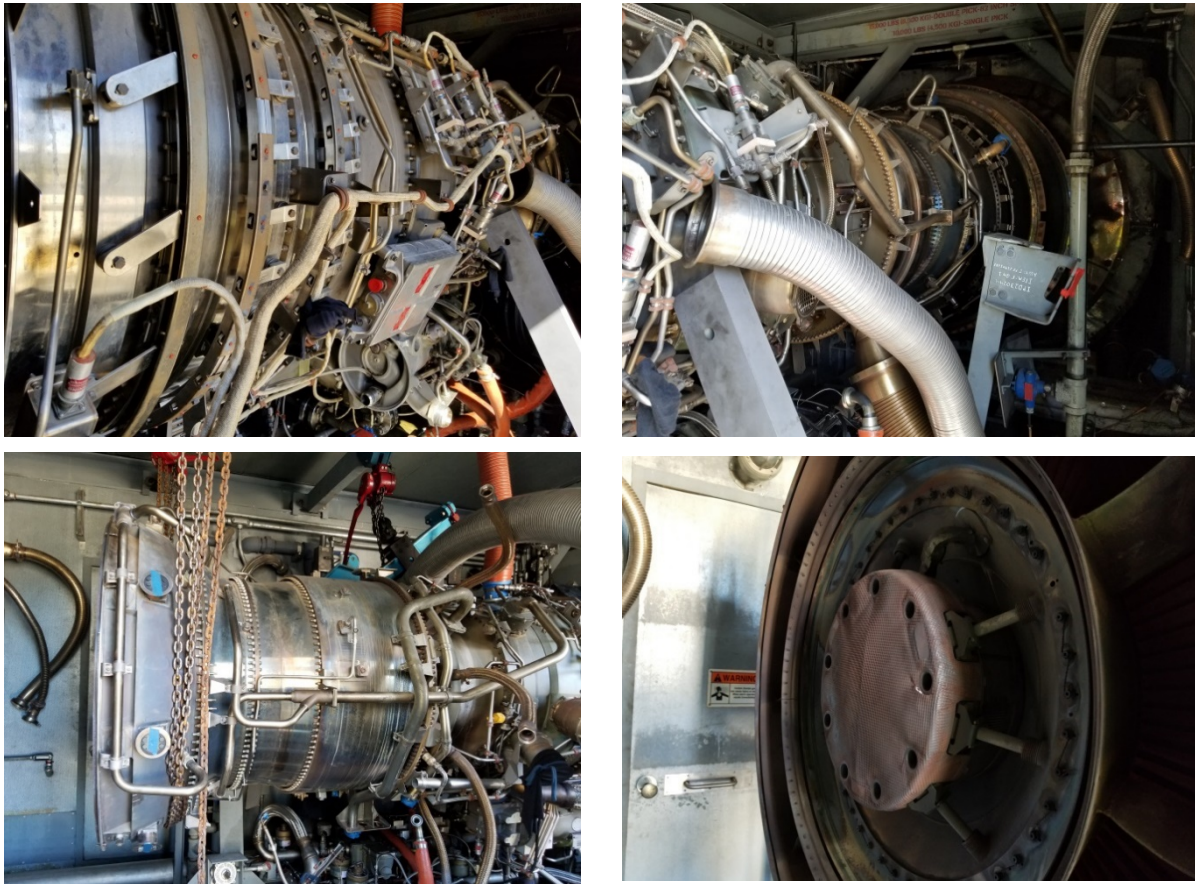
**Figure 3-2 — Gas Turbine 2A Out-of-Service for Repairs**

As of 2018, the GTs had accumulated between 5500 and 8500 fired hours since initial installation (see Table 5-2). Several of the FT8-3 GTs experienced failure of the thermal barrier coatings (TBCs) and issues with the hot end of the PT section. Failure of the TBC may be an issue with fuel quality, water entrainment, fuel conditioning, or an issue with the OEM design. Vaporized liquid hydrocarbons or condensates are known to create localized thermal spots during the combustion process and may affect the integrity of coatings and erosion of base material. Significant loss of coatings, particularly accumulations, may affect the equipment's cooling systems and possibly the turbine rotor balance. On the cold end of the system, degradation of the compressor components may be linked to the ingestion of marine salt. P&W recognized this potential with the introduction of a new primary air inlet coalescing pre-filter for use at installation in coastal locations. P&W Service Bulletin No. 11M05 describes the service as mandatory for facilities within one mile of a coastal shoreline. The recommended filter modifications and media replacements have been completed at Mayagüez per the OEM recommendation, but Sargent & Lundy recommends that Plant staff consult the turbine OEM for approval of the modifications. Review of the installed system should be completed to ensure an effective solution is installed.

PREPA believes the issue experienced with the loss of TBC is due to poor manufacturing practices and that the PT issue is a design error, possibly with seals. The turbine OEM P&W noted that similar issues had been documented with other turbines in their fleet manufactured around the same time using the same blade surface preparation procedures prior to application of the high-temperature coating. P&W has since updated their surface preparation procedures for blade coating and furnished guidance for corrective

All eight PT sections have been cycled back through P&W's shop in Connecticut for repairs; however, further investigation is required to determine a root cause. Review of fuel oil laboratory analysis reports for recently delivered fuel shows that results are within the P&W liquid distillate fuel specification requirements; however, there may be issues with site-specific storage, fuel forwarding systems and equipment, or final fuel conditioning. It is recommended fuel samples are tested downstream of the fuel conditioning skid and final filters to ensure that salts and condensates that may accumulate during fuel storage are not at the root of the issue. Sargent & Lundy recommends a third-party root-cause analysis to conclude these blade discussions.

Figure 3-2 shows GT 2A out of service for blade repairs in 2019.

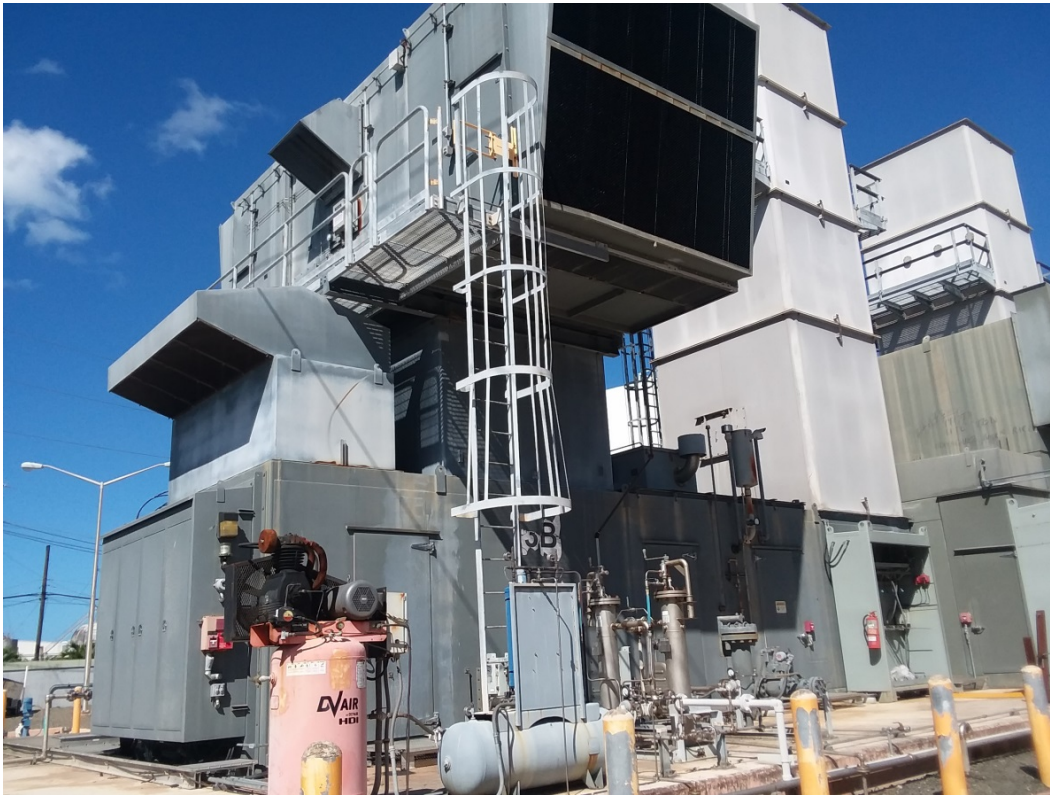
**Figure 3-3 — Paint Touchup in Process**

Corrosion may become a concern at this site if Plant staff is not diligent in keeping associated issues in check. As mentioned throughout this report, there are some indications that the equipment and material selections for the installation are not entirely adequate for the conditions at Mayagüez. The main enclosures of the GTs were repainted in 2019 (see Figure 3-3, right side for stack paint). Surface-level corrosion is generally not a concern; however, if left unattended, similar to the other sites across the island, corrosion rapidly progresses from simple cosmetic concerns to more serious issues that can affect safety and operability.

For plants such as Mayagüez that are often used for peaking services, it is even more important to ensure that idle equipment is protected from the elements, condensation, and salts. During normal operation, the equipment is kept hot, fluids are circulated, and fans are kept on for cooling. During idle time, moisture and corrosive salts are more apt to deposit onto the equipment. Repetitive deposition and evaporation of salt-laden moisture will lead to pitting, such as that found on the GT intake system; the results have been noted by the OEM and are now the subject of a service bulletin that is being addressed by Plant staff. Over extended periods, such as those for the four turbine units currently idle at Mayagüez, preservation measures, layup practices, and humidity control become increasingly more important to realize the full design life of the Plant and equipment.
