17 AUG 2022 – 230kV Lines to AES Outage, Load Shed Event Analysis

NEPR-IN-2022-0004

September 2, 2022

Name: 17AUG2022 Major Outage Event – AES 230kV Line 50700 Outage, Loss of Generation and Load Shedding Event

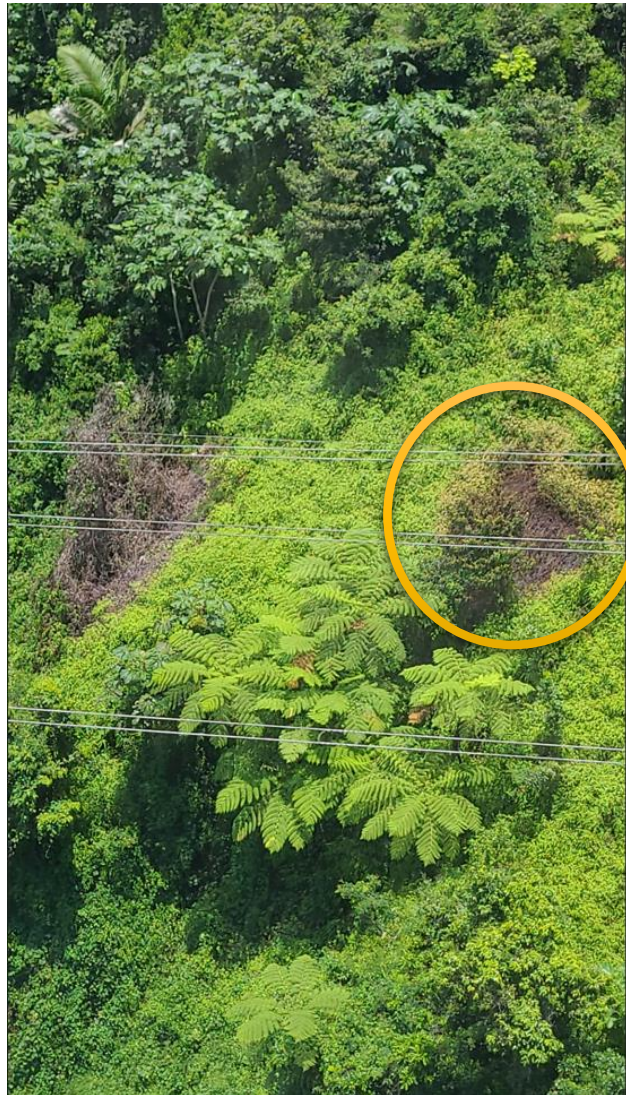
At 11:07:24, line 50700 from Yabucoa to AES tripped due to a high impedance type fault caused by vegetation (figure 3-2 below). With line 50700 from AES to Yabucoa open, all the generation from AES was served via the remaining 50700 line to Aguirre.

The 230 kV line 50700 was restored to the system at 19:14.

Figure 3-2 Burned Vegetation at the point of the fault in Line 50700 from Yabucoa to AES

1. Repair line 50700 from Aguirre situation.
2. Control vegetation at line 50700 from AES to Yabucoa.
3. Verify the cause 230kV circuit breaker 0074 open at Aguirre. This had no impact to this event but could be problematic for future events.
4. Restore primary and secondary power line carrier protection to line 50700 from AES to Aguirre. This had no impact to this event but could be problematic for future events.

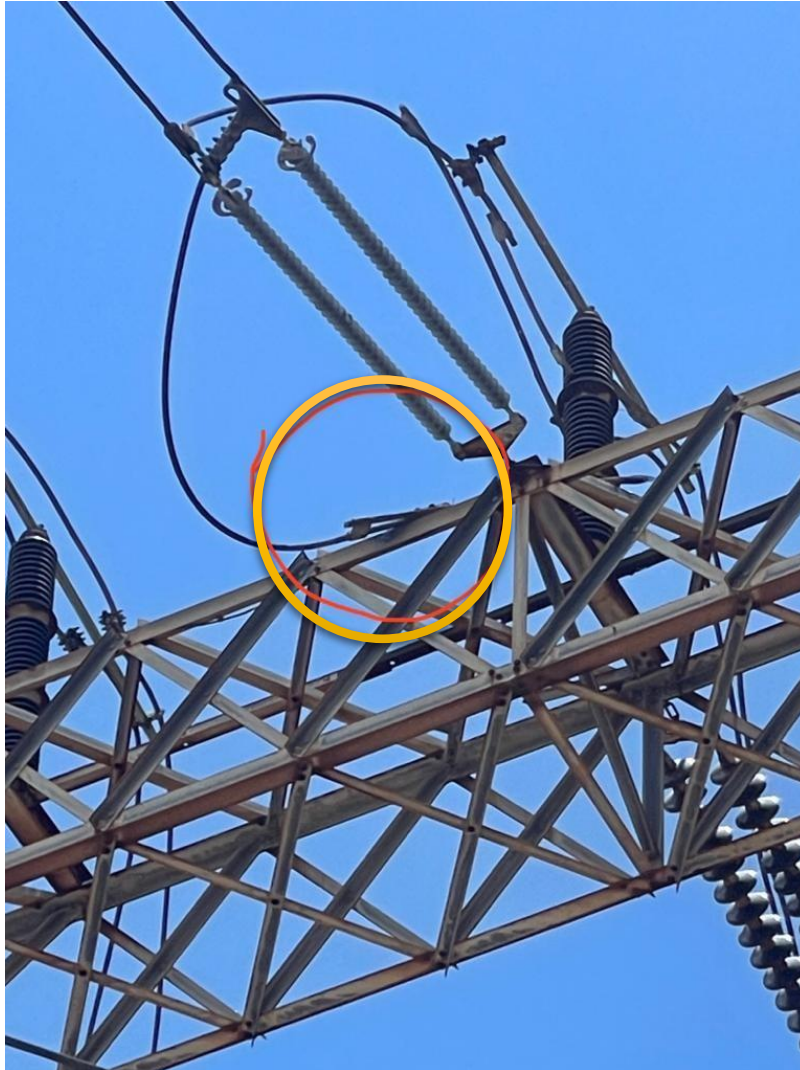
At 11:10:47, an open jumper occurred at line 50700 near Aguirre to AES (figure 3-3 below). The open jumper contacted the 230 kV structure. The line differential protection tripped instantly the 230 kV circuit breakers 50730-0052 at Aguirre and 50710-0052 at AES. Generation from AES was isolated from the system and automatic underfrequency load shed was necessary to avoid a black-out.

The open jumper was repaired by LUMA crews, and 230 kV line 50700 was restored to the system at 17:37.

3-3 Figure Open Jumper contacting 230 kV structure at 50700 from AES to Aguirre

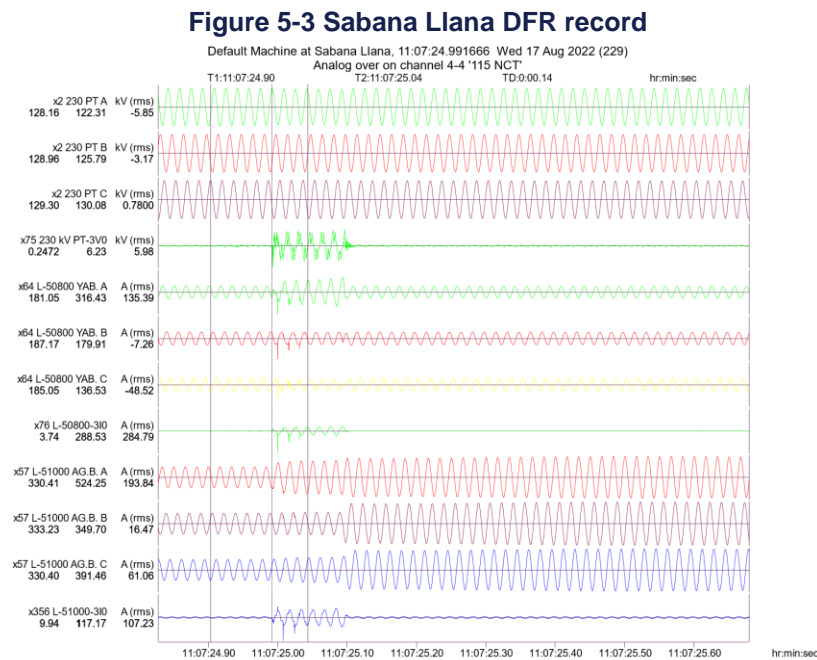
The digital fault recorder from Sabana Llana Transmission Center recorded the transient vegetation fault at line 50700 from AES to Yabucoa was cleared from the system (refer to figure 5-3 below). With the loss of 50700 transmission line segment, some of the load current from the south generation to the north loads was then transmitted via 230 kV line 51000 from Aguas Buenas to Sabana Llana to balance the system after the fault.

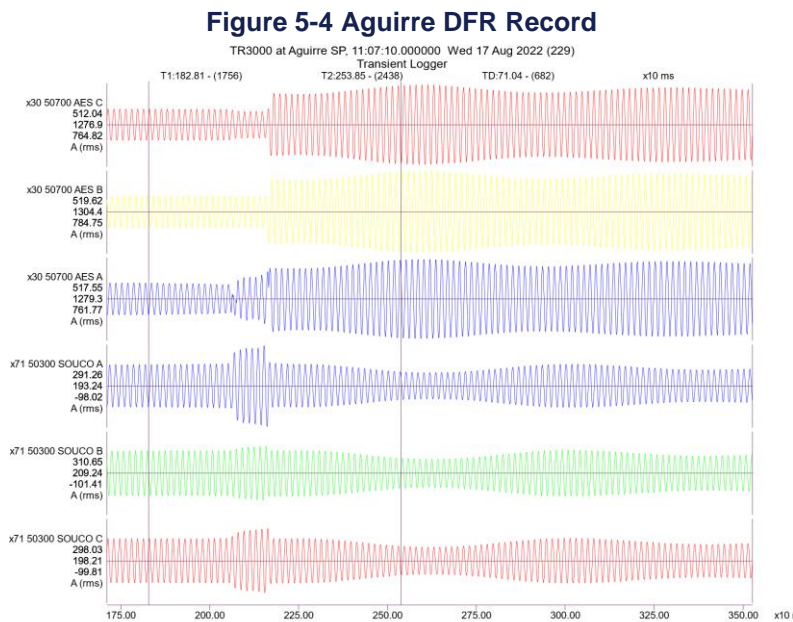
The digital fault recorder from Aguirre recorded the initial fault at line 50700 from AES to Yabucoa (refer to figure 5-4 below). With the loss of this 50700-transmission line segment, all the generation from AES to the system was served via line 50700 segment to Aguirre, the load current at line 50700 increased to an average of 1,283 amperes.

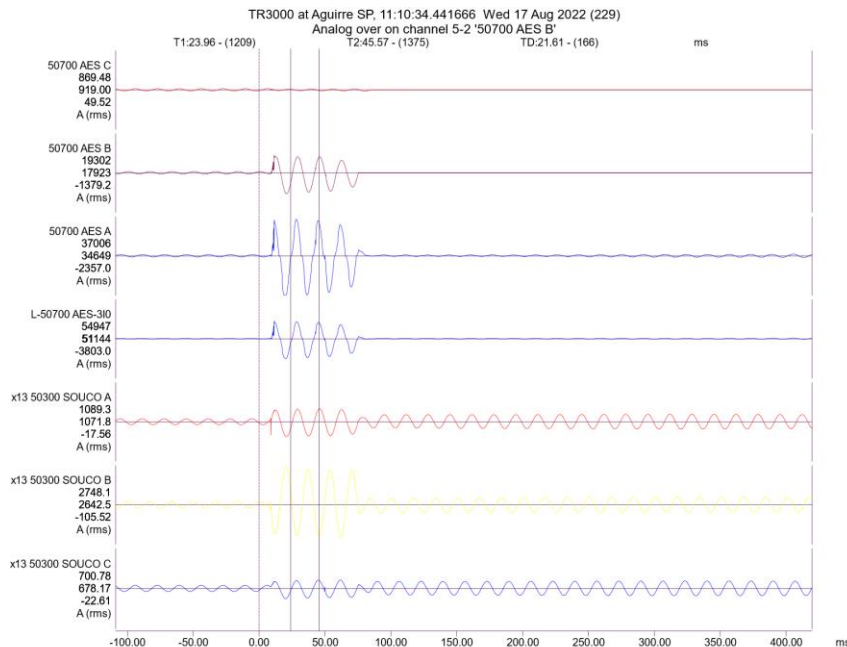
Figure 5-9 Aguirre DFR Record

The digital fault recorder from Aguirre recorded the fault at line 50700 from AES to Yabucoa (refer to figure 5-9 below). With the trip of this 50700-transmission line segment, all the generation from AES to the system was isolated from the system.

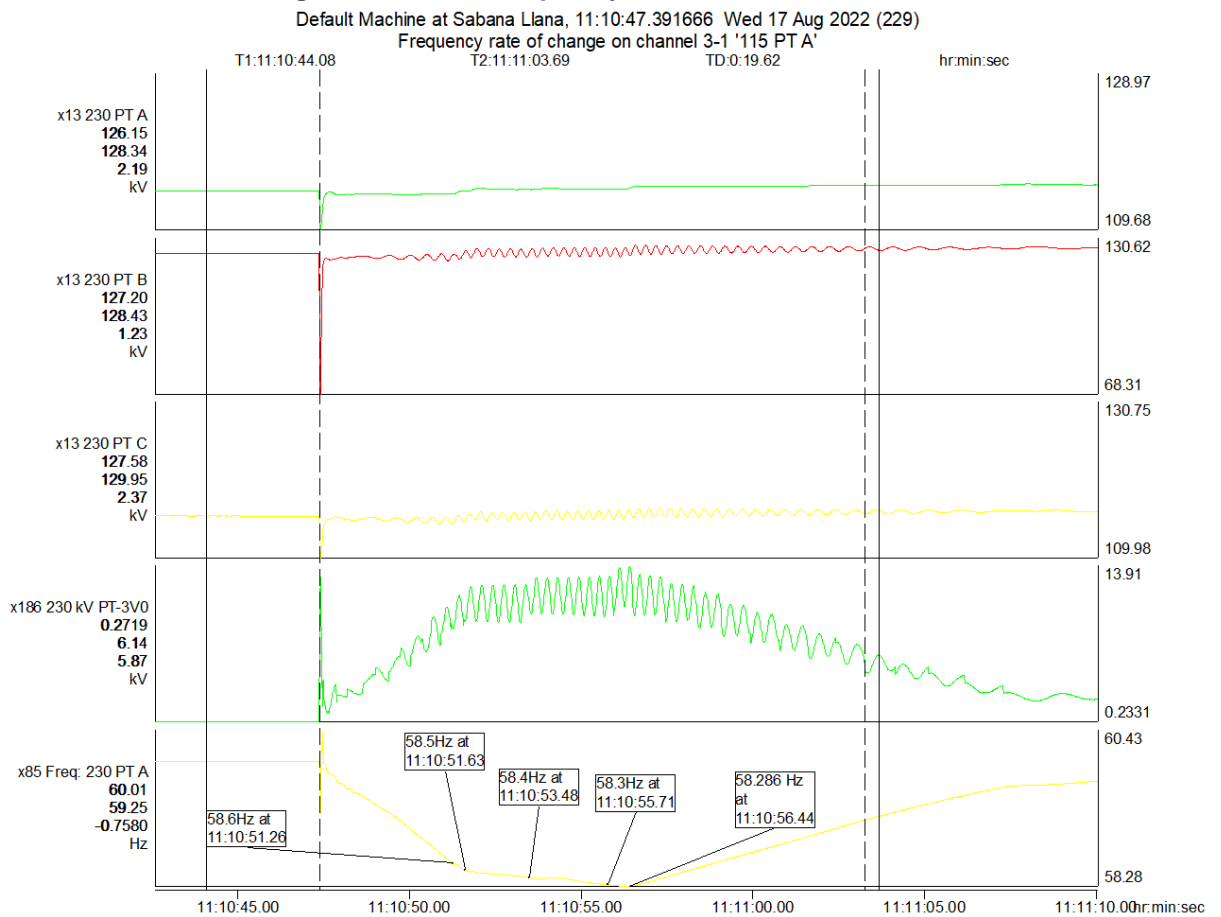
Figure 5-10 Underfrequency Disturbance - Load Shed

At 11:10:56.44, 9 seconds after the AES generation was isolated, the automatic underfrequency load shed scheme manage to stabilize the system. The frequency reached the lowest point of 58.29 Hz and started restoration, see figure 5-10 (below).
