IN RE: INTERRUPCIÓN DE SERVICIO  
ELÉCTRICO DE 6 DE ABRIL DE 2022

**CASE NO. NEPR-IN-2022-0002**

**Motion Submitting Root Cause Evaluation  
of April 6<sup>th</sup> Incident and Request for  
Confidential Treatment**

(Root Cause Evaluation Report)

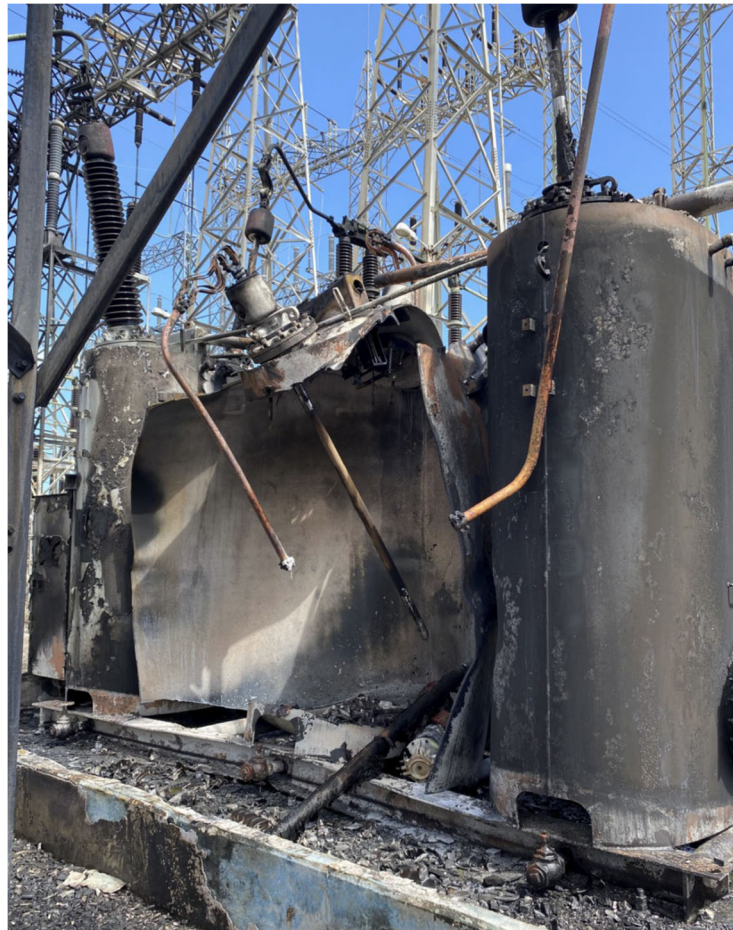
Figure 5: Damaged OCB #0082

At 2042 hours on Wednesday, April 6th, 2022, a fault occurred in the 230 kV switchyard of the Costa Sur Steam Plant (SP). Phase B of Oil-Circuit Breaker (OCB) #0082 suffered a catastrophic failure (see Figure 5).<sup>1</sup> A detailed description of the event is provided in LUMA's Outage Event Progress Report<sup>1</sup>. A summary of these analyses is described here.

OCB #0082 connects to Costa Sur SP's generation unit #5 to the transmission grid. After synchronizing unit #5 to the grid, the circuit breaker began to experience internal arcing, resulting in the generation protection system sending a trip command to OCB #0082. During the opening, phase B tank of the OCB # experienced a catastrophic failure followed by an explosion and flying debris that damaged bus #6 (see Figure 4 for reference). The failure affected four

adjacent circuit breakers and several portions of the substation's lattice structures. Due to the circuit breaker's failure, the 230 kV circuits at Costa Sur SP needed to open to clear the fault, which disconnected EcoEléctrica from the grid and resulted in subsequent outage events that cascaded into a full blackout of Puerto Rico's electrical system. Under-frequency load shedding occurred but was insufficient to prevent total system collapse. By 2100 hours on Saturday, April 9th, 83.5% of customers impacted by this event had been restored, and by Sunday, April 10th at 0300 hours, 99% of customers impacted had been restored.<sup>1</sup>

After this event, LUMA took the following immediate corrective actions in preparation for restoring the 230 kV bus #6 and replacing damaged circuit breakers #0074 and #0082<sup>6</sup>:

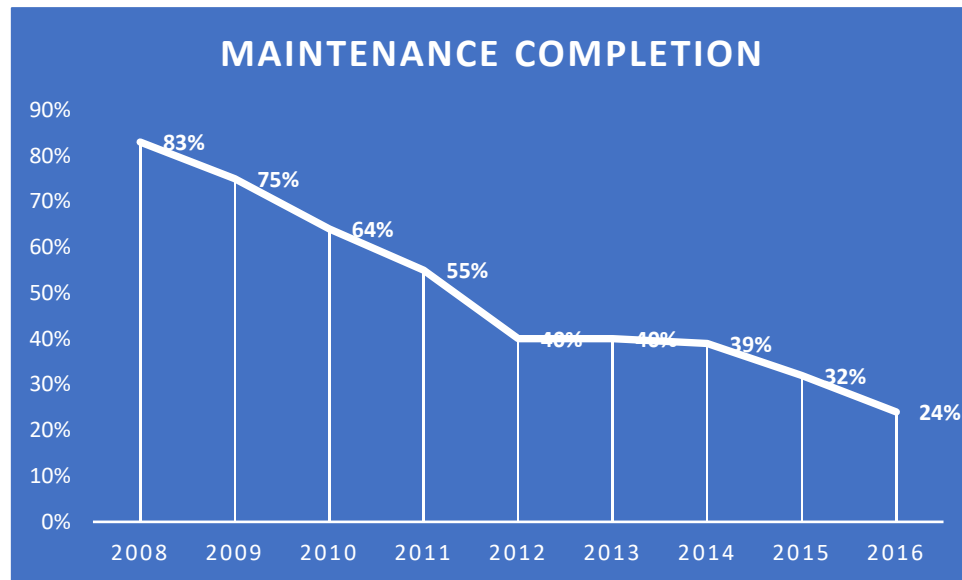
Figure 7: PREPA Maintenance Completion<sup>14</sup>

In 2016, PREPA indicated that the status of their electric system inspection and maintenance program was deteriorating.<sup>14</sup> This information indicated that there were issues with both the maintenance program and the ability of PREPA to retain and recruit key personnel to manage the inspection and maintenance program effectively. PREPA indicated the following completion level of maintenance tasks, as shown in Figure 7. As indicated by the results in Figure 7, the effective maintenance completion declined continuously from 2008 to 2016 to the extent that only 24% of maintenance was being completed within its required time period. The impact of this condition is that asset condition deteriorates without the appropriate attention and leaves the system in a vulnerable state relative to equipment condition and reliability.

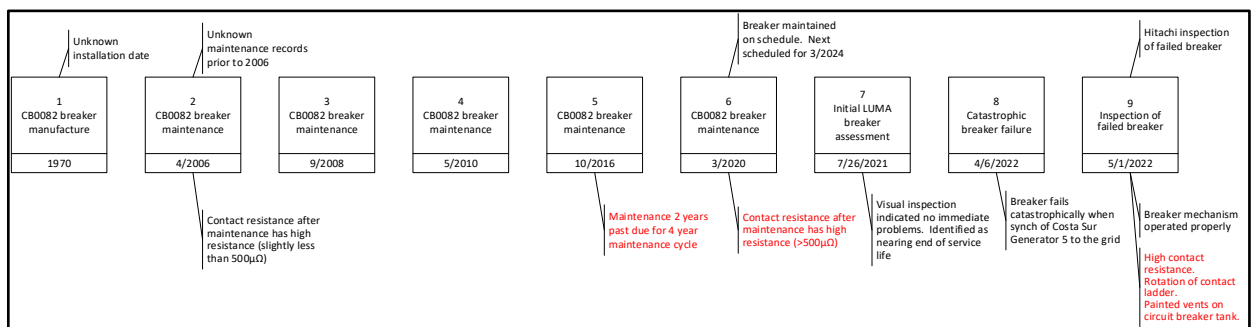
Figure 8: OCB #0082 Maintenance History Timeline

The circuit breaker maintenance was documented for 2006, 2010, 2016, and 2020. The next scheduled maintenance would be 2024. All of the breaker maintenance was performed by PREPA. Key findings from the review of the maintenance data are:

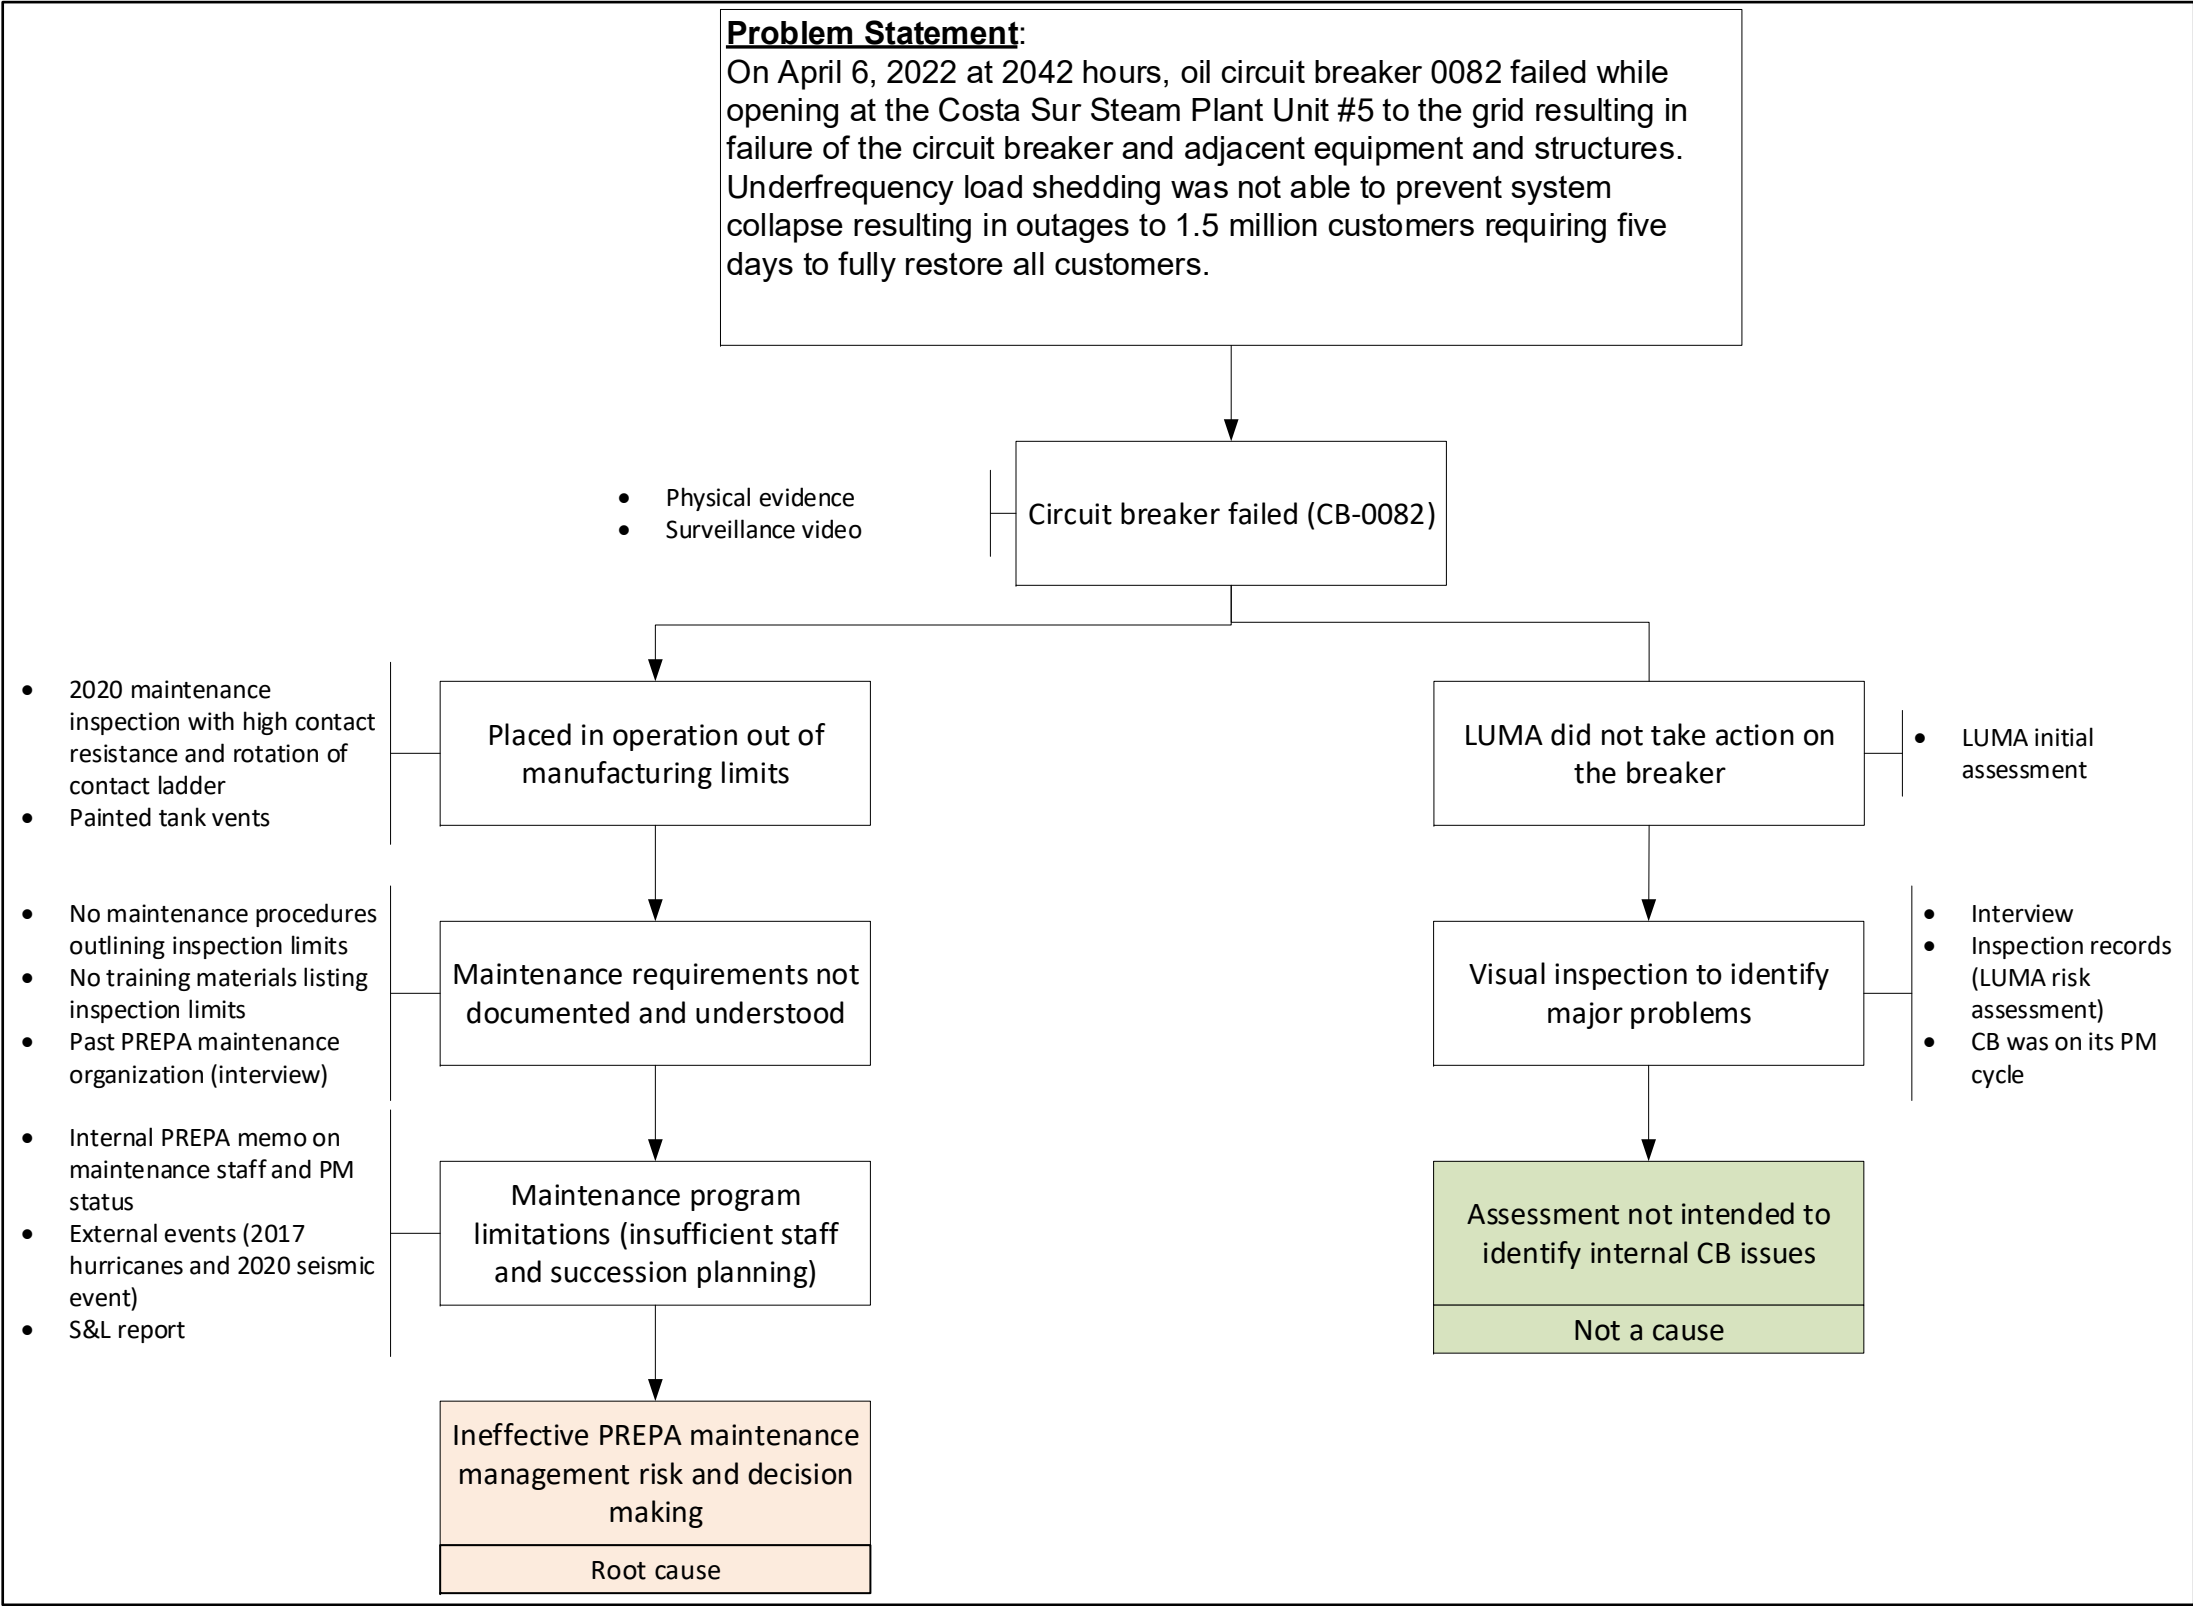
Figure 9: Causal Analysis of Failed Circuit Breaker

**Root Cause 1: Ineffective PREPA maintenance management and decision-making led to the Oil-Circuit Breaker (OCB) #0082 breaker being placed into service by PREPA after maintenance in 2020 with contact resistance significantly over the manufacturer's recommended limits.** Exponent states that PREPA should not have placed the OCB #0082 back in service with this high level of contact resistance. This resulted in arcing across the contacts in the circuit breaker, heating the oil in the equipment which vaporized the oil, creating high pressure hydrogen that could not be released and resulted in the explosion.

These are the primary drivers for the outage event due to the equipment failure at Costa Sur.

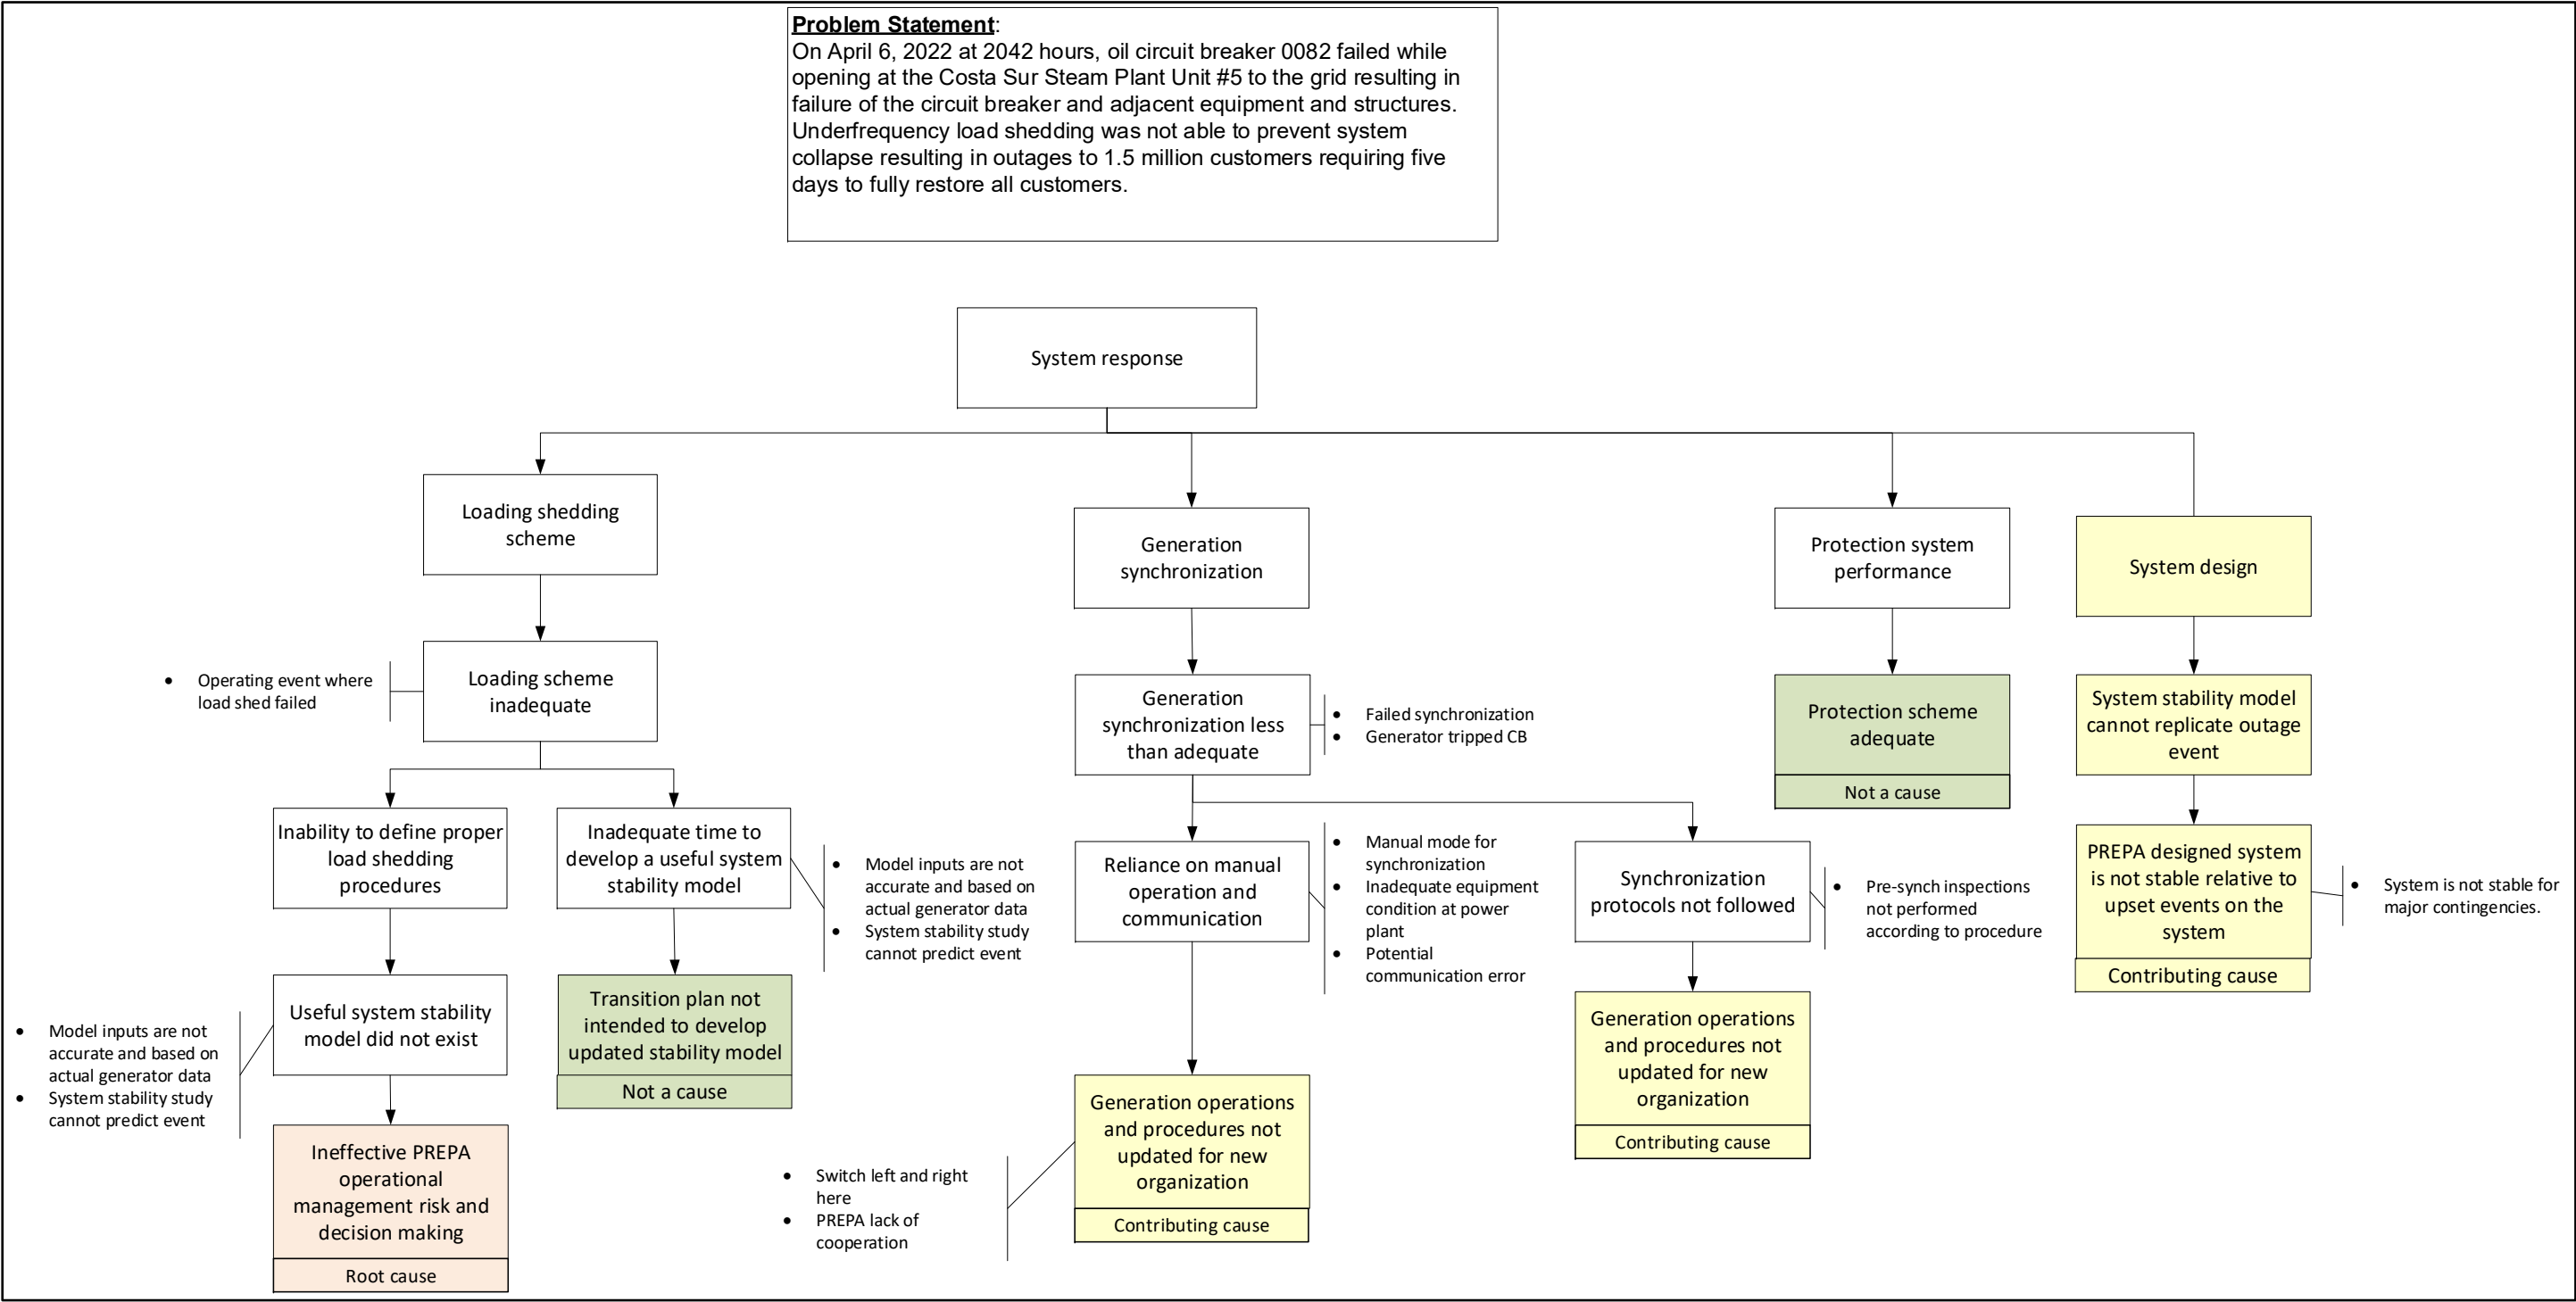
Figure 10: Causal Analysis : System Response

**Root Cause 2: Ineffective PREPA operational management and risk decision-making resulting from not having a system stability model to assist in development of load shedding schemes.** The protection devices for the most part functioned as intended after the explosion of OCB#0082. When the Costa Sur and Ecoeléctrica plants disconnected, the under-frequency load shed was insufficient to stabilize the system and a blackout occurred. An accurate system stability model that includes generator performance characteristics, helps determine how much load shed is needed to maintain the balance between generation and load and prevent island wide blackouts of the electric system. Despite multiple requests from LUMA, PREPA has not provided access to the generator performance data needed to create the system model.
