IN RE: INTERRUPCIÓN DE SERVICIO  
ELÉCTRICO DE 12 DE JULIO DE 2022

**CASE NO. NEPR-IN-2022-0003**

**Motion to Submit Redacted Versions of  
Preliminary Report, August Monthly  
Progress Report, and Final Report of July  
12<sup>th</sup> Incident**

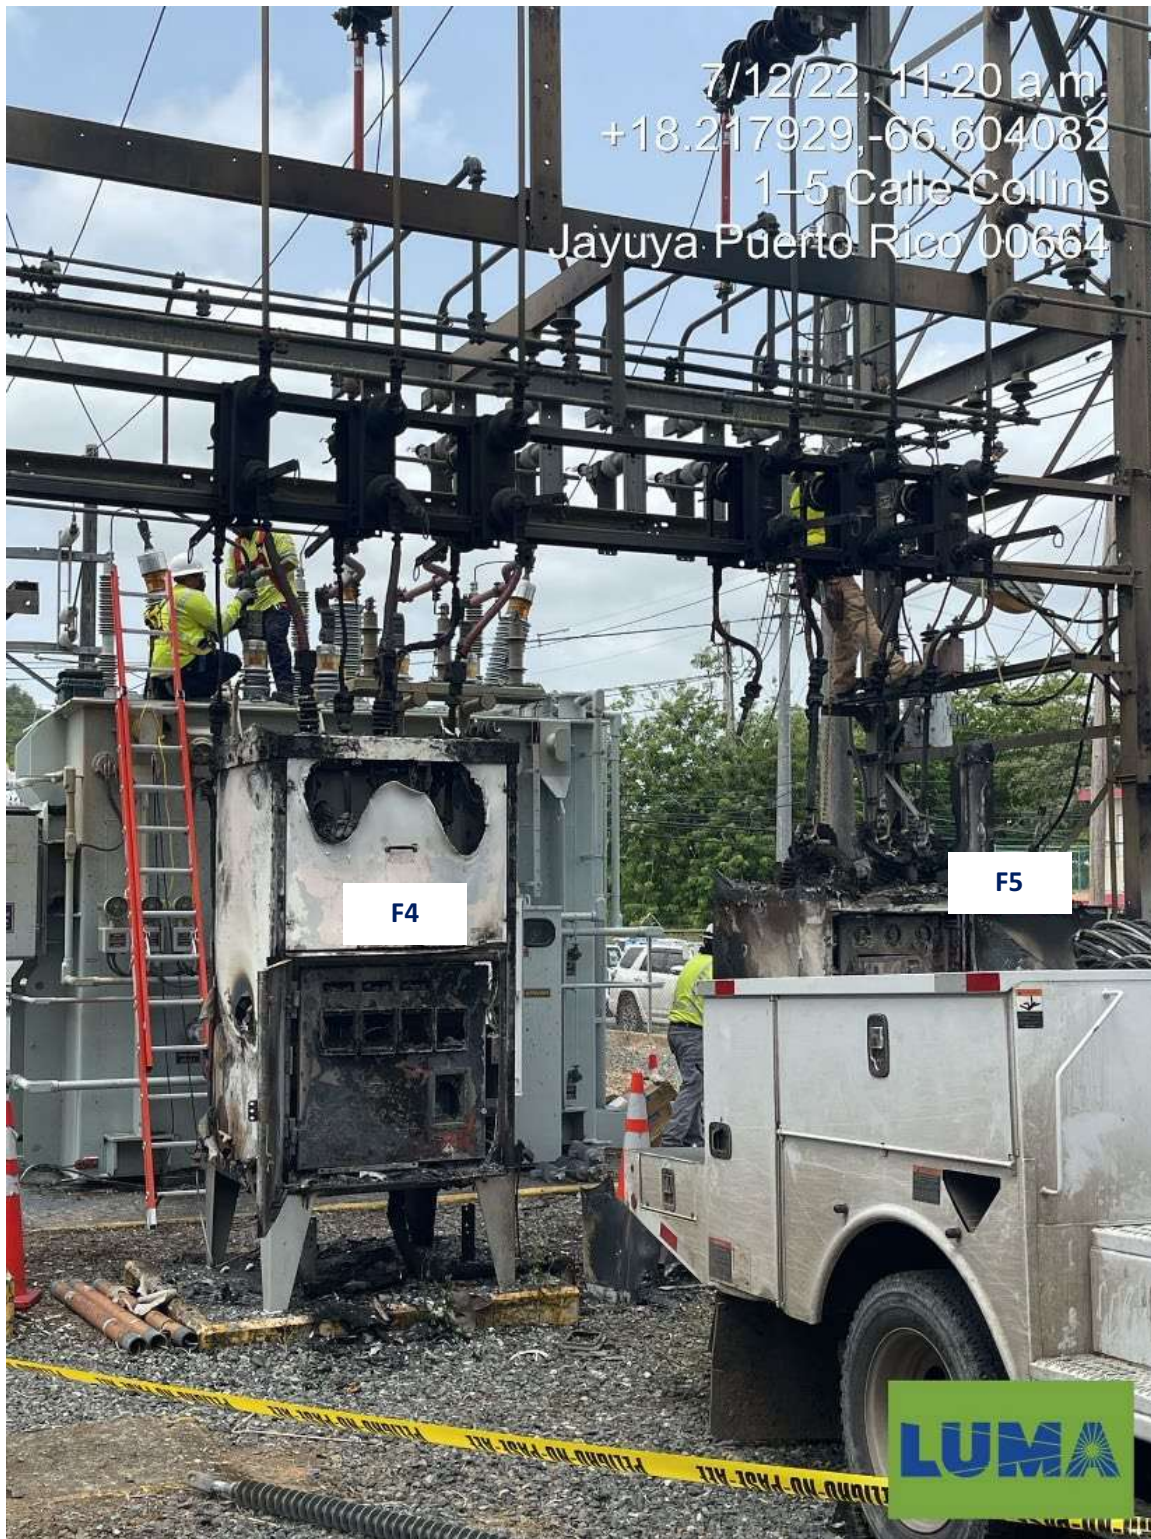
- Two 4.16 kV circuit breakers failed (feeders F4 and F5).
- One PT on the 4.16 kV bus failed.
- Six 4.16 kV fuse disconnect switches failed (metering and AMR circuits).
- Twelve 4.16 kV solid-blade disconnect switches failed (auxiliary switches for circuit breakers F4 and F5).
- 4.16 kV bus support and bus bar incurred damage at substation 8302.
- 115 kV bus support incurred damage at substation 8301.
- 115 kV insulator incurred damage at substation 8302.
- Jayuya's RTU failed.
- One 115 kV S&C Electric Company type SMD 2B – 65E standard speed fuse extinguished in 115/4.16 kV substation 8302.
- Two 115 kV S&C Electric Company type SMD 2B – 65E standard speed fuses extinguished in 115/4.16 kV substation 8301.

**Figure 3-1 Photo of Damaged Circuit Breakers, Disconnect Switches, and Associated Hardware After Fault**

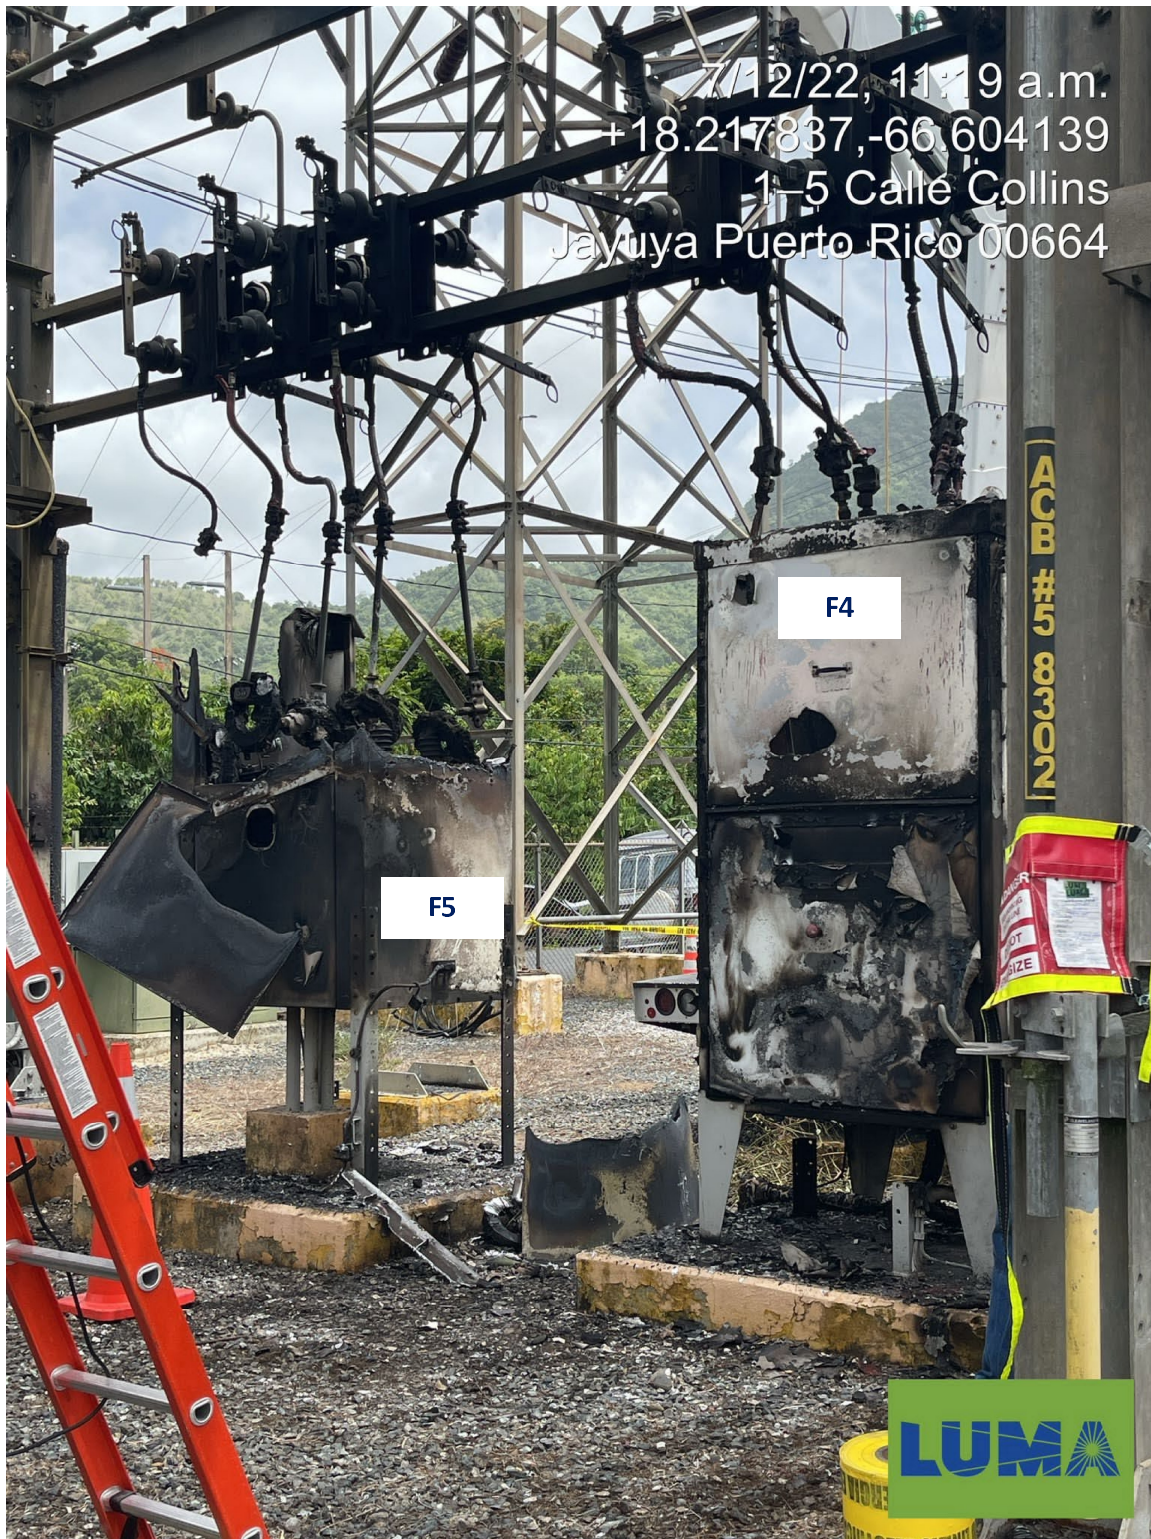
Figure 3-2 Photo of Damaged Circuit Breakers, Disconnect Switches, and Associated Hardware After Fault

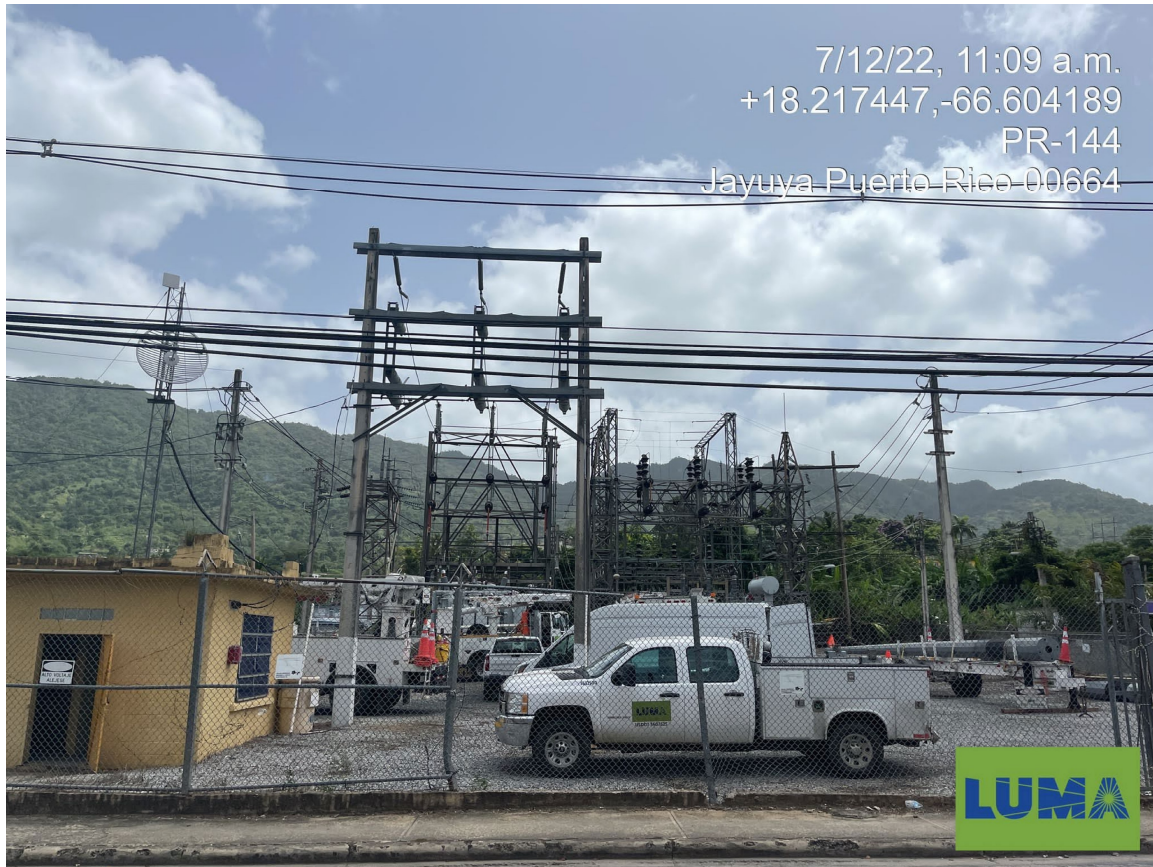
**Figure 3-3 Photo of Substation Damage - Side View**
