**DR-4339-PR Public Assistance**

**PROJECT SCOPE OF WORK WITH COST ESTIMATES**

***FAAS<sub>t</sub> - Dams Minor Repairs***  
***(Dams/Hydro)***

***GM #436621***

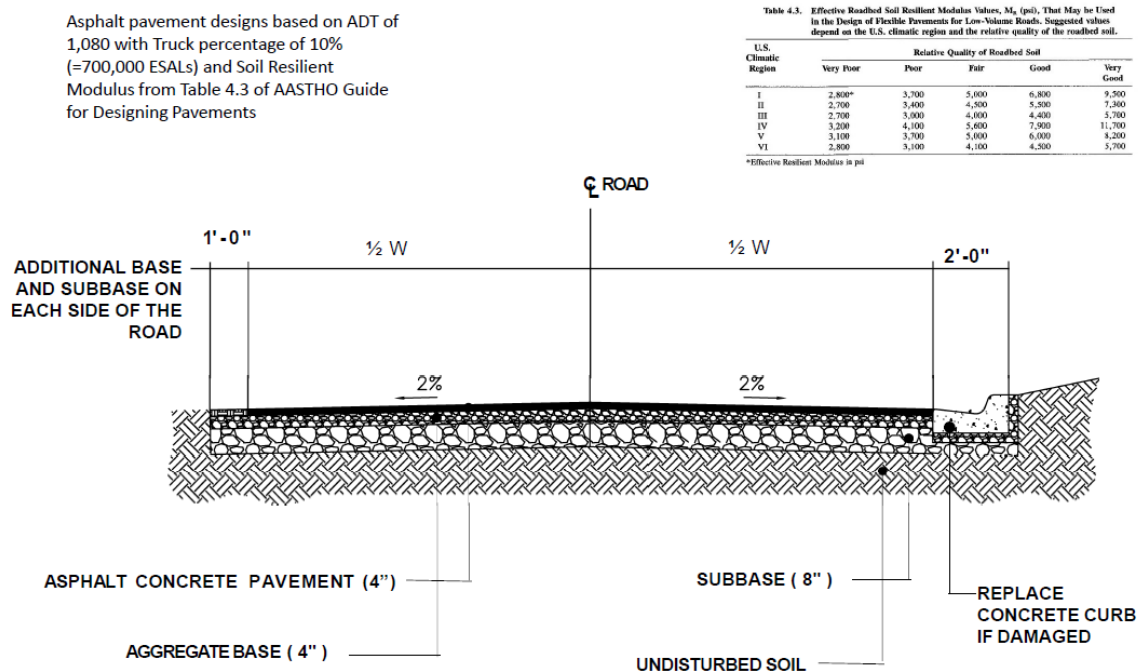
Figure 2 – Asphalt Roadway Section (Typical)

- Exterior Site and Dam's Intake Structure - 18.060599, -66.099029
  - Remove temporary gravel surface and reconstruct asphalt roadway to codes and standards. replace 5,025 SF (335 FT L x 15 FT W) of 4 IN asphalt roadway. See typical section, Figure 2.

- Place 5,025 SF of geotextile drainage blanket between pavement and subbase to strengthen subgrade.
- Construct concrete drainage swales along both sides of roadway to carry water away from the road and prevent washouts. 2 X 335 LF = 670 LF
