CASE NO. NEPR-IN-2022-0004

**Motion Submitting Preliminary Report on
August 17th Incident and Request for
Confidential Treatment**

17 AUG 2022 – 230kV Lines to AES Outage, Load Shed Event and Restoration Report

Name: 17AUG2022 Major Outage Event –
AES 230kV Line 50700 Outage, Loss of Generation and Load Shedding Event

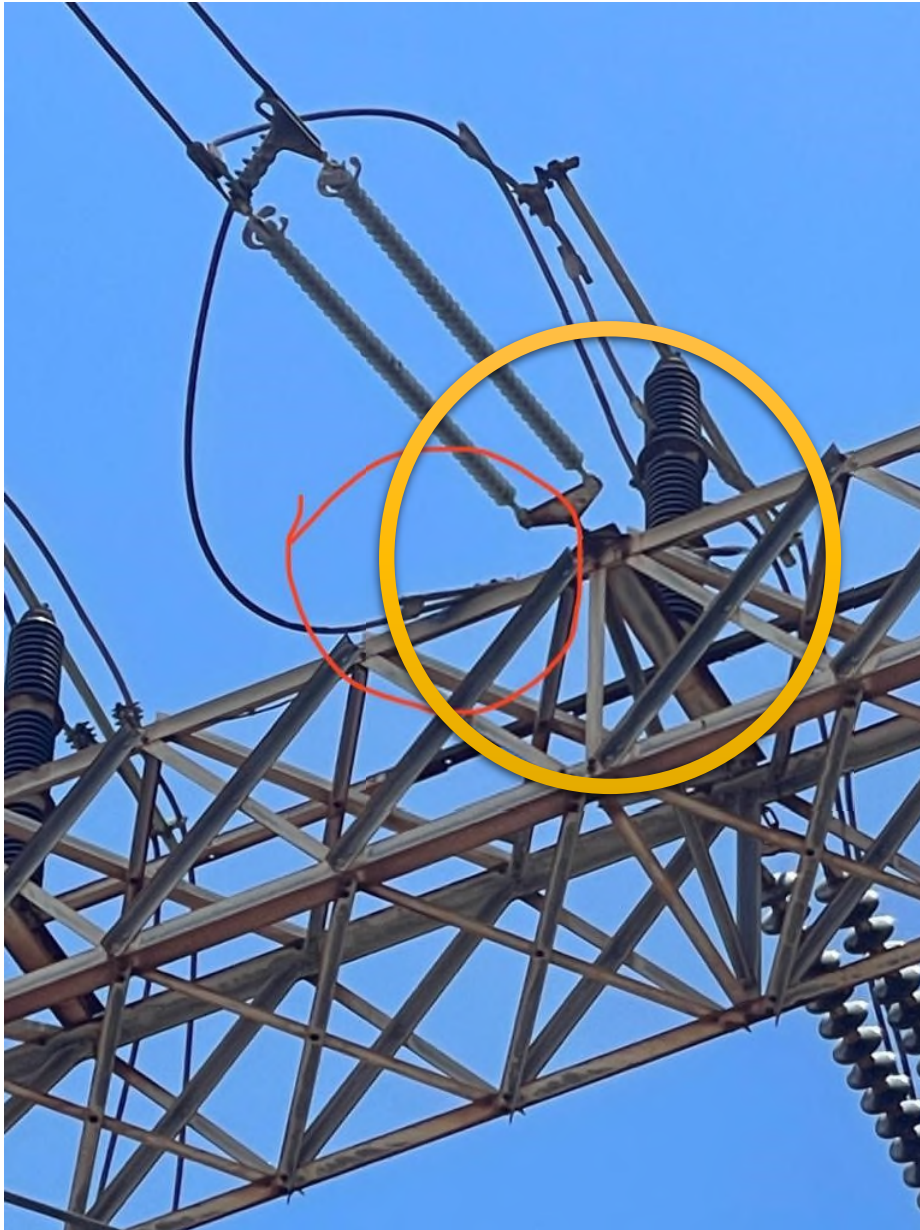
Figure 3- Line 50700 Aguirre to AES – Open Jumper

At 11:10:47, an open jumper occurred at line 50700 near Aguirre to AES. The open jumper contacted the 230 kV structure. The line differential protection tripped instantly 230 kV circuit breakers 50730-0052 at Aguirre and 50710-0052 at AES. During this event, 230 kV circuit breaker 0074 at Aguirre opened for unknown reasons.

The figure below shows the open jumper on the 230kV Line 50700 AES to Aguirre.

Vegetation has been identified as one of the causes of the event at line 50700 from AES to Yabucoa (breakers 50720 and 0062 at AES). A contributory cause of the event was the open jumper on the 50700 line near Aguirre to AES (breakers 50710 and 0052 at AES). These two events caused the loss of AES generation and initiated the load shed event. The delayed return to service of Aguirre unit 1 exacerbated the magnitude of the load shed event, and the additional 450 MW of power that it would have provided could have potentially accelerated the restoration process.

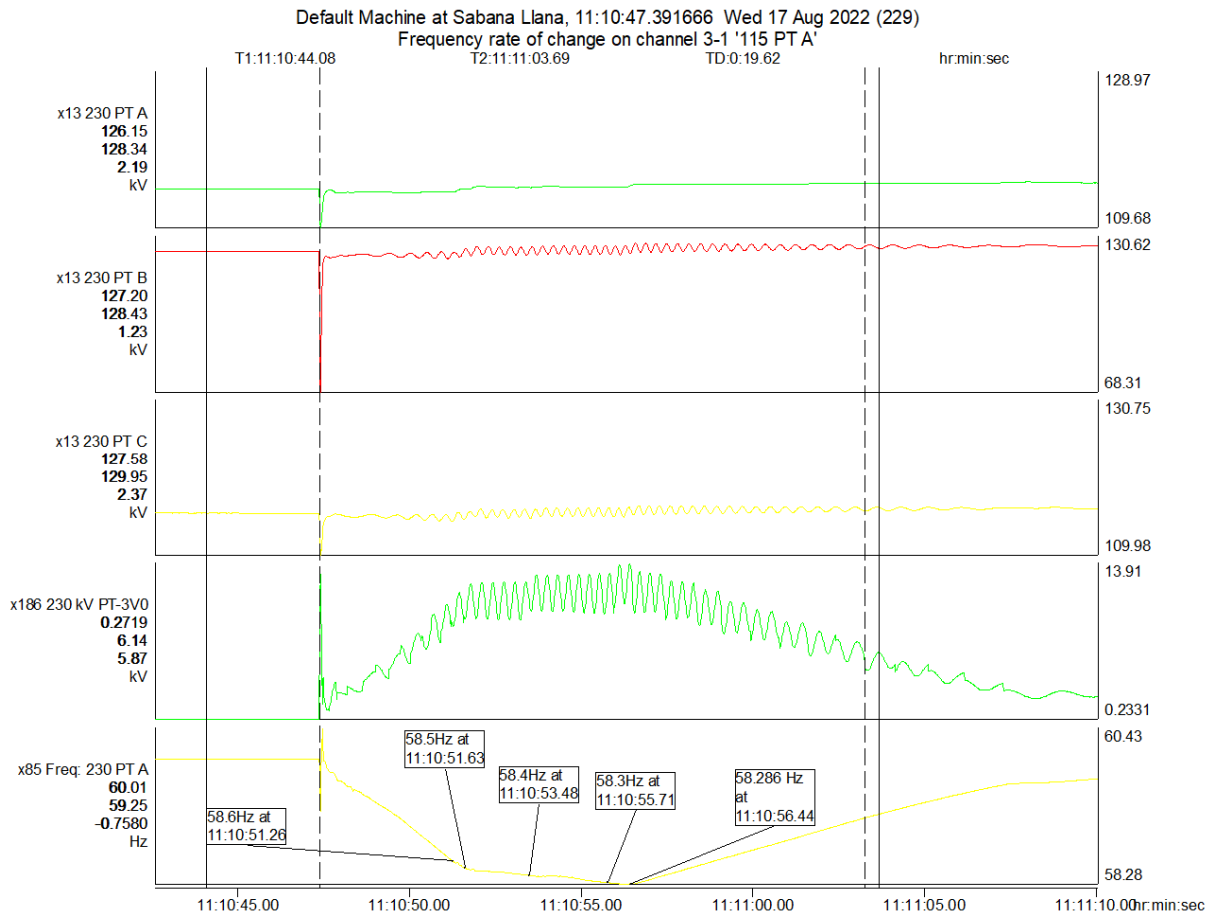
Figure 6 - Frequency Changes during the Event

The following traces show how the frequency was decaying during the event (from the transient recorder):

- At 11:10:51.26 the frequency was 58.6Hz
- At 11:10:51.63 the frequency was 58.5Hz
- At 11:10:53.48 the frequency was 58.4Hz
- At 11:10:55.71 the frequency was 58.3Hz
- At 11:10:56.44 the frequency was 58.2Hz
