IN RE: INTERRUPCIÓN DE SERVICIO ELÉCTRICO DE 12 DE JULIO DE 2022

CASE NO. NEPR-IN-2022-0003

Preliminary Report on July 12th Incident

Jayuya 115/4.16 kV Substations 8301 and 8302 Outage July 12, 2022 Event and Restoration Report

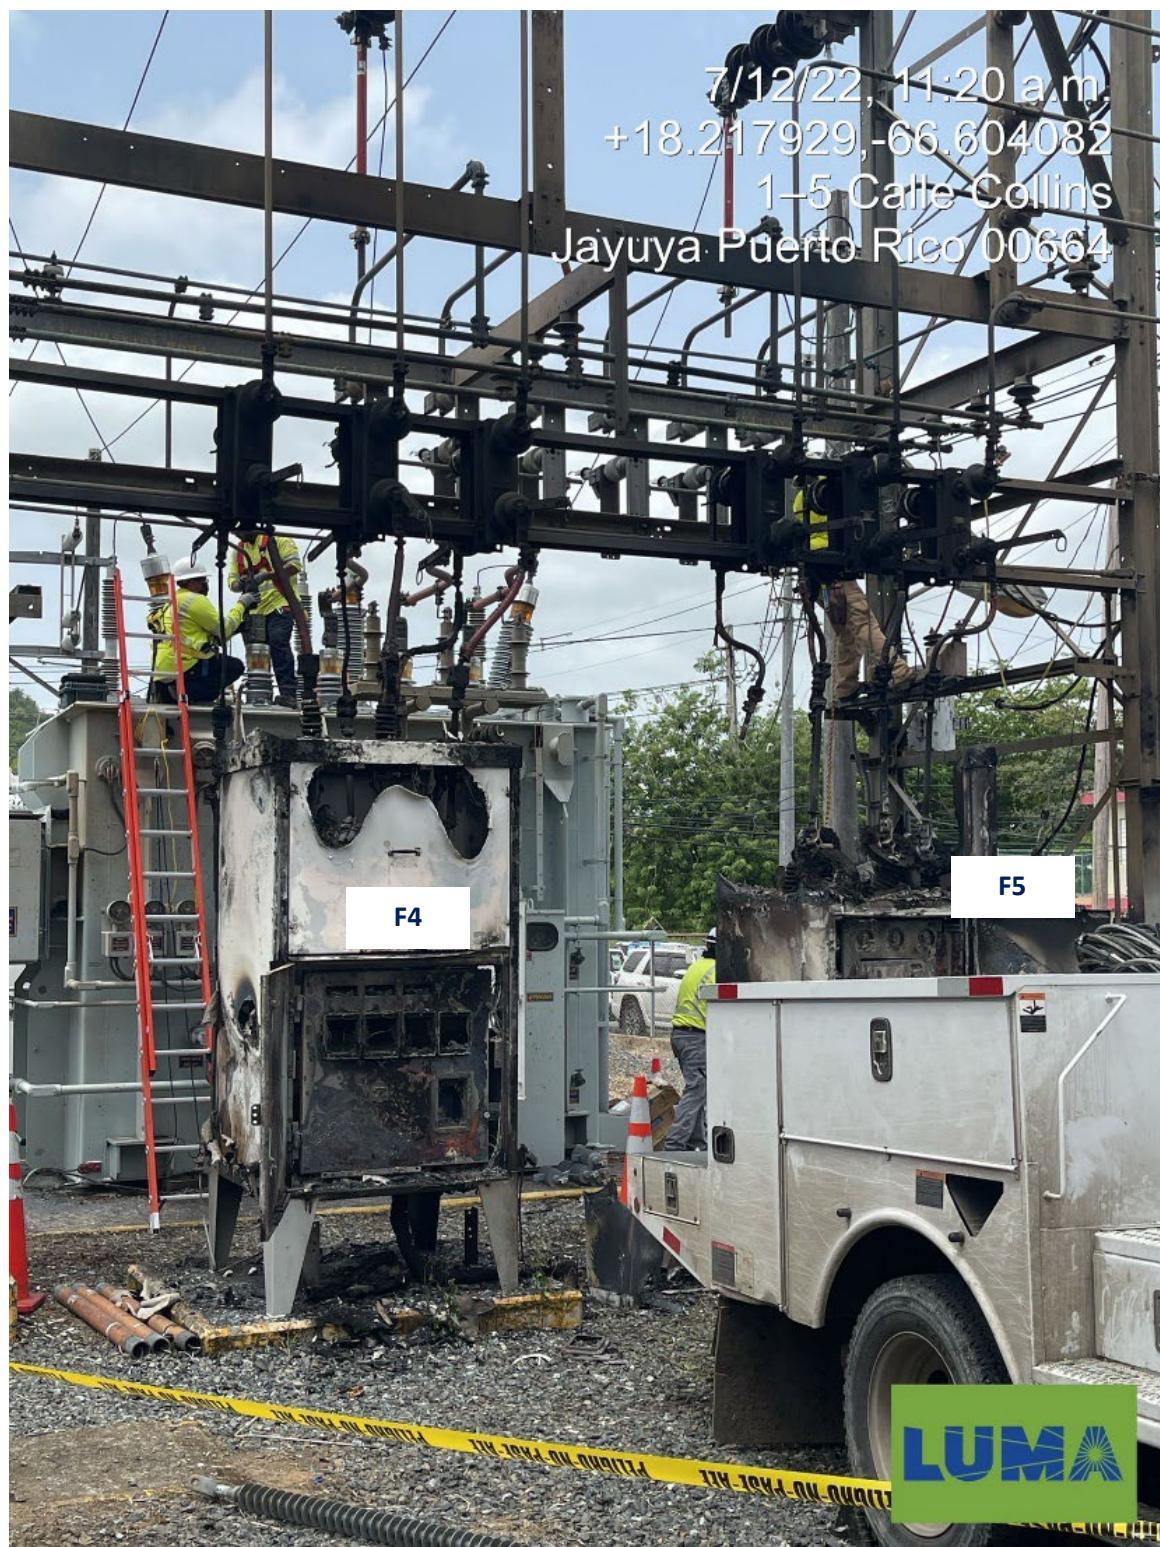
- Two 4.16 kV circuit breakers failed (feeders F4 and F5).
- One PT on the 4.16 kV bus failed.
- Six 4.16 kV fuse disconnect switches failed (metering and AMR circuits).
- Twelve 4.16 kV solid-blade disconnect switches failed (auxiliary switches for circuit breakers F4 and F5).
- 4.16 kV bus support and bus bar incurred damage at substation 8302.
- 115 kV bus support incurred damage at substation 8301.
- 115 kV insulator incurred damage at substation 8302.
- Jayuya's RTU failed.
- One 115 kV S&C Electric Company type SMD 2B 65E standard speed fuse extinguished in 115/4.16 kV substation 8302.
- Two 115 kV S&C Electric Company type SMD 2B 65E standard speed fuses extinguished in 115/4.16 kV substation 8301.

- Performed Megger, CT ratio, and power factor tests to onsite replacement circuit breakers for FCBs F4 and F5. Timing and velocity tests are being scheduled. The damaged FCBs F4 and F5 will be removed as well as 12 damaged disconnect switches.
- Installing replacement FCBs F4 and F5 and then commissioning.
- Replacing damaged control and power wiring.
- Replacing RTU damaged input and output cards. Once completed, the RTU will be commissioned to the interface point.
- Repairing transformer 8301's tap changer.
- Energizing transformer 8302 when all repairs in the substations have been completed.
