Submission of Public Version of Detailed Report on the February 21st Incident

# NEPR-IN-2022-0001

# Analysis for Disturbance Event on February 21, 2022

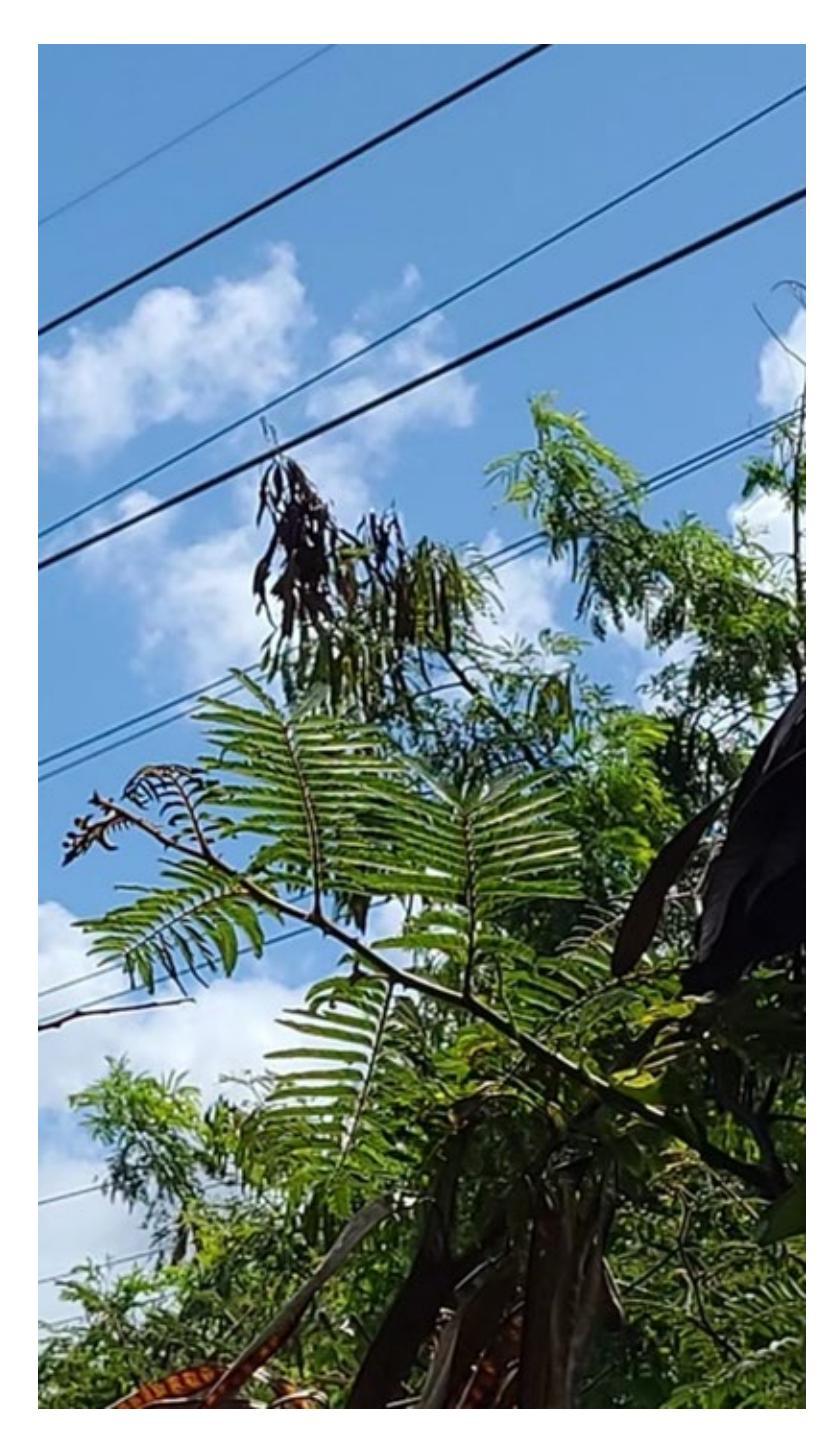
In addition, the security cameras of a local business near the fault recorded the probable fault on video. A cell phone recording after the fault shows a small brush fire was initiated by the short circuit.

Figure 2-2 Fault Initiation due to Vegetation Reported by Line Patrol (Note Line Proximity to Vegetation)

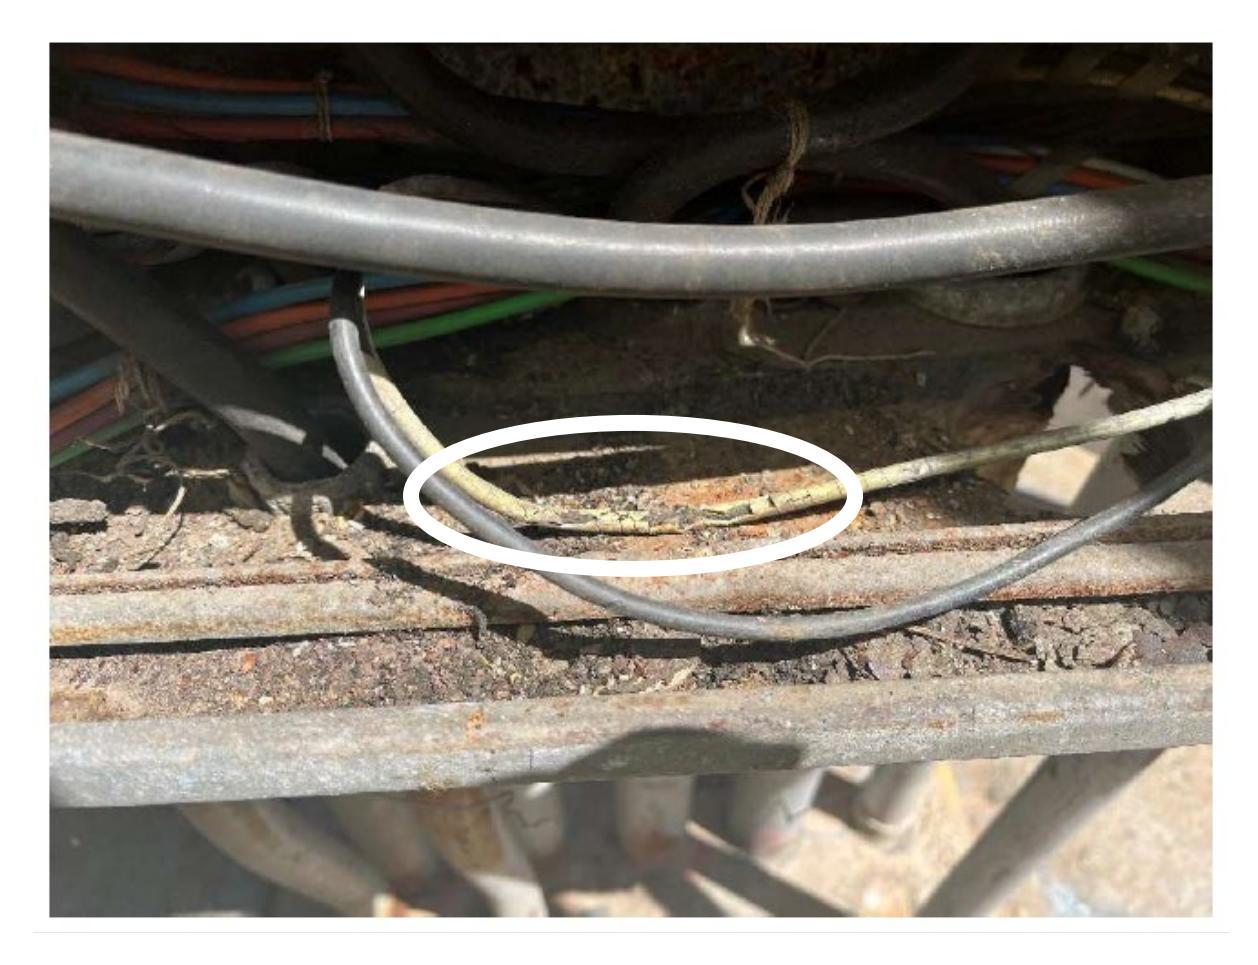
After field troubleshooting, a short circuit in the dc wiring, due to degraded insulation by aging, was located, and the corresponding dc circuit breaker tripped.

Figure 2-3 Short Circuit in DC Wiring due to Degraded Insulation (Circled)

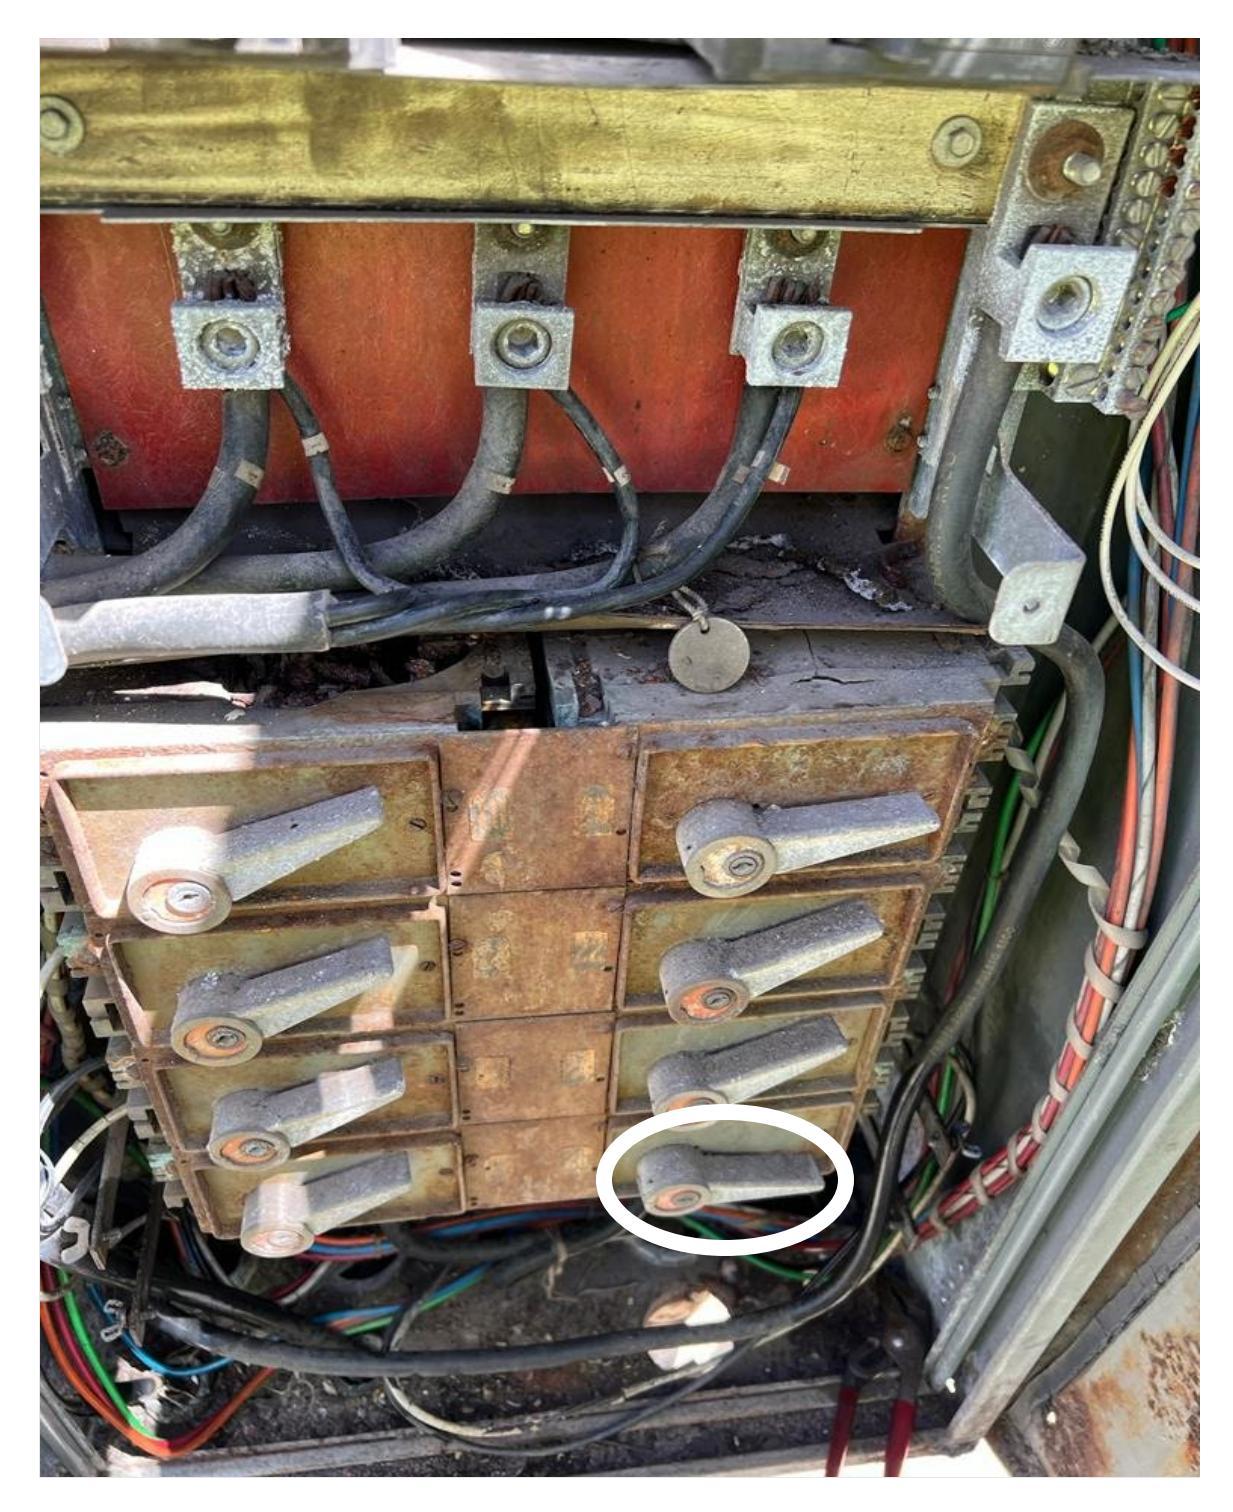
The cause of the circuit breakers not operating was the lack of dc power to the circuit breakers, due to a tripped dc circuit breaker. The dc circuit that was tripped is the power supply for the three circuit breakers in the bay: 38140, 0084, and 0086.

Figure 2-4 Weathered and Rusted DC Circuit Breaker Panel for 115 kV Circuit Breakers' Power; Bottom Right Circuit Breaker Tripped (Circled)

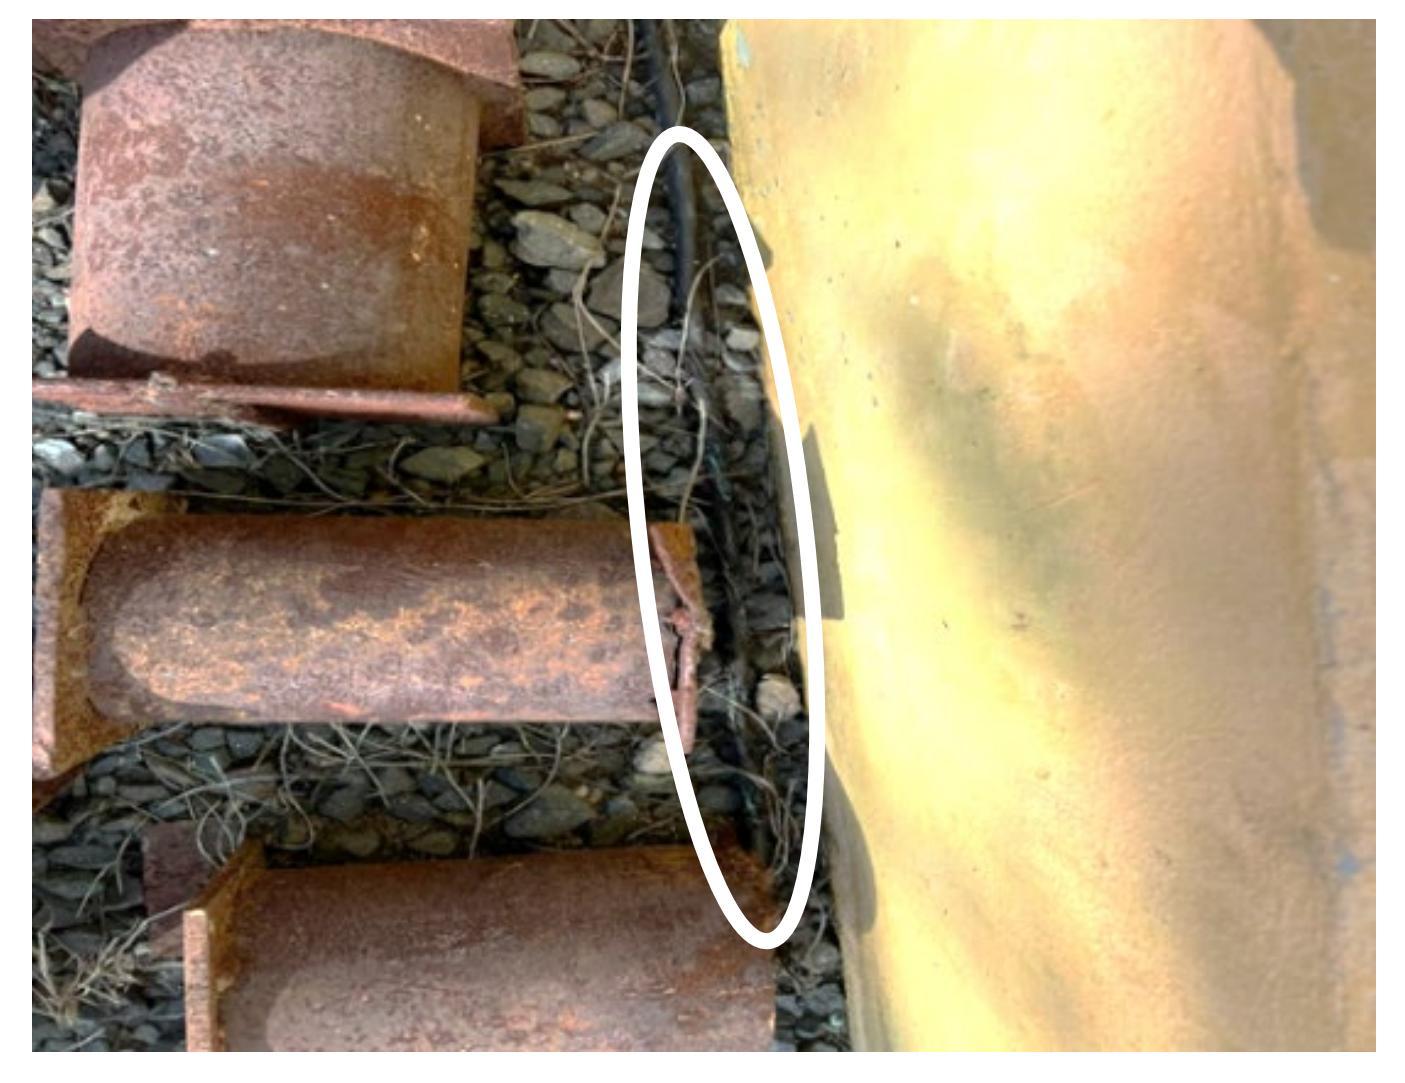
However, the BF scheme did not operate due to faulted current transformer (CT) wiring, preventing the BF relays to read the system currents. At this stage, the system enters the emergency state.

Exposed wire, which in today's standards should be protected by running inside a conduit or trench rather than being buried. Trash adjacent.

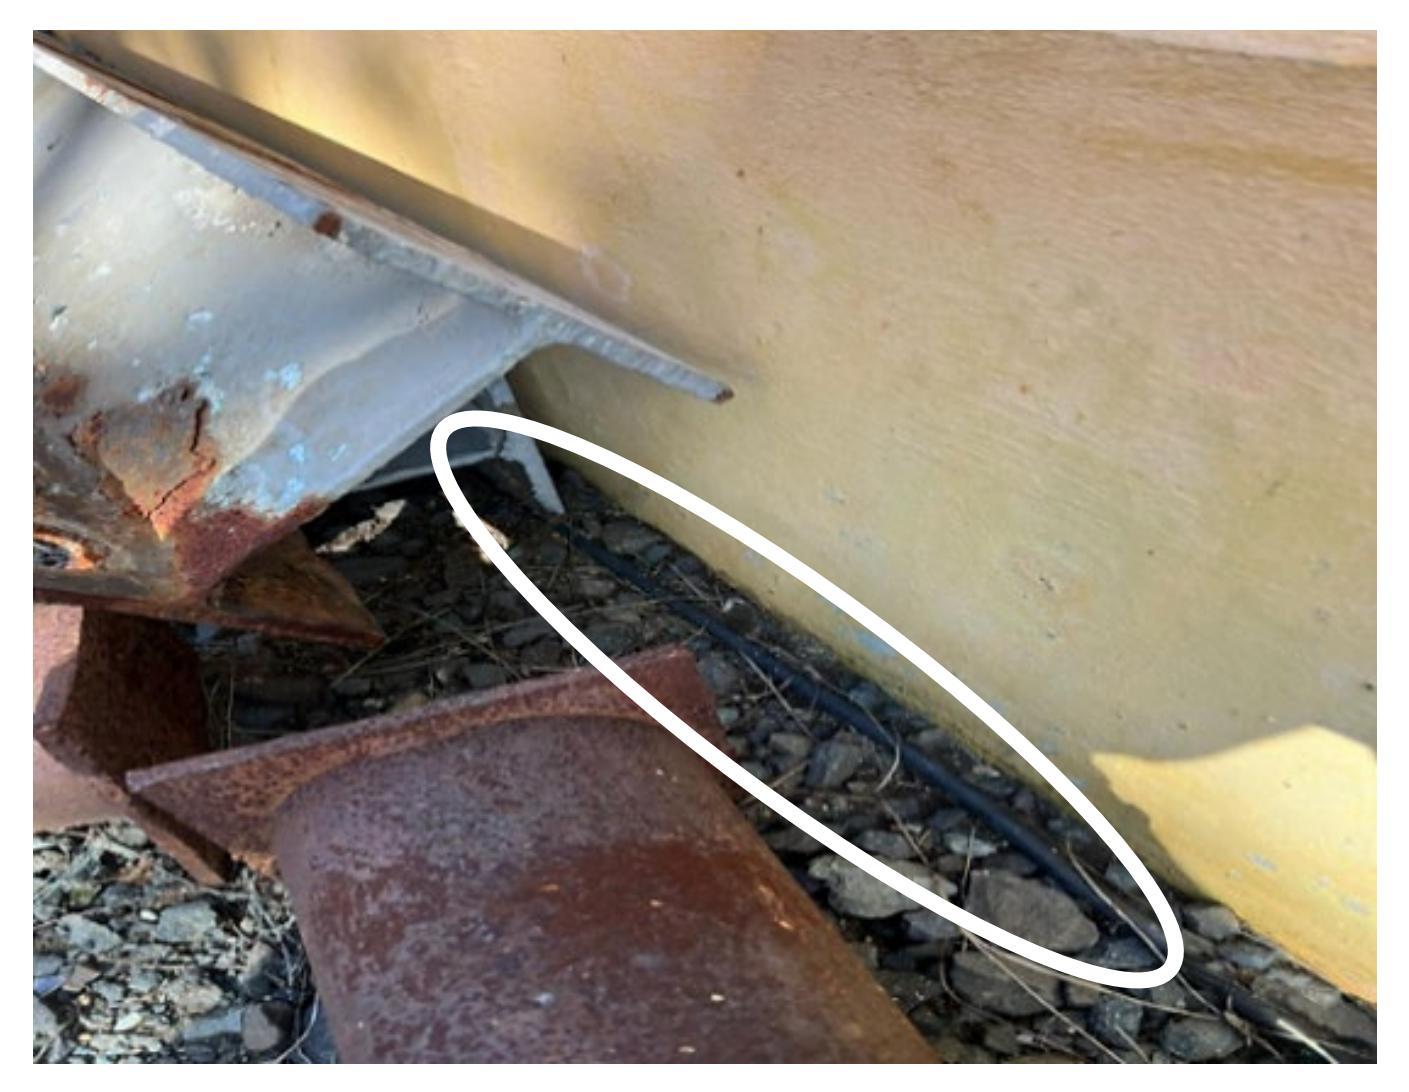
Wire that failed circled. Note exposure to elements and trash adjacent.

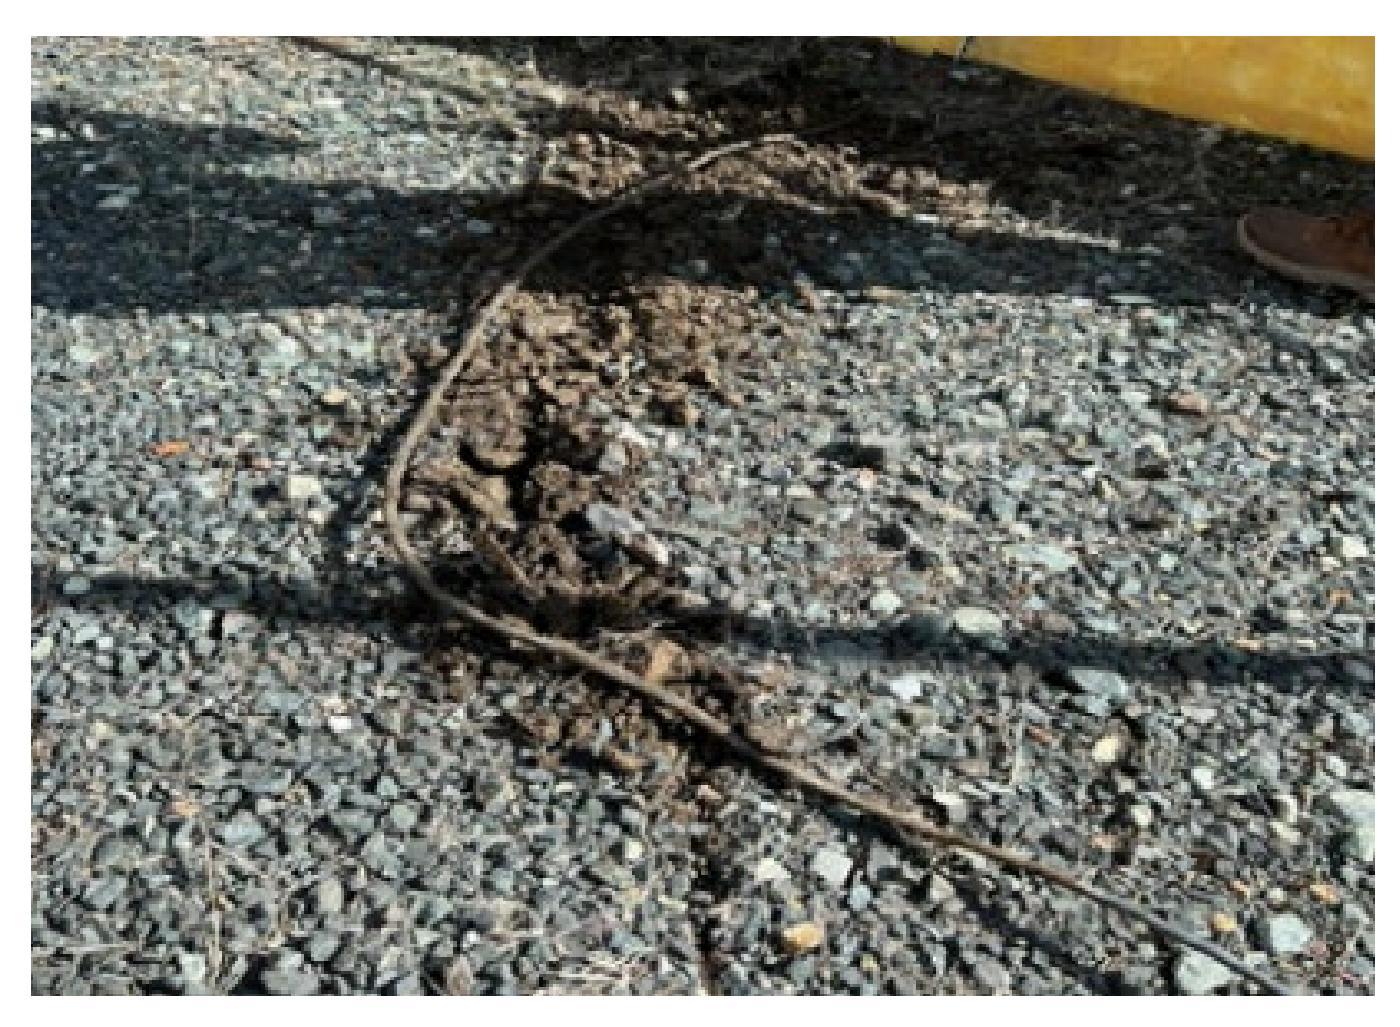
Excavated cable reveals cable insulation deterioration.

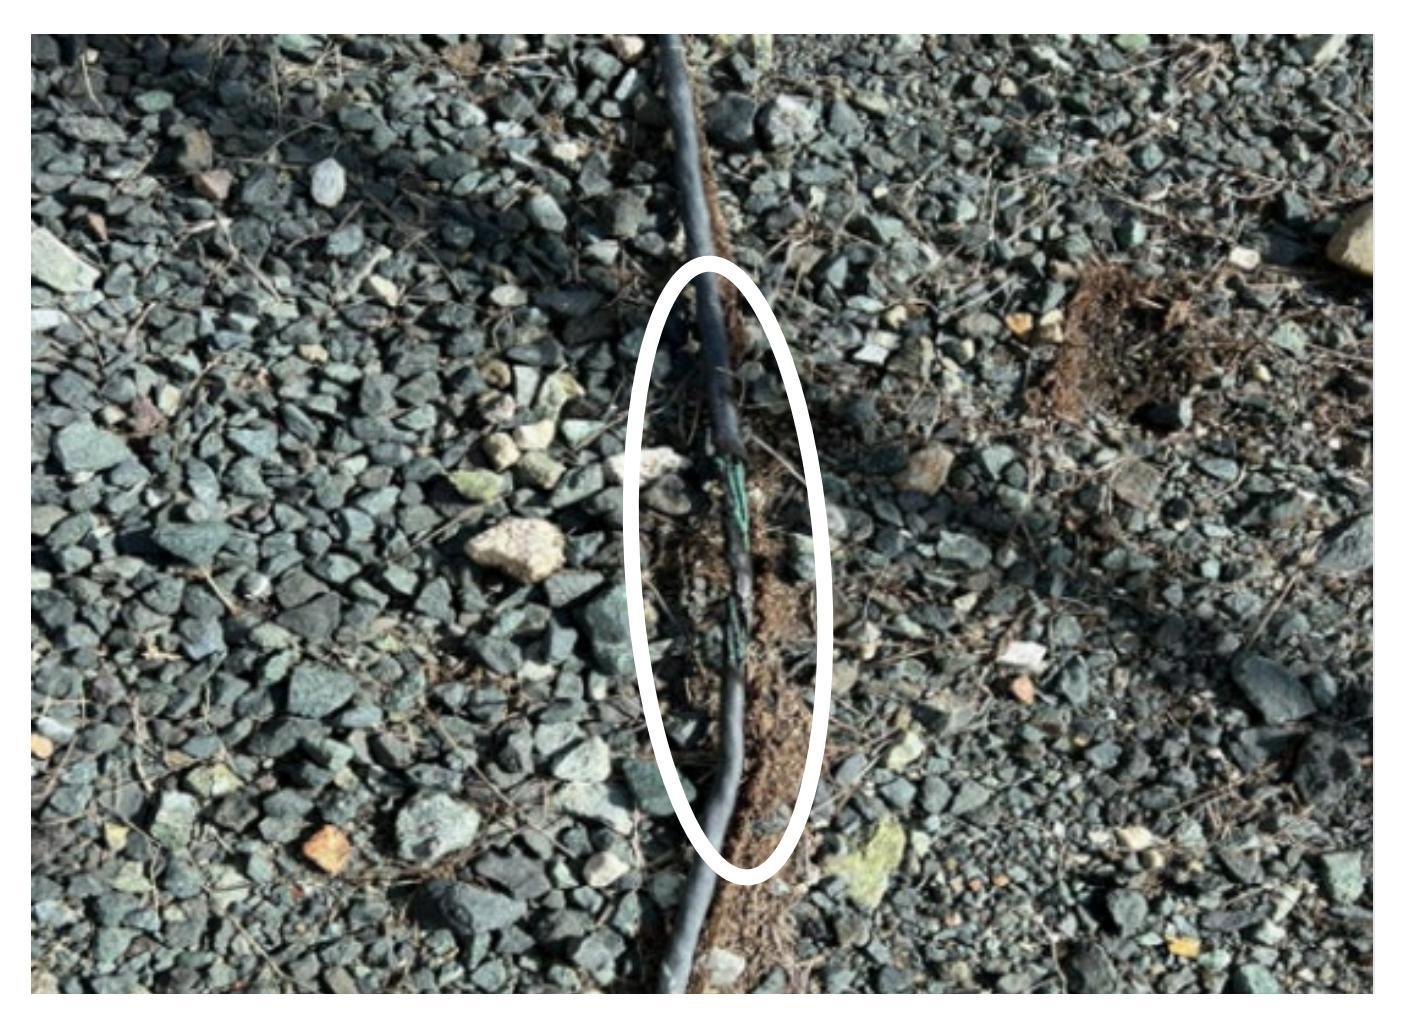
Closeup of wire's damaged insulation.

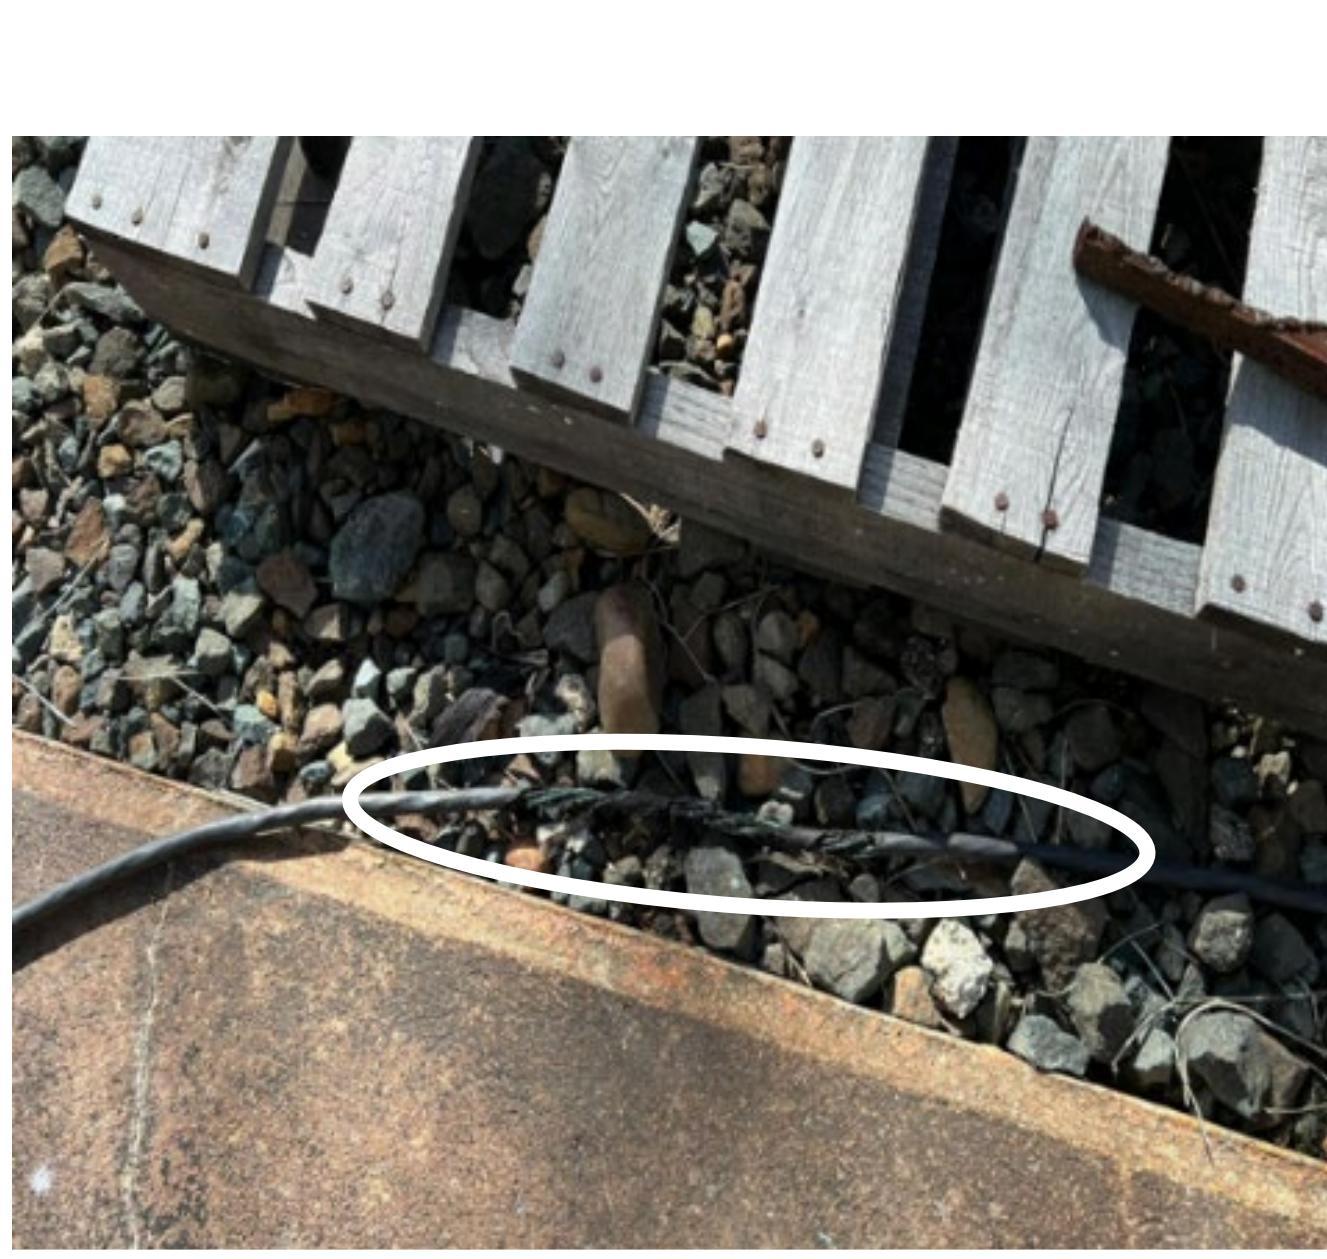
Another example of wire insulation damage and trash on jobsite

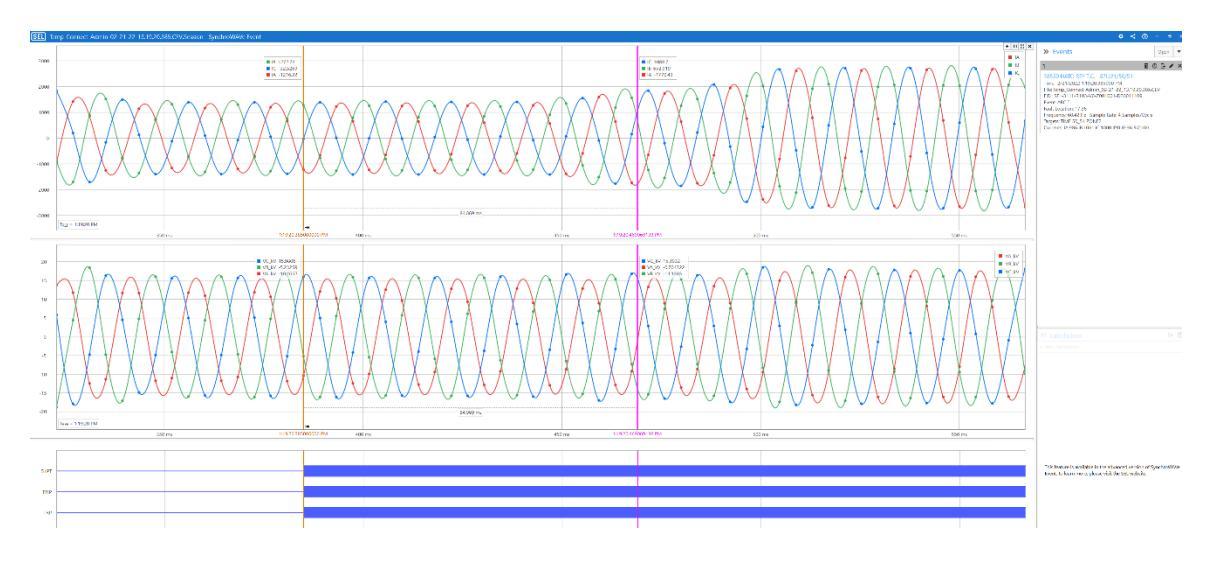
Figure 3-18 Fault Records Data from Hato Rey Terminal of Line 38500 – No Interruption of Fault Current

The circuit breaker's operation was tested with no issues reported. Maintenance will be performed in circuit breaker 38550.

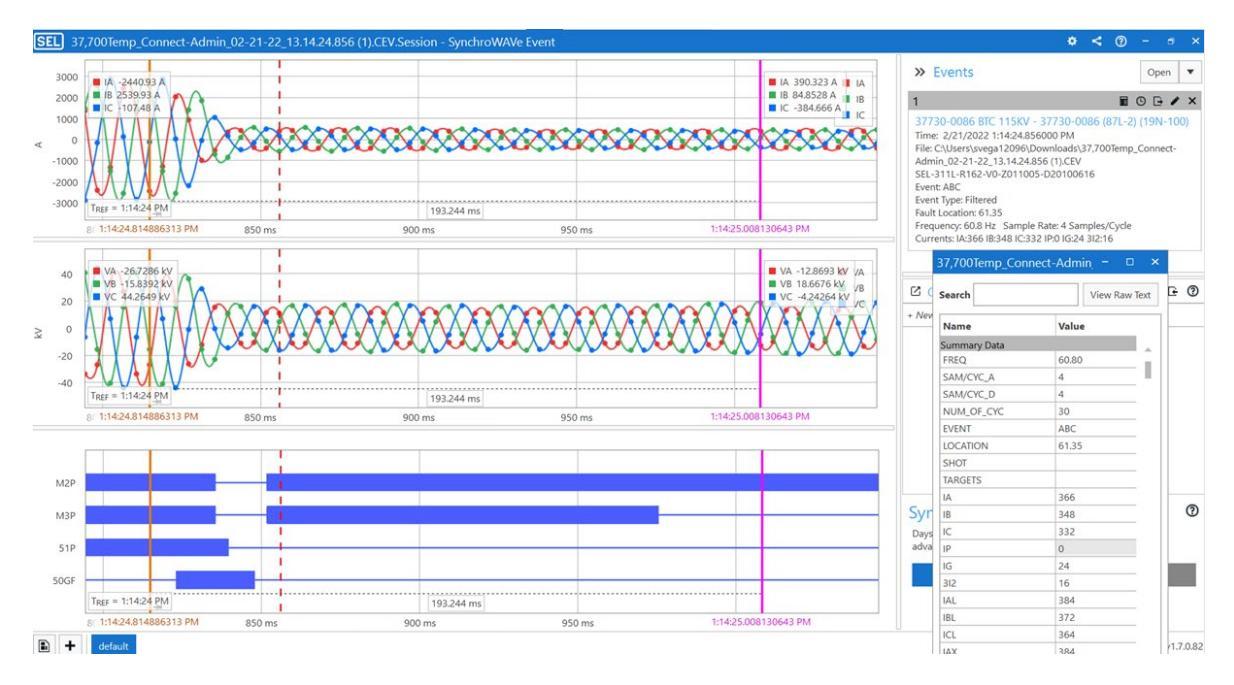
#### Figure 3-36 Zone 2 and Zone 3 Elements Incorrectly Deactivated and 51P Element Deactivated

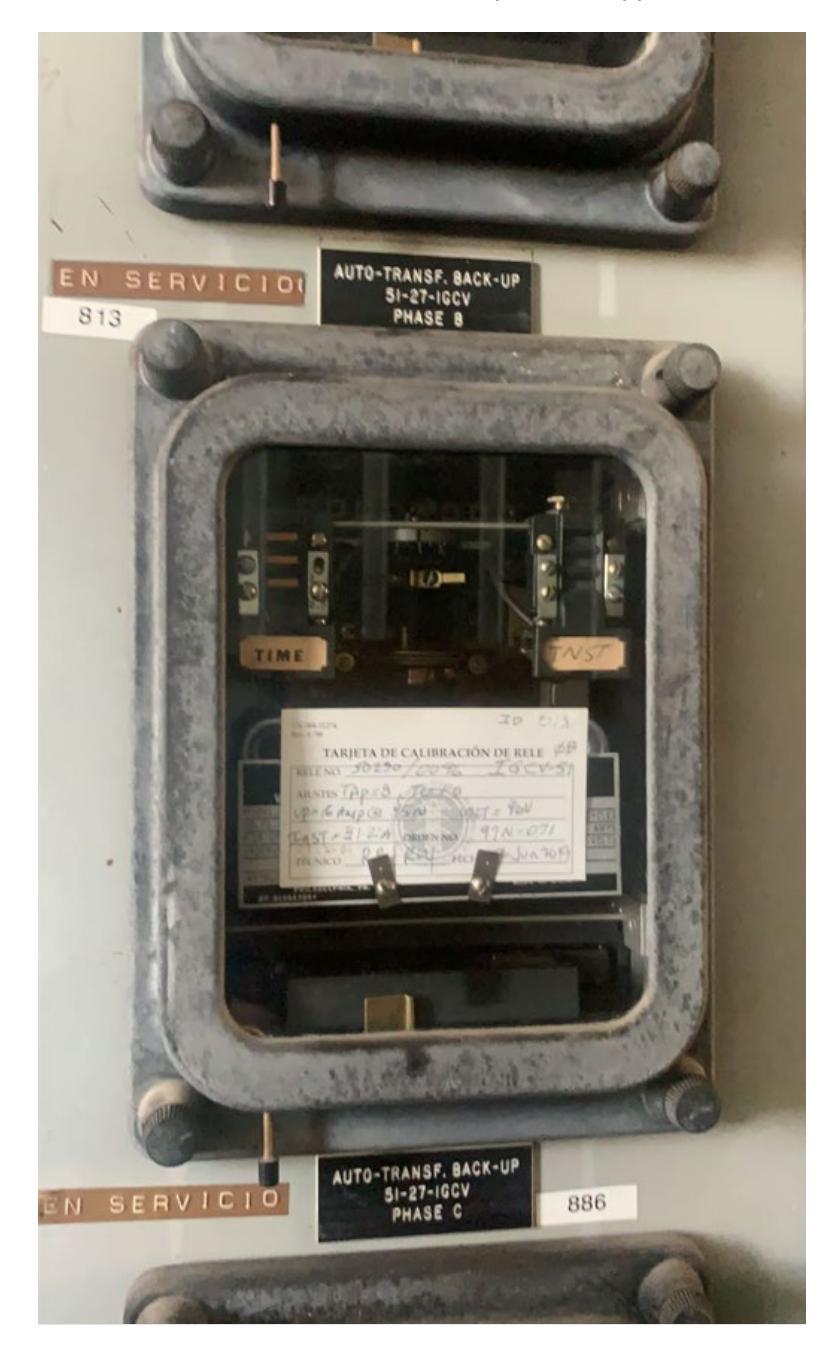
LUMA's Substations Maintenance team informed IGCV-51 phase B tripped.

Figure 3-45 IGCV-51 Phase B with Flag of Time-Delay Operation
