Independent Engineering Report

Palo Seco Steam Plant

Puerto Rico Electric Power Authority

Report SL-015976.PS

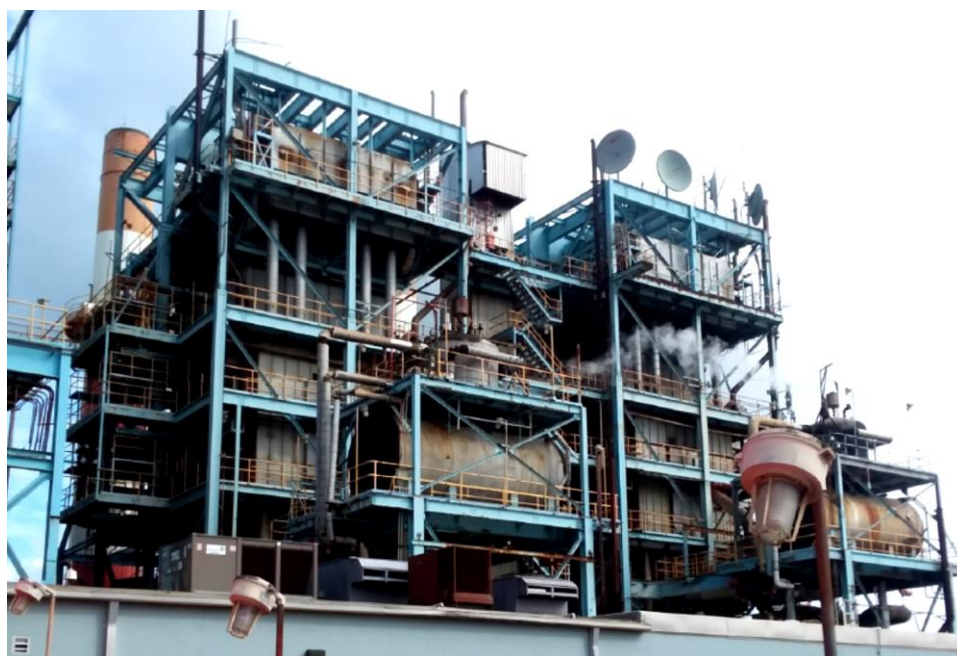
Palo Seco Units 1 and 2 (PS1 and PS2) are tangentially fired CE HFO-fired boilers with reheat and a nameplate capacity of 85 MW each. The units are rated 1450 psi, 1,000°F boilers at 857.7 MMBtu/h. Additional details about the boilers and steam turbines were not available for review. Unit 1 began commercial operation in 1960, and Unit 2 began commercial operation in 1961.

Figure 2-1 — Palo Seco Boilers, Units 1 and 2

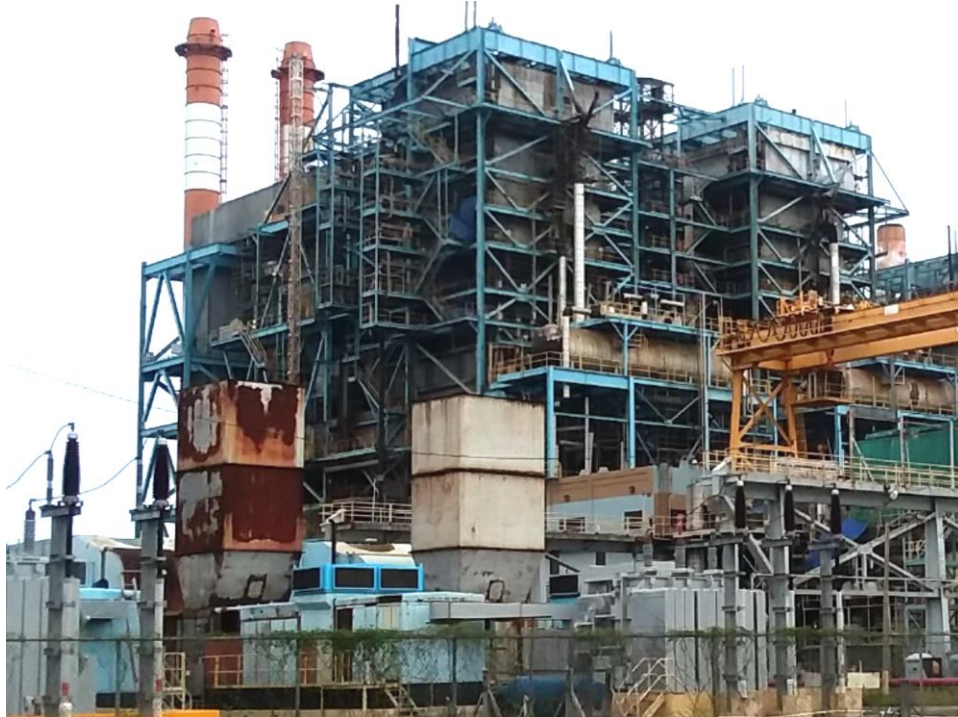
Palo Seco Units 3 and 4 (PS3 and PS4) are tangentially fired CE HFO-fired boilers with a nameplate capacity of 216 MW each. The steam turbines are rated 1800 psi, and the boilers are 1971 MMBtu/h. Additional details about the boilers and turbines were not provided for review. The units began commercial operation between 1967 and 1968.

Figure 2-2 — Palo Seco Boilers, Units 3 and 4

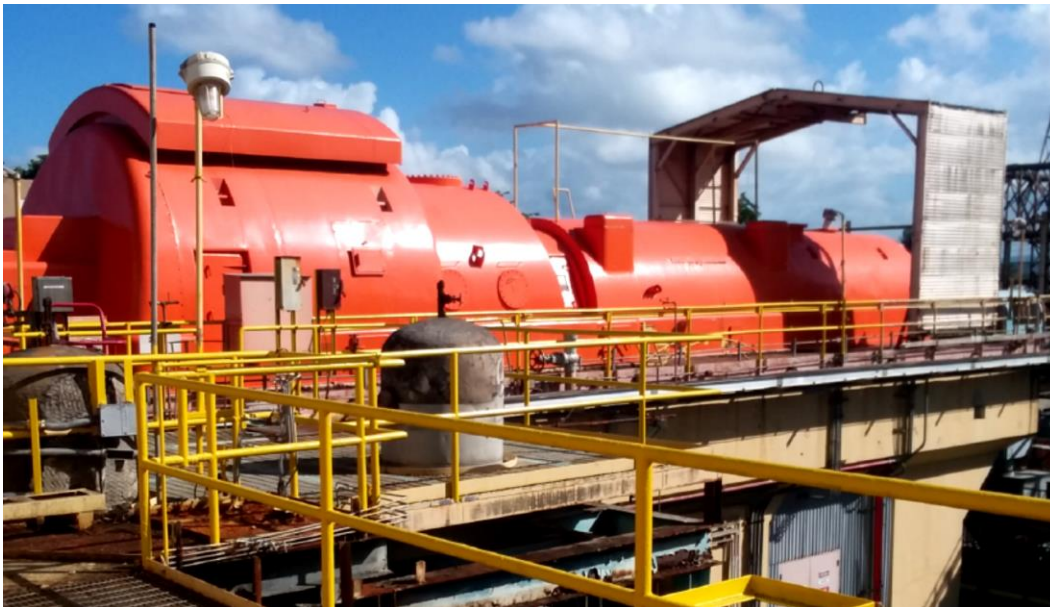
Figure 2-3 — Palo Seco Unit 1 Steam Turbine

The turbines are a down discharge configuration. The condenser is located below the exhaust discharge duct with the turbines above the auxiliary spaces and equipment rooms. The turbine deck is wide and unobstructed, with some deterioration shown in the walkways and catwalks at an approximate elevation of 42 ft. (30 ft. above grade).

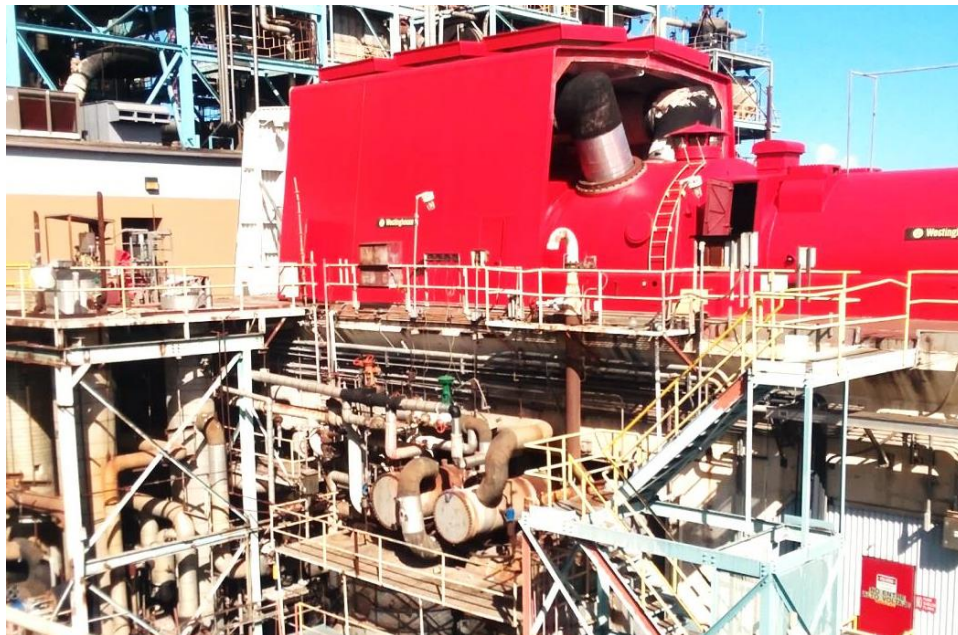
Units 3 and 4: The steam turbines for Units 3 and 4 are Westinghouse and provided with three pressure sections. The HP and IP sections are opposed flow. The low-pressure section is dual flow, down exhaust configuration.

Figure 2-4 — Palo Seco Unit 3 Steam Turbine

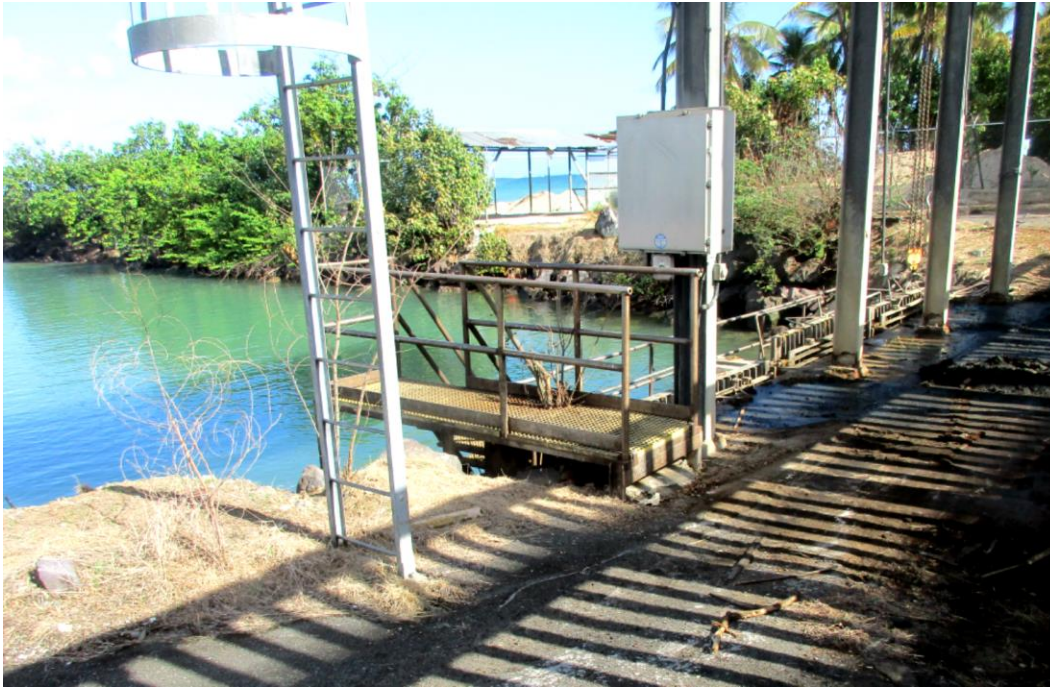
fouling and maintaining adequate cooling water system flow and heat transfer. Maintenance outages usually include cleaning of hard marine buildup in the system.

Figure 2-5 — Palo Seco Water Intake, Unit 1

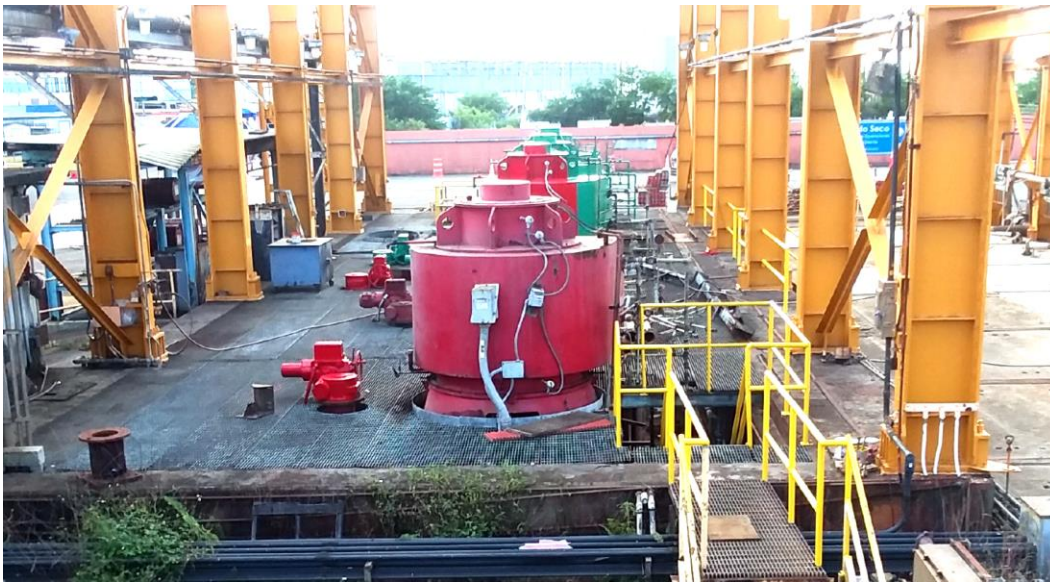
The pumps are mounted to the concrete deck above the water intake basin. A service platform is provided at the motor level for servicing and inspection of the units. An overhead crane is available for maintenance removal and access.

Figure 2-6 — Palo Seco Unit 3 and Unit 4 Circulating Water Pumps

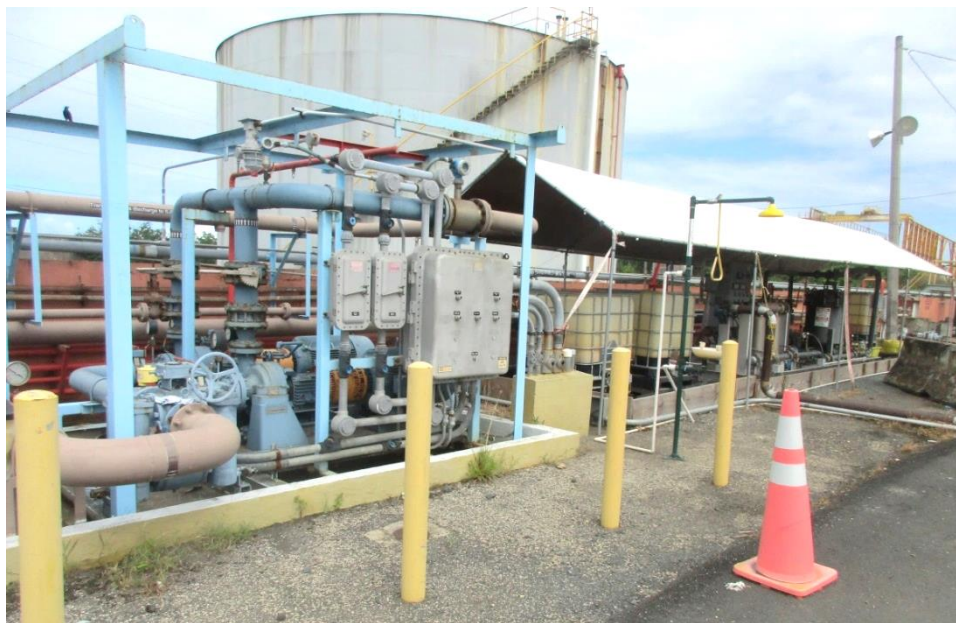
Fuel storage and transfer systems on site include HFO and No. 2 for the thermal units and the GTs, respectively. No. 2 is received into three tanks that feed the GT units. These tanks can be arranged to receive fuel directly from fuel delivery trucks or by pipeline. Palo Seco receives HFO and No. 2 fuel oil from ships and barges unloaded at the station's oil discharge docks in the San Juan Bay. The HFO and No. 2 are stored in onsite tanks prior to being forwarded to the thermal and GT units, respectively, for firing to generate electricity.

Figure 2-7 — Palo Seco Diesel Oil Tank #1 and Transfer Pump Skid

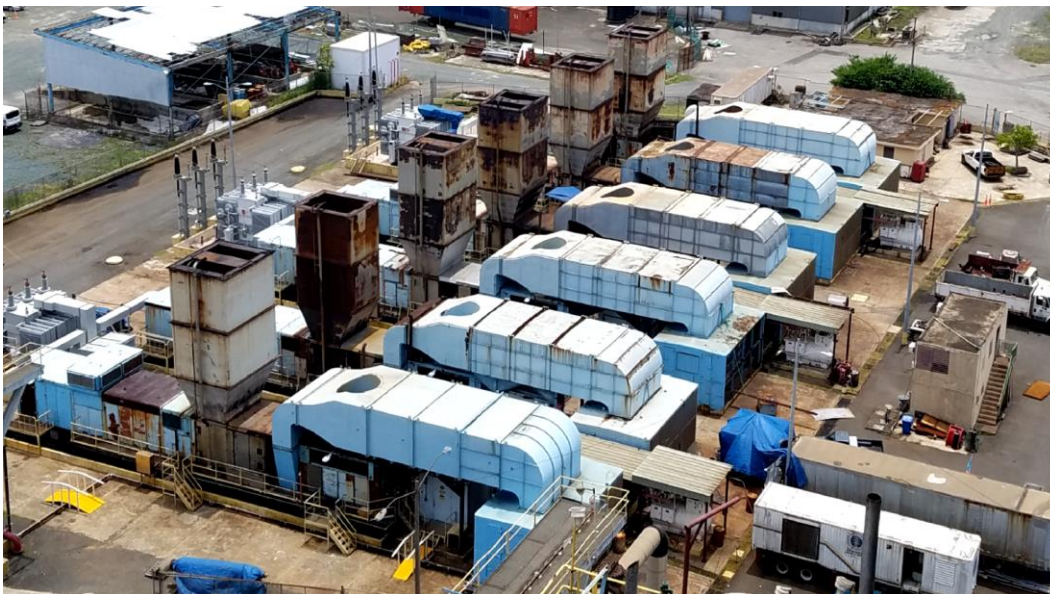
Figure 2-8 — Palo Seco Gas Turbines

The turbines are a GE design that was first available for delivery in 1961. The units are each rated at 23,450 kW for 6,000 hours of use a year. The model also has an available peak rating of 25,300 kW for limited (2,000 hours/year) usage. The nominal (new) heat rate is 12,370 Btu/kWh. The compressor has a compression ratio of 10.2, with a combustion turbine inlet temperature of 1805°F and exhaust temperature of 958°F. The output turbine shaft has a speed of 5105 revolutions per minute and a gear box reduces the speed for the generator to 3600 revolutions per minute. The design is licensed to Hitachi and John Brown Engineering for manufacture and delivery. The GT is self-contained, described as a packaged unit with only a fuel source required for operation.

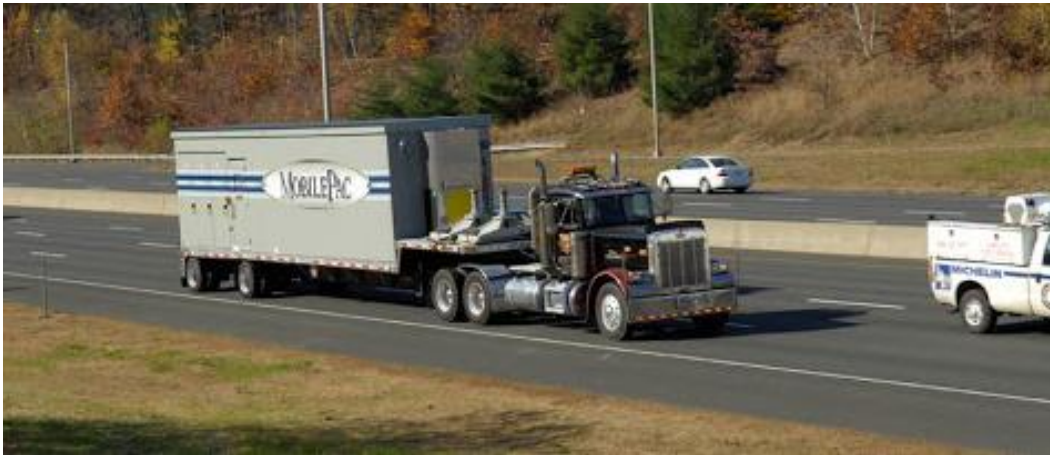
In 2019, the Plant added three new PWPS MOBILEPAC FT8 units rated 30.941 MW at standard ISO conditions. The units are designed to operate on liquid fuel or natural gas, and each unit consists of two trailers: one with the turbine, generator, and exhaust system, the other containing the 15-kV switchgear, control system, protective relays, motor control center, and hydraulic start package. Figure 2-9 shows an example of one trailer in transit. The three units were procured to meet the needs of a fast-response generation source and can be brought online during power shortage emergencies like those that resulted during the 2017 hurricane season. The mobile design allows the units to be transported by road and redeployed in a matter of days wherever additional generation is needed. At the Palo Seco site, these units are located adjacent to the GIS building and are tied into the primary side of the Unit 2 MPT.

Figure 2-9 — PWPS FT8 MOBILEPAC Gas Turbine in Transit

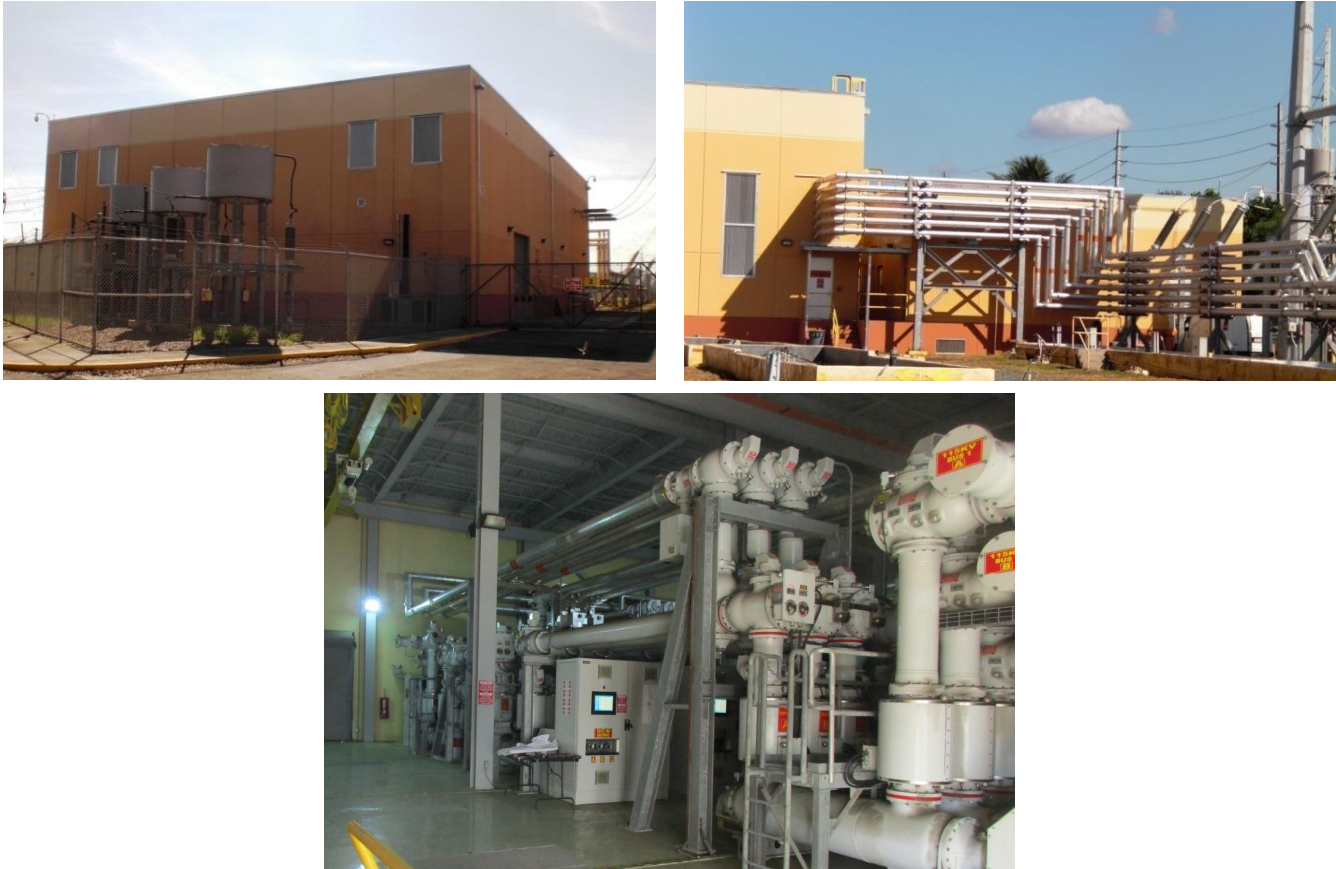
The GIS replaced the old 38-kV and 115-kV open-air switchyard in 2012. The energized parts are contained using gas-insulated technology and are divided into two buildings based on the voltage level. The GIS facility review is out of the scope of this document but is included here for information only.

Figure 2-10 — New Palo Seco Gas GIS Building

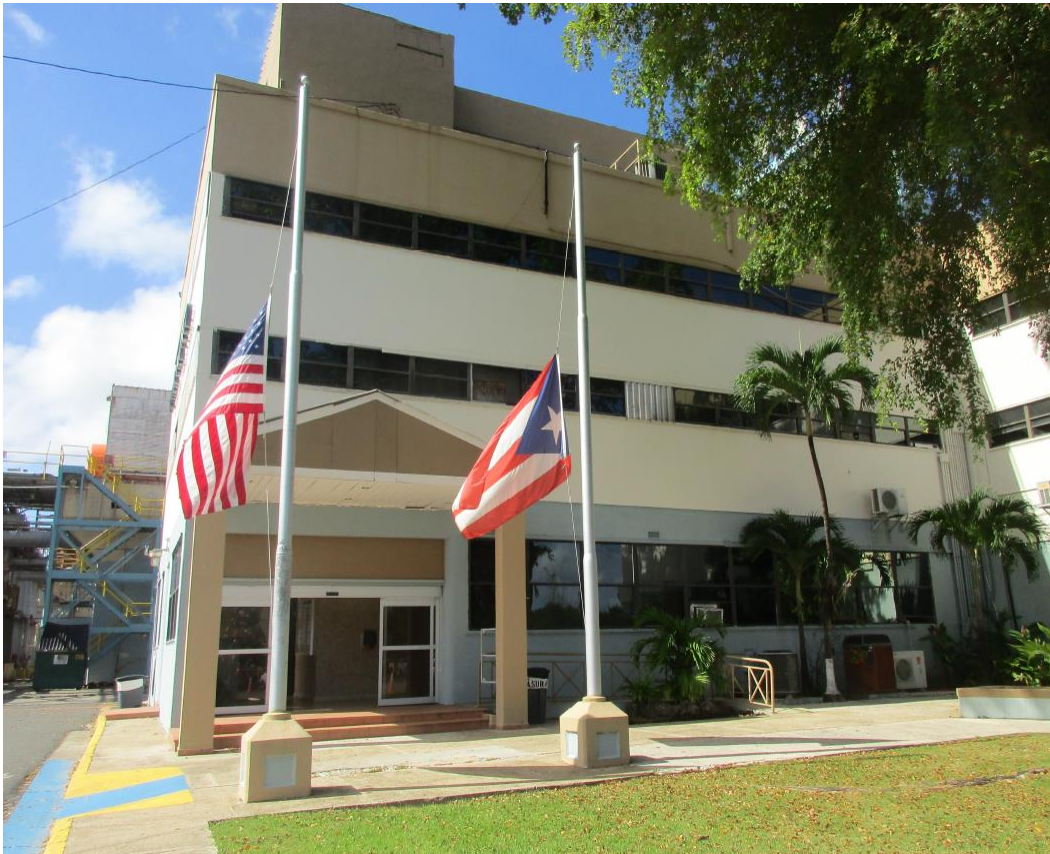
Figure 2-11 — Palo Seco Main Administrative Building

The Administration/demineralization plant building is a multistory structure. The main offices are located here and have an elevator, conference rooms, support staff offices, and library. A separate area houses the demineralization plant equipment including the pumps, tanks, and water treatment skids.

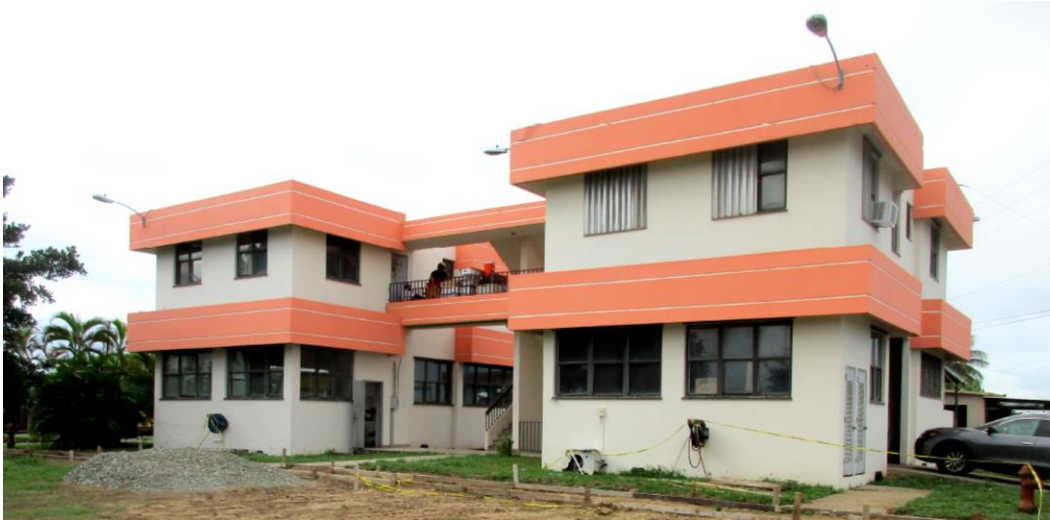
Figure 2-12 — Palo Seco Gas Turbine Administrative Building

The GT administration and support buildings house the workshops and offices for the six GT units on site. The building is located on the west side of the facility adjacent to the outdoor storage area for the GTs.

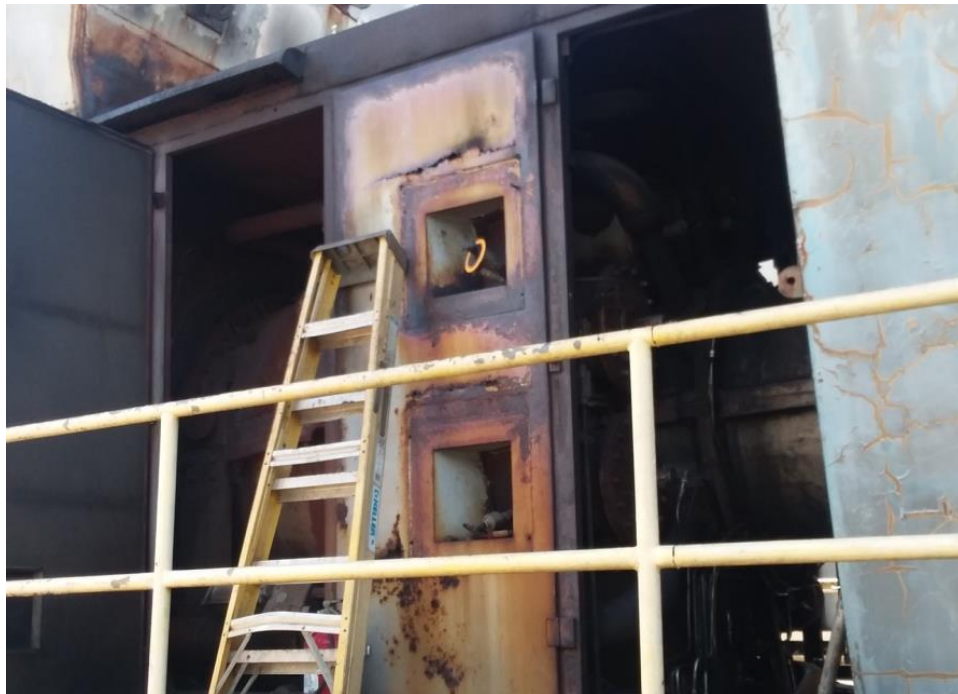
Figure 3-2 — Palo Seco GE Gas Turbine Corrosion

Each GT weather enclosure was compromised. The enclosure doors and seals were corroded, loose, or missing. Many of the doors were open, allowing the interior of the GT enclosure to be exposed to the environment. On some units, the shell steel was corroded throughout. The operators indicated that, despite the appearance, the units in operation are reliable and were in use after the 2017 hurricanes to provide emergency power to the grid.

The infrastructure required to keep the GTs available is minimal, with essentially only a fuel and electrical connection required. Future operability requires repair and inspection of the units as suggested. The units could be evaluated for temporary repair while replacement units are being considered. Life extension repair of the units could be considered; however, the skid and enclosure supporting the GTs are in poor condition, and the feasibility of repairs is limited.

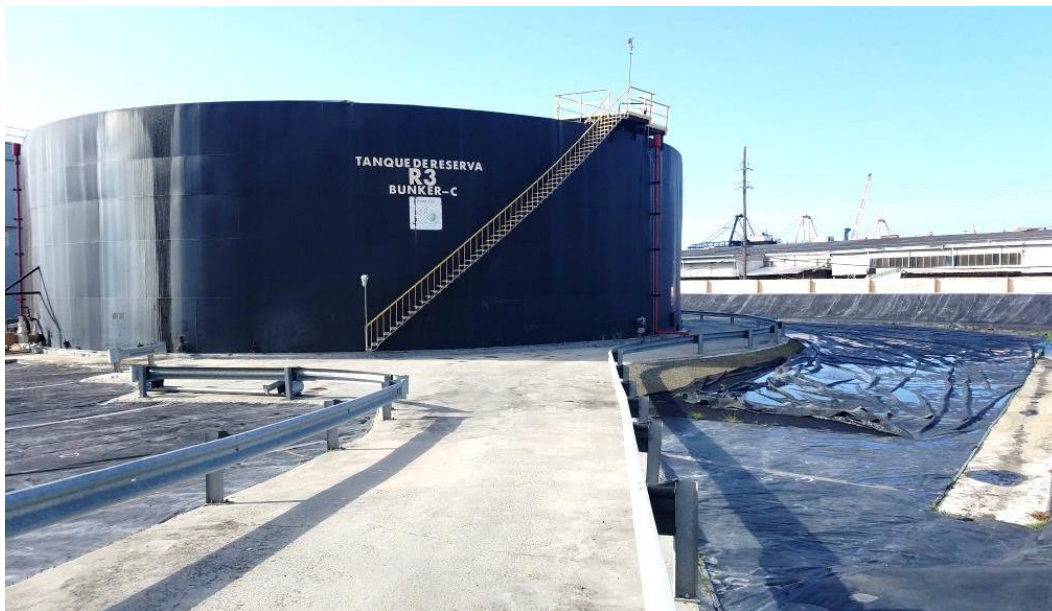
Figure 3-3 — Damaged Palo Seco HFO Fuel Oil Reserve Storage Tank R-3

- **Existing Fuel Oil Storage Facilities:** While some corrosion-related repairs could be anticipated, the existing fuel oil system could be used to support new generating units either as a source of primary fuel or backup fuel.

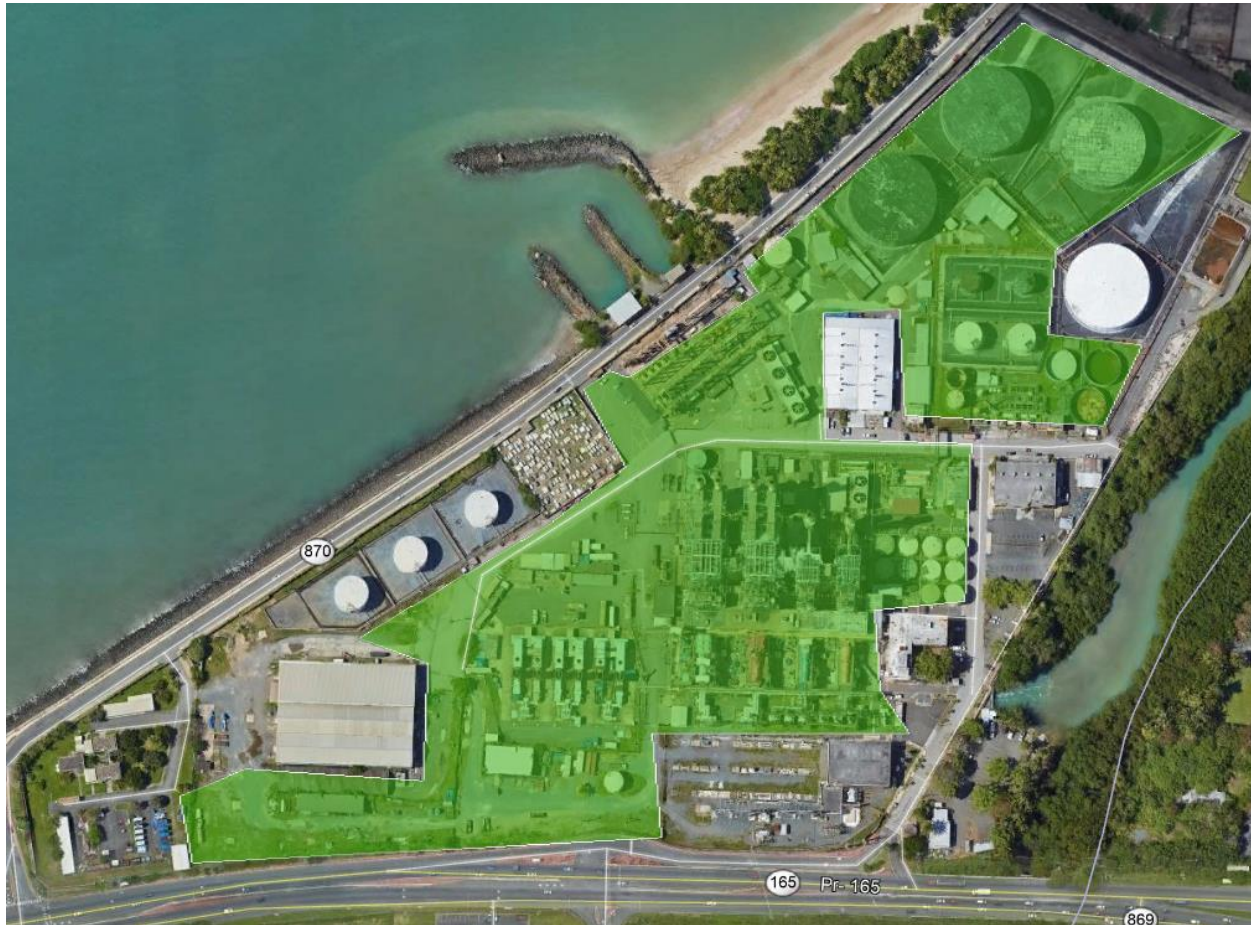
The Palo Seco facility has significant space for repurposing and reuse (see Figure 3-6, with the conceptual repurposed area shaded in green). This is in addition to the currently open areas at the southwest side of the Plant. The HFO system should be retired with any plant upgrade to newer technology or tank made available as additional No. 2 storage. If consideration for a diesel fuel oil system is anticipated for a backup fuel, the system can be evaluated as is or expanded as required. If fuel gas is considered either as a primary or as a dual-firing design, some or all the areas dedicated to fuel tanks and containment can be reclaimed for other equipment or use.

Figure 3-6 — Palo Seco Potential Reclamation Areas

A phased-in approach for equipment replacement may be considered. Temporary rentals may be used with the newly constructed GIS facility to keep the Plant online and generating power as demolition and a systematic restoration and replacement plan is carried out. The Plant has potential for more efficient, cleaner, combined-cycle plant design, possibly coupled with a hybrid configuration for instantaneous power.
