O&M Concession
**Independent Engineering
Report**
San Juan Power Plant

Puerto Rico Electric Power Authority

Report SL-015976.SJ

November 13, 2020

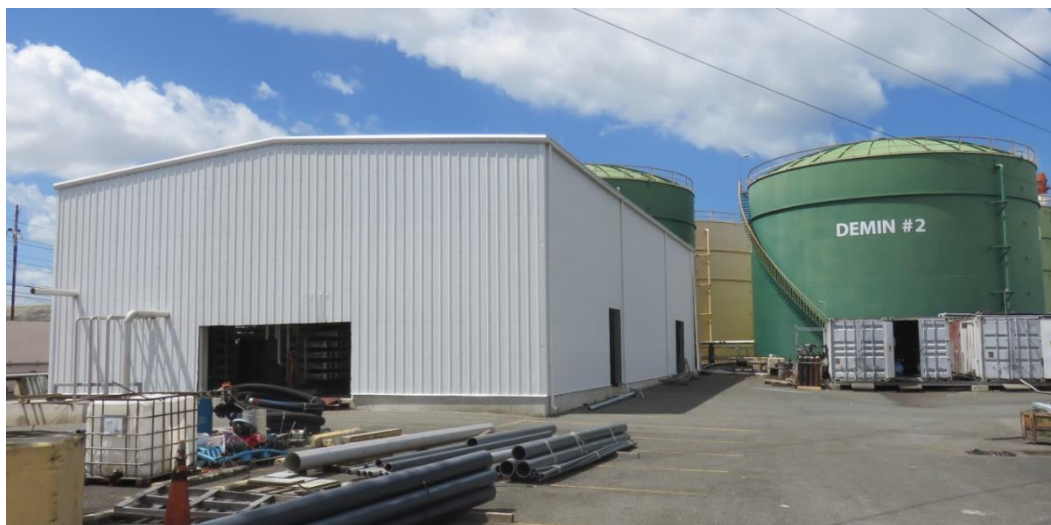
Figure 4-1 — Location of New RO Water Treatment System

The new water treatment facility is under construction, and as of March 2019, the building was near completion and equipment was being installed. The new facility is shown in Figure 4-1 and is located adjacent to the demineralized-water tanks on the south side of the Plant near the main entrance.

Water treatment plant, March 2019

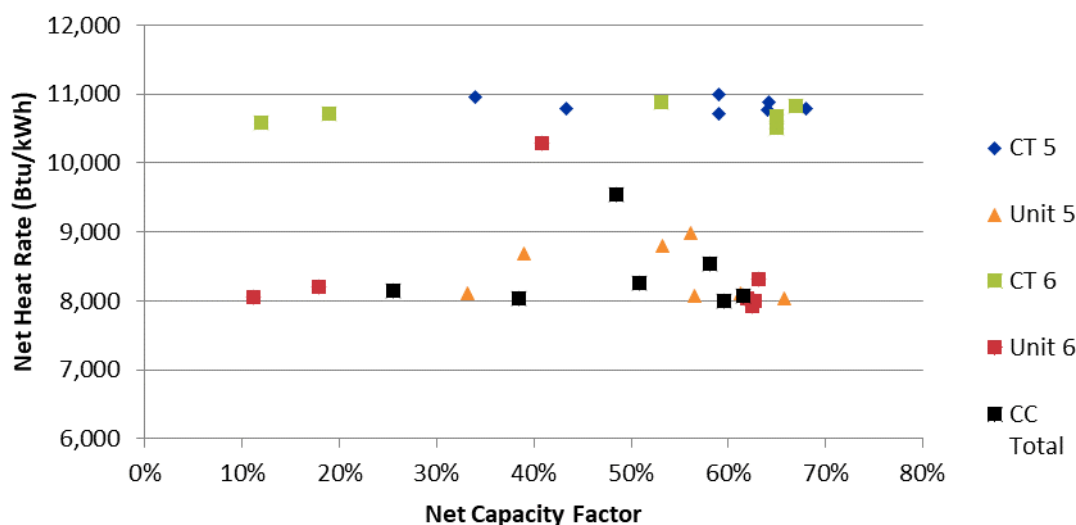
Figure 6-9 — San Juan Combined-Cycle Units: Heat Rate vs. Capacity Factor

San Juan's combined-cycle units show lower heat rates in comparison to other combined cycles in the fleet; however, the rates are high in comparison to other combined-cycle units. The original heat-rate calculation indicates the combined-cycle heat rate is 6,696 Btu/kWh at full load; at partial load, the values can be significantly higher. The combined-cycle net heat rate ranges within 8,036–9,538 Btu/kWh.

Sargent & Lundy recommends PREPA evaluate the reference performance data for the San Juan combined-cycle units and compare it to the original heat rates indicated in the Plant guaranteed values. Previous recommendations in Section 3.1.2.1 regarding heat rate and efficiency indicate that steam-side issues should be evaluated and corrected.
