GOVERNMENT OF PUERTO RICO
PUBLIC SERVICE REGULATORY BOARD
PUERTO RICO ENERGY BUREAU

IN RE: April 16, 2025, Bluesky Total Blackout Event	**CASE NO. NEPR-IN-2025-0003** **SUBJECT: Memorandum of Law in Support of Request for Confidential Treatment of Exhibits 1 and 2 Submitted on June 16, 2025**

MEMORANDUM OF LAW IN SUPPORT OF REQUEST FOR CONFIDENTIAL TREATMENT OF EXHIBITS 1 AND 2 SUBMITTED ON JUNE 16, 2025

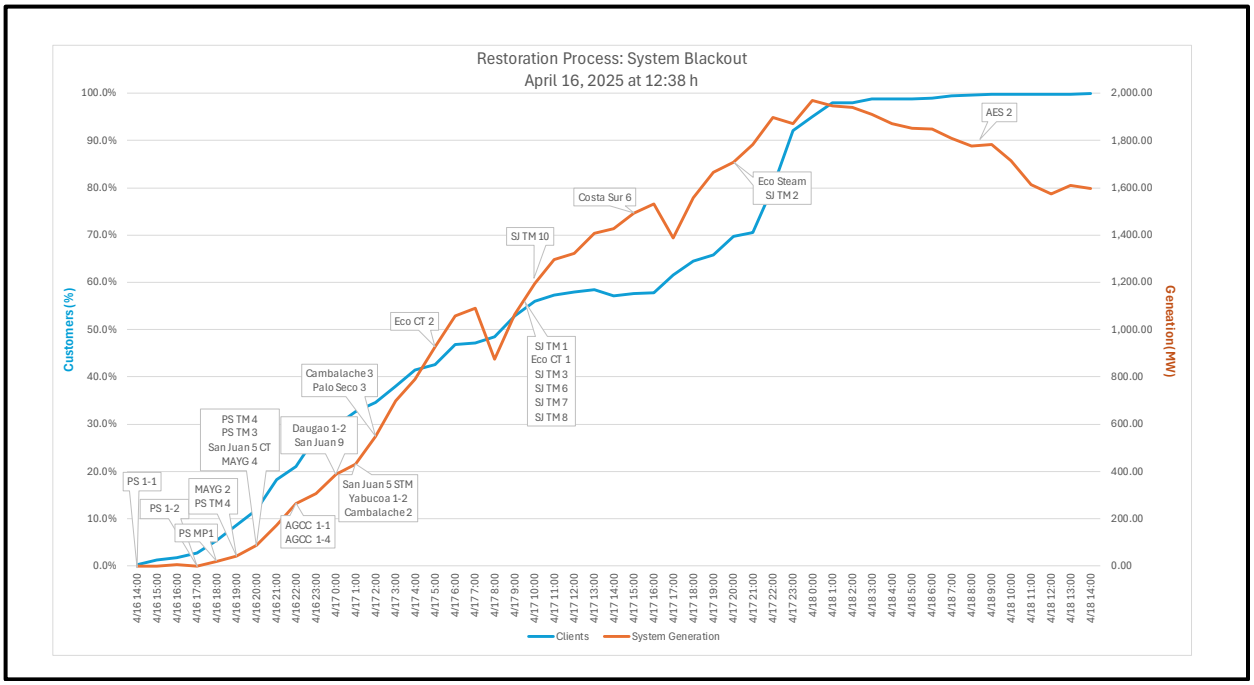
Figure 8. Restoration History.[5]

occurred. From an overall perspective, the return to service occurred with no major issues.[16] The customer restoration is shown in Figure 8 with all customers being restored by 1400 hours on April 18, 2025.
