Preliminary Facts of April 16th, 2025, Island-wide Outage Event

Outage Name: 16 APR 2025 Island-wide Outage Event

Event Number: OE2504-108

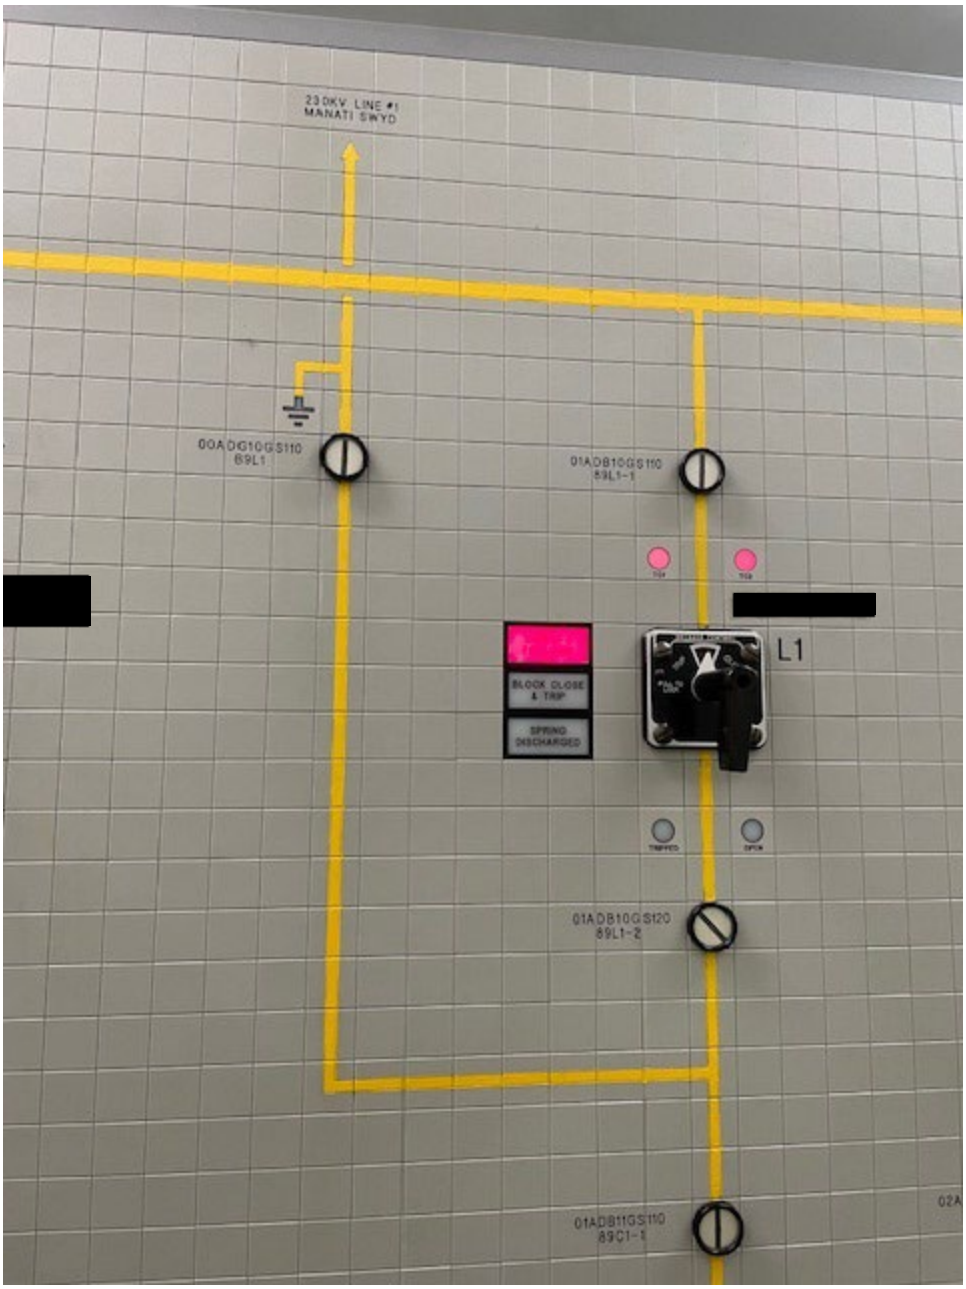
Rodent bait

Conduit into control room

Trip coil lights [redacted]

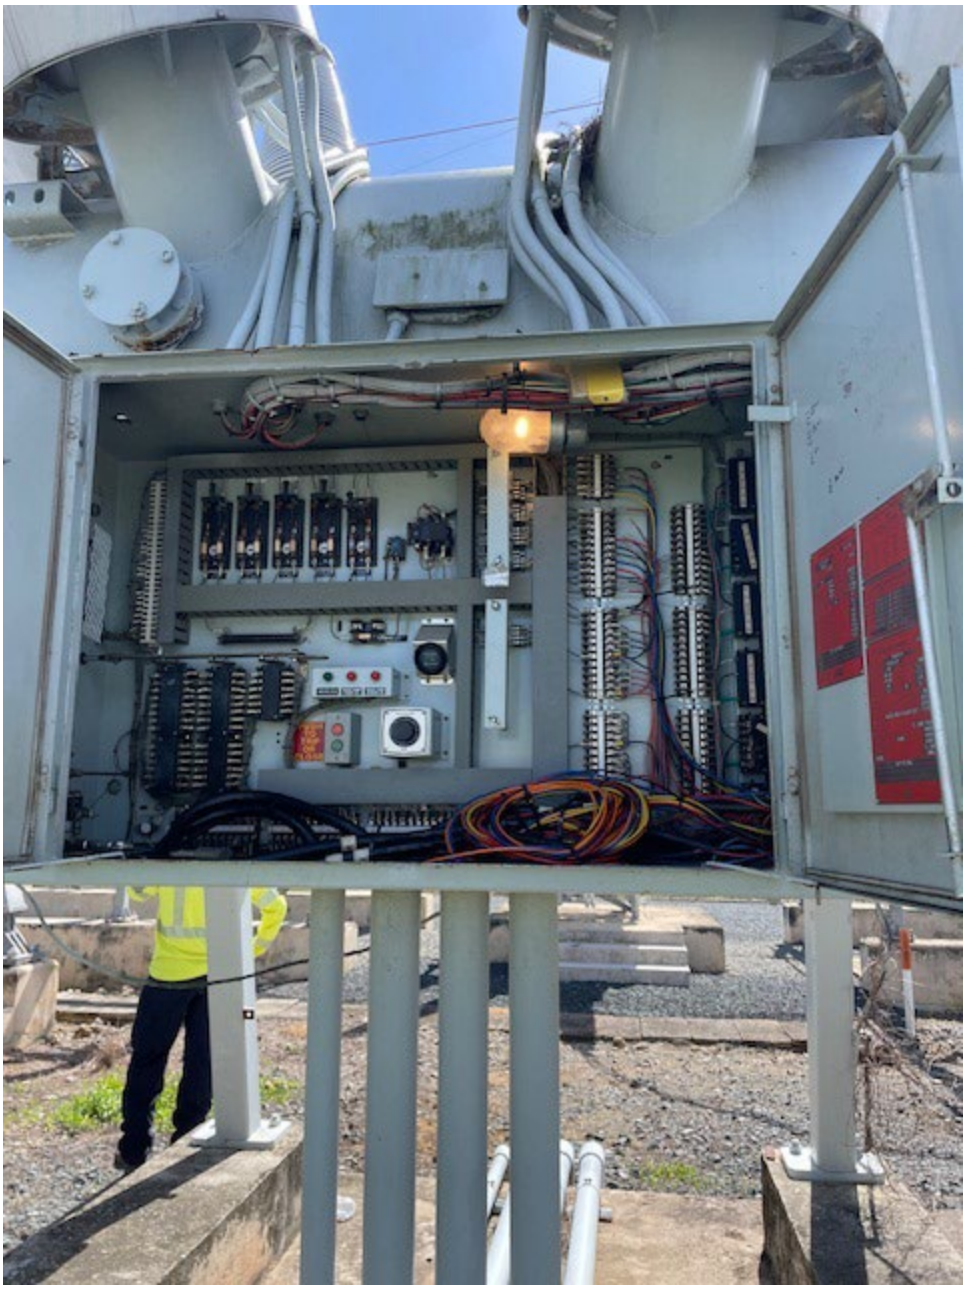
[redacted] control box conduit LB to cable trench

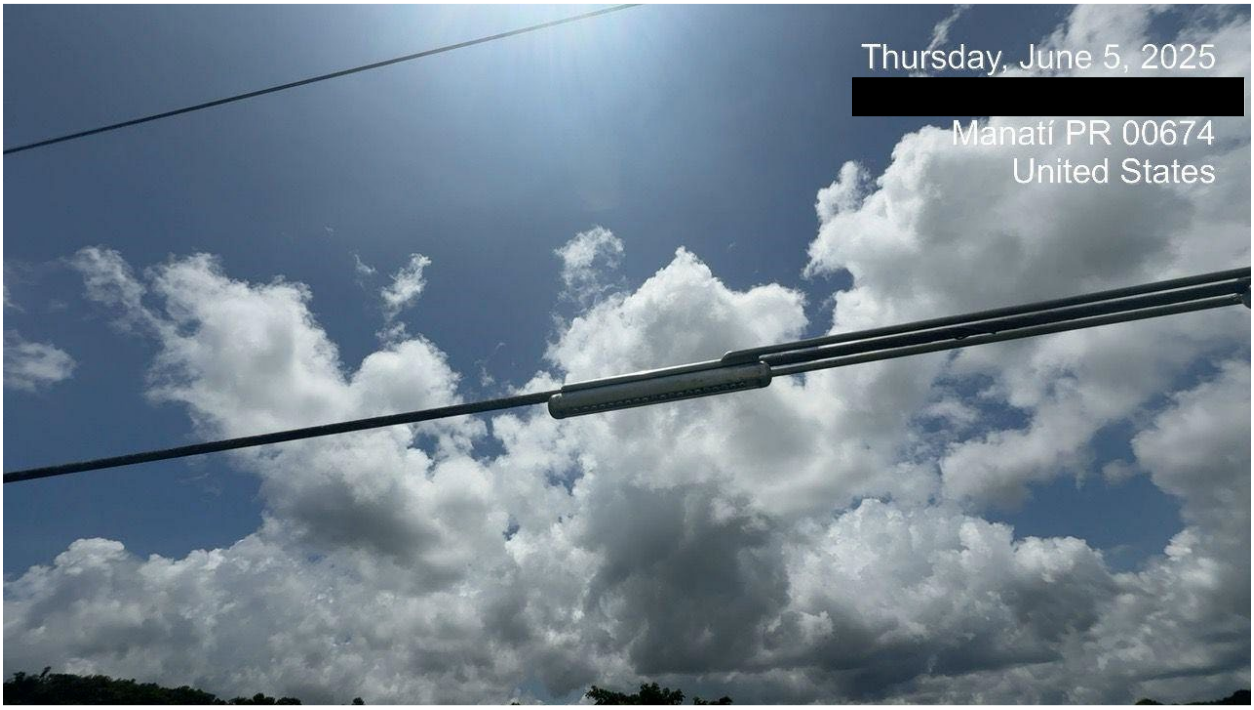
Privileged and Confidential
Photos of Line [redacted] Repair: Received June 6, 2025

Below is a photo provided by LUMA. They informed that the crews installed the star clamp yesterday to reinforce the damaged conductor.
