**REQUEST FOR PROPOSALS FOR
TEMPORARY EMERGENCY
GENERATION**

COSTA SUR RECOVERY PROJECT REPORT

Strategic Action Plan
Condition Assessment, Value Engineering and Decision Making
Restoration of Lost Power Capacity at Costa Sur Power Plant (CSPP) due
to Earthquake Damages

***Emergency Structural Inspection and Assessment
Preliminary Report of Immediate Remediation Needs
And Repair Approach
1-30-20***

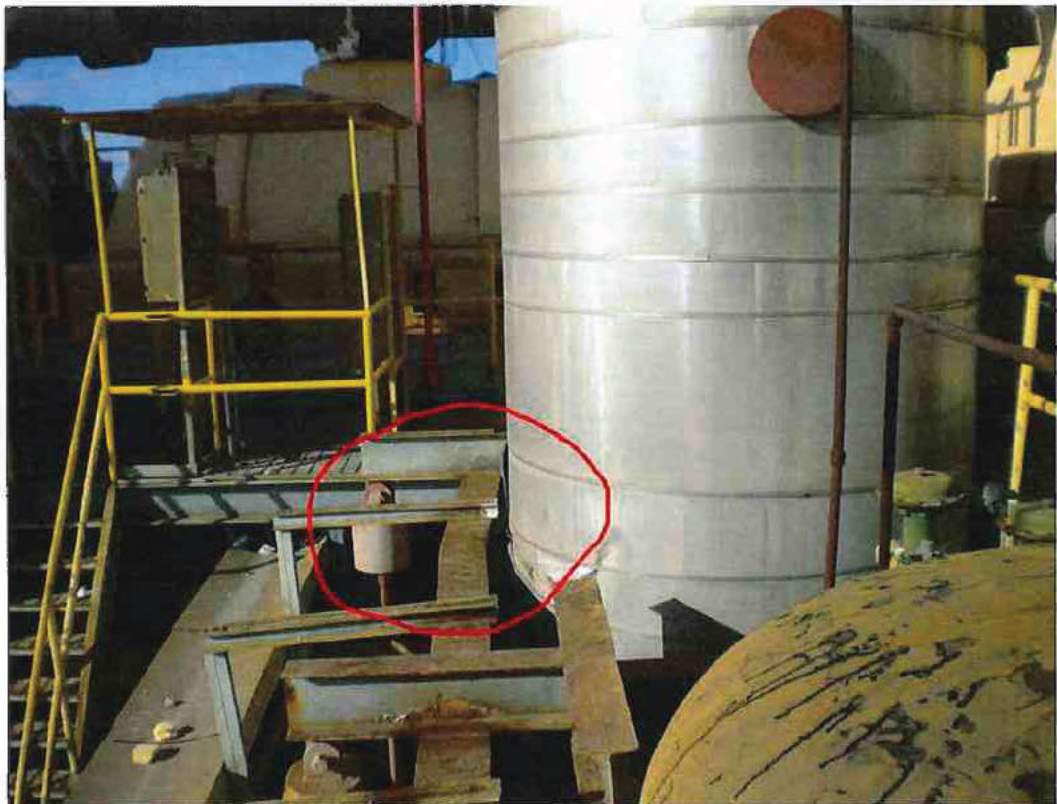
Photo 35 - U-6 Bent Heater 6 Lateral Restraint
