Independent Engineering Report

Cambalache Power Plant

Report SL-015976.CA

September 30, 2021

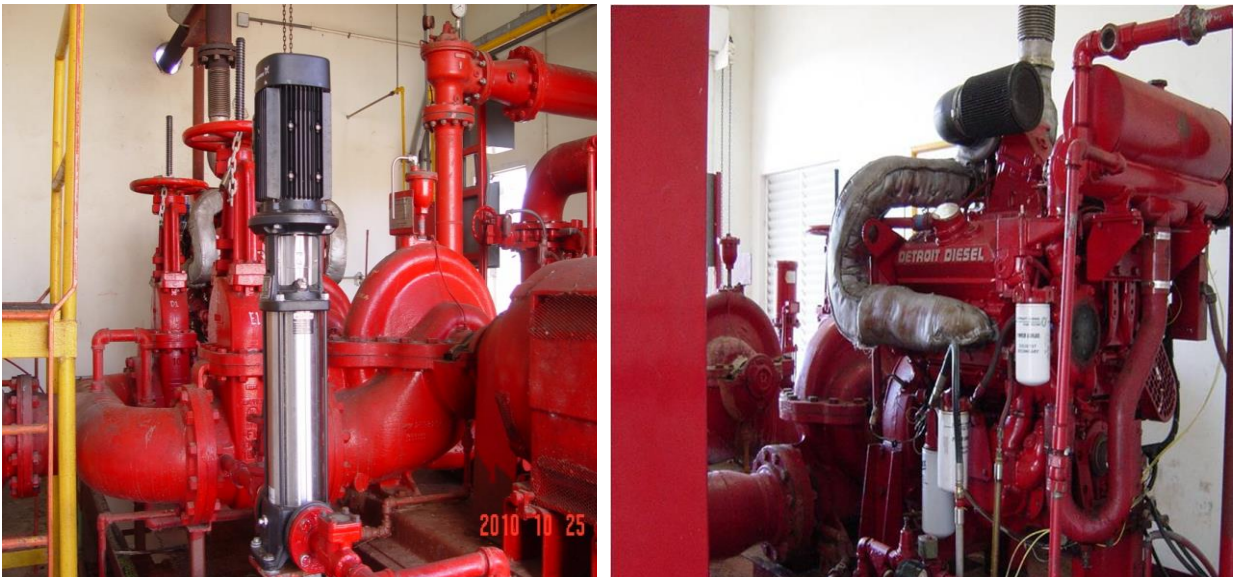
Figure 3-8 — Electric and Diesel Firewater Pumps

Inspection of the Plant's fire protection systems during the 2018 walkdown did not reveal any outstanding operational or maintenance concerns. Figure 3-8 shows the electric and diesel motor-driven firewater pumps in their enclosure. These photos are from 2010, but Plant staff notes that the system remains in working order and that the enclosure provides good protection from the elements.
