O&M Concession  
**Independent Engineering  
Report**  
Central Hidro Gas Mayagüez Plant

**Puerto Rico Electric Power Authority**

**Report SL-015976.MG**

**August 31, 2021**

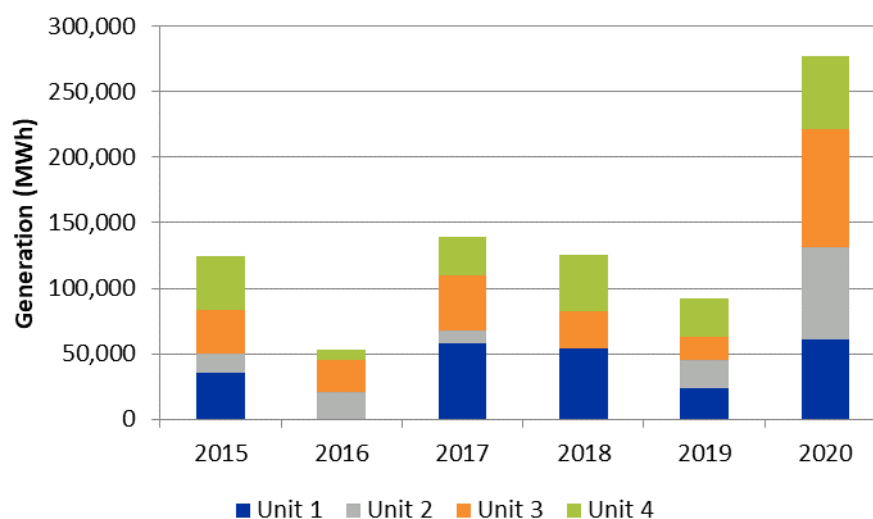
**Figure 6-1 — Mayagüez Gas Turbine Generation**

The generation figure provides totalized information for the annual plant generation of power. Power output has remained relatively flat over the last few years, as the Plant is dispatched as needed as a peaker. Power output increased in 2020, mainly due to the outage at Costa Sur from earthquakes in January 2020. After the 2017 hurricanes, the available units were dispatched according to load demands and system requirements. Total power generation was at a high of 276,964 MWh in 2020 and a low of 52,993 MWh in 2016. The net generation in 2016 was lower because Unit 1 was offline for maintenance and repair for a significant portion of that year.

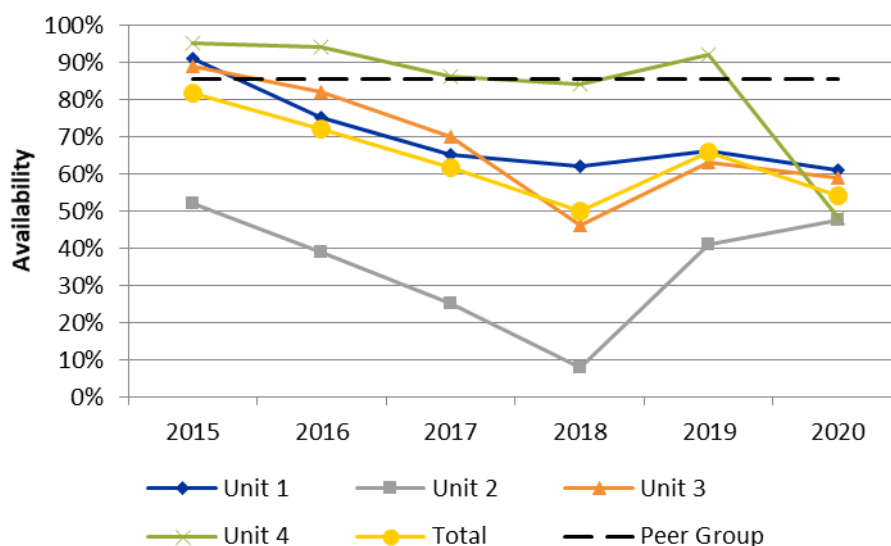
**Figure 6-2 — Mayagüez Gas Turbine Equivalent Availability Factor**

The availability of the Plant has been trending lower in recent years. The availability decreased from a high of 82% in 2015 to a low of 50% in 2018. This lower trend is indicative of the equipment issues (such as the blade coatings on Unit 2 and Unit 3) and reliability of the gas turbines; however, the deratings and issues with the units continue to be corrected on an ongoing basis. For 2020, the availability is lower than average, which mainly can be attributed to extended outages on Unit 2 and Unit 4 related to the January 7, 2020 earthquake. The units were returned to service.

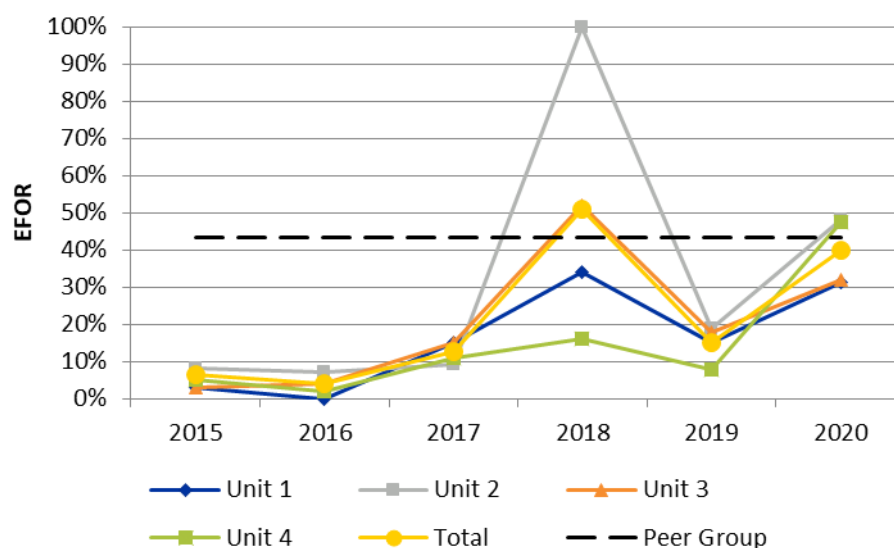
**Figure 6-3 — Mayagüez Gas Turbine Equivalent Forced Outage Rate**

As the availability of the Plant has trended lower, the EFOR rose in response to the extended outages of Unit 2 and Unit 4. Units 1 and 3 were largely derated with partial generation, and without half of the generating power available for those two units, the EFOR and related values will significantly increase. That skews the average higher and reflects the capital equipment importance of expediting repairs to maintain availability and capacity. The average EFOR has generally been below 15%; however, it increased to 51% in 2018 and was 40% in 2020 due to the outages and deratings previously discussed in the respective years. Overall, the EFOR is lower than other similar units, showing that Plant staff is addressing unit issues similarly or more quickly.
