IN RE: INTERRUPCIÓN DE SERVICIO  
ELÉCTRICO DE 6 DE ABRIL DE 2022

**CASE NO. NEPR-IN-2022-0002**

**Motion Submitting Root Cause Evaluation  
of April 6<sup>th</sup> Incident and Request for  
Confidential Treatment**

(Root Cause Evaluation Report)

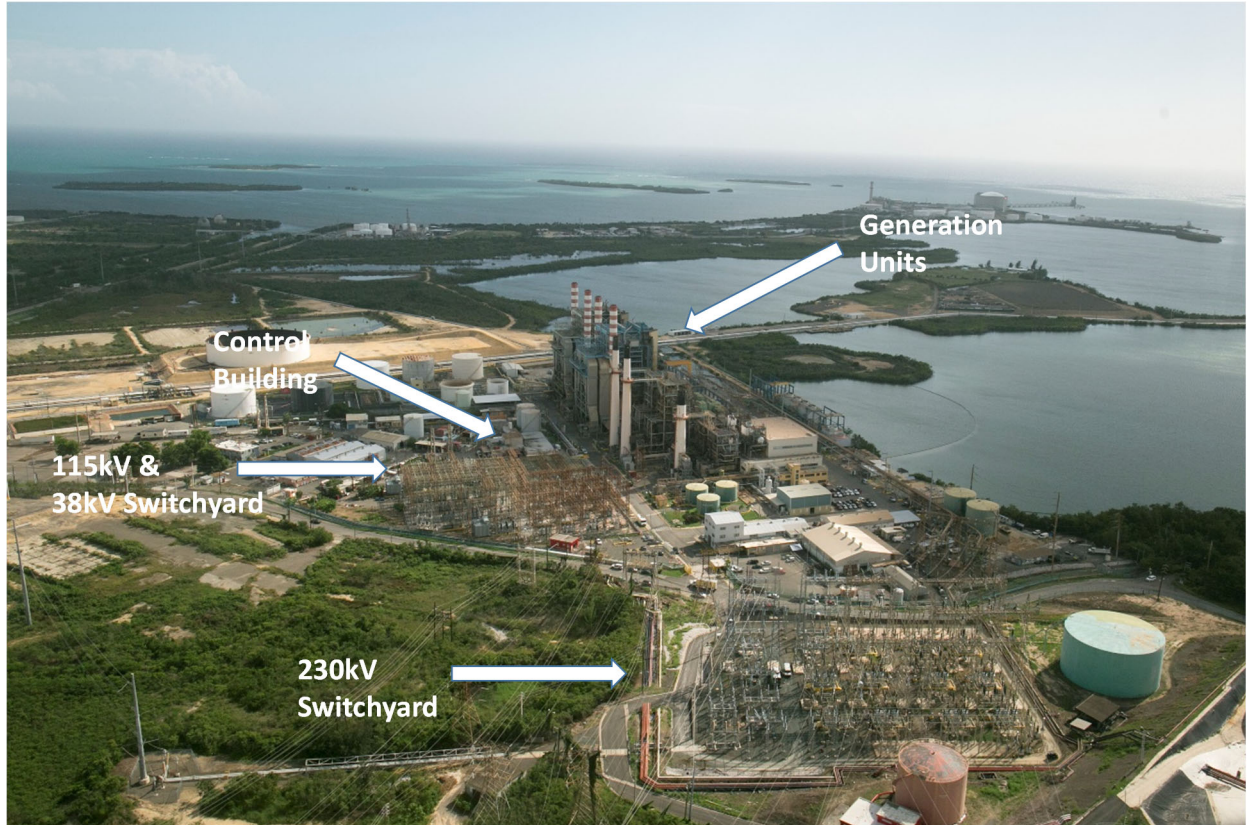
Figure 1: Aerial View of Costa Sur Steam Plant Prior to April 6<sup>th</sup> Event (switchyard is in foreground of photograph)

The Costa Sur Steam Plant (SP) is a network of facilities involving the thermal generation plant and the electrical facilities, including the 230 kV Switchyard and 115/38 kV Switchyards (see Figure 1). Costa Sur's 230 kV switchyard has a breaker and a half configuration with five bays that include four (4) gas circuit breakers and 11 oil circuit breakers from circa 1969-1976. Figure 2 provides an aerial view of the 230 kV Costa Sur Switchyard.

The elevation of the switchyards for the Costa Sur SP has two different levels (Figure 1):

The current protection and control panels for both switchyards are in the Control Room building of the power plant (see Figure 1).

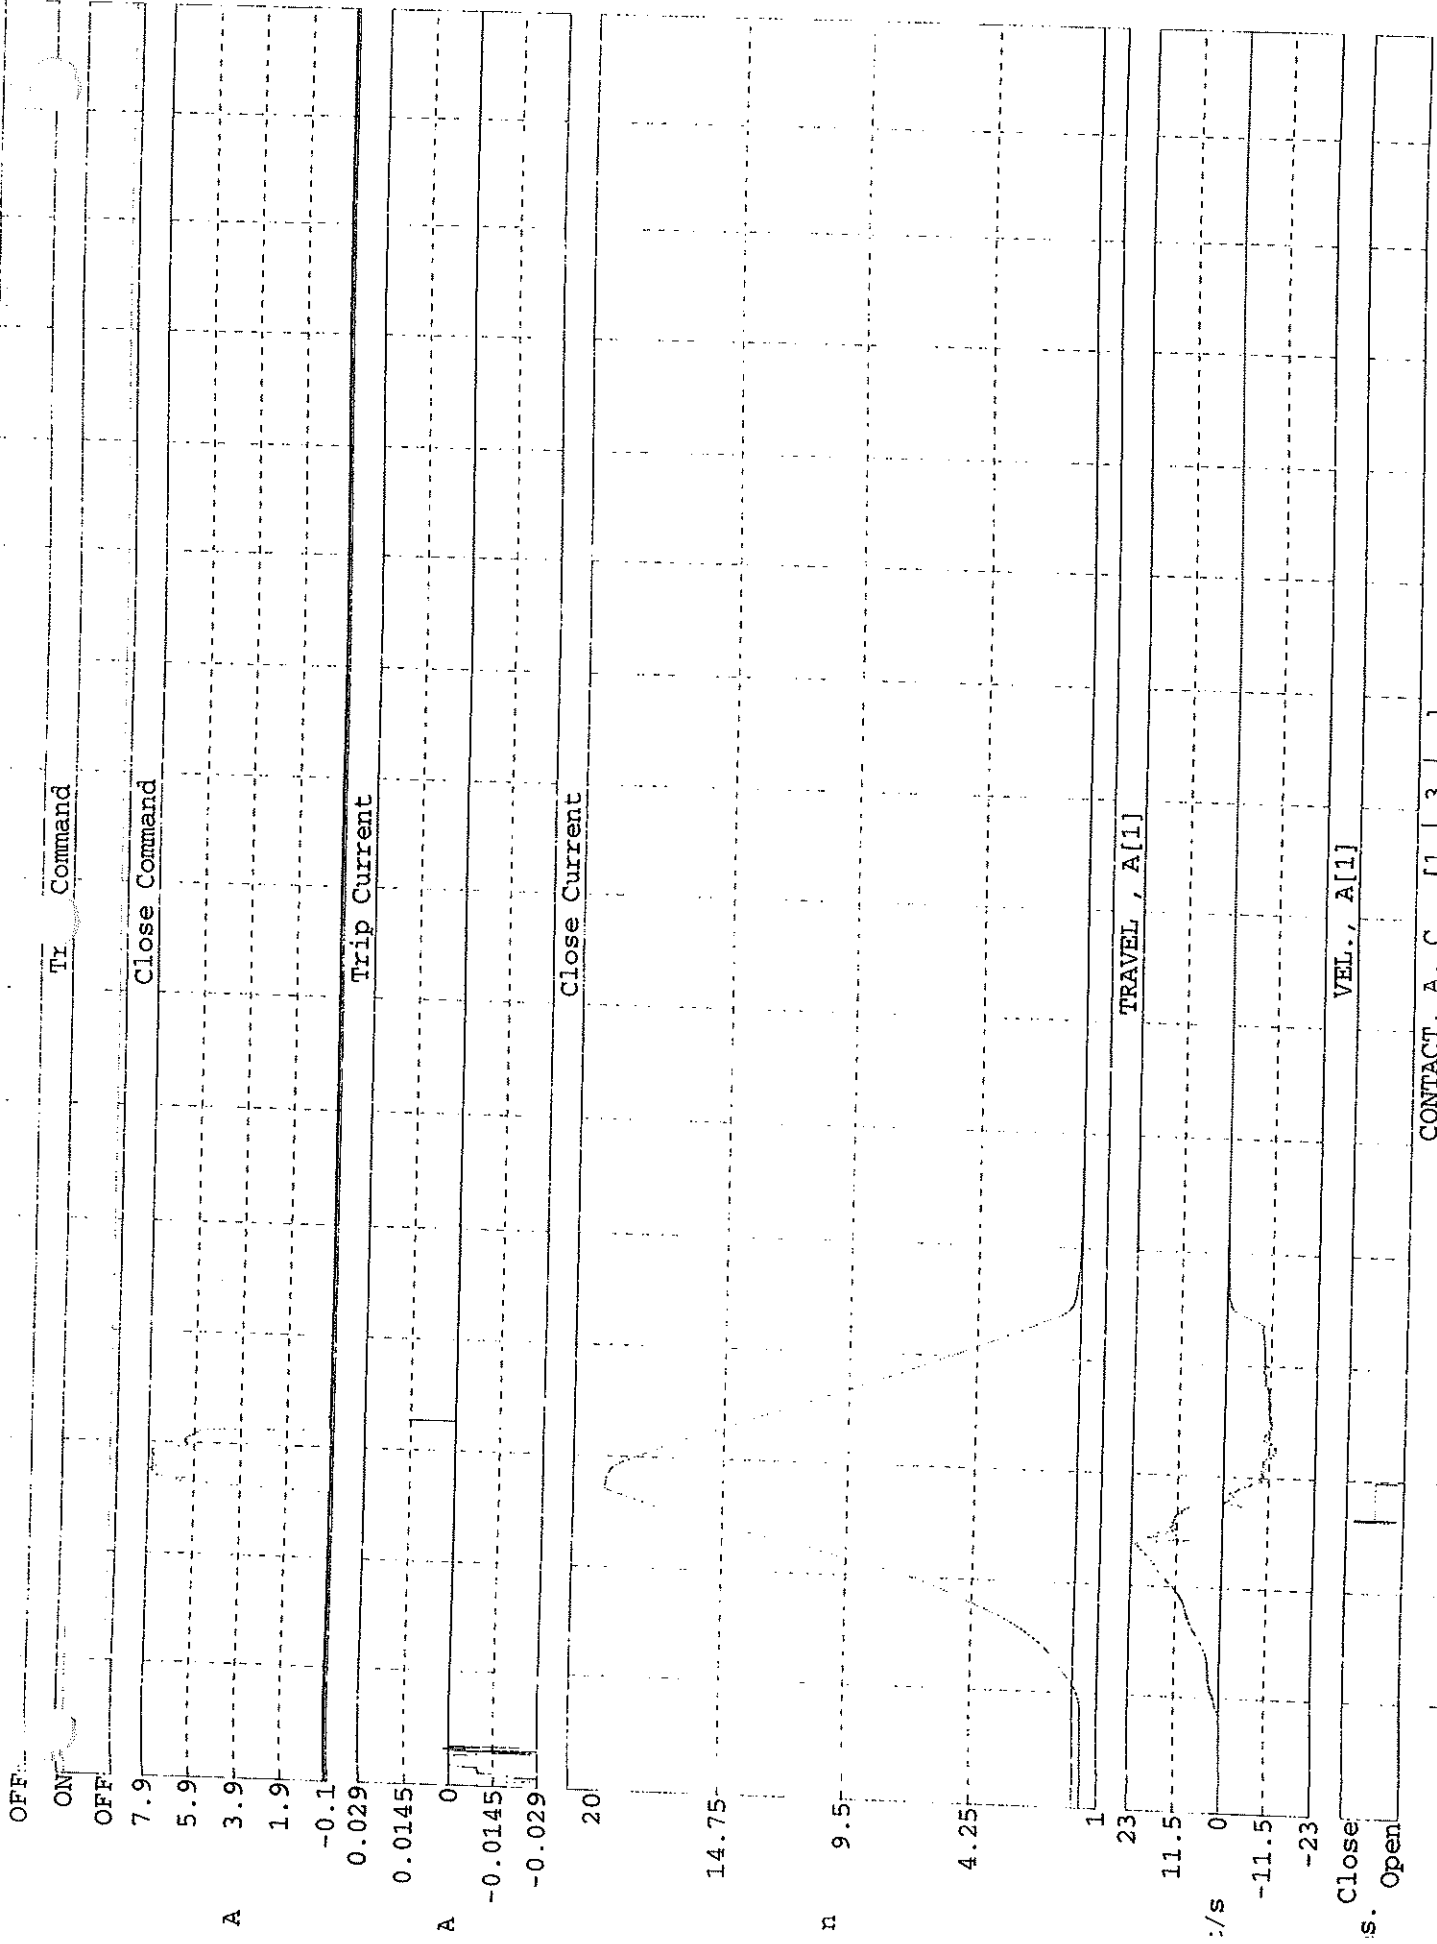
**BREAKER PERFORMANCE REPORT**  
TDR9000 Version: RE 4.01

Manufacturer : I.T.E.	Location: Sample Location 1
Model Number : 230-KM-20000-20	Circuit : OCB 0082
Serial Number: 41-30125-1085	Operator: ING.E.W.RIVERA
Instr Book # :	
Mechanism # : PA-45A	
Mech Instr # :	
Special ID : 091-00-00-07	Operation Counter :
Test Type : TRIP	Test Plan Name :

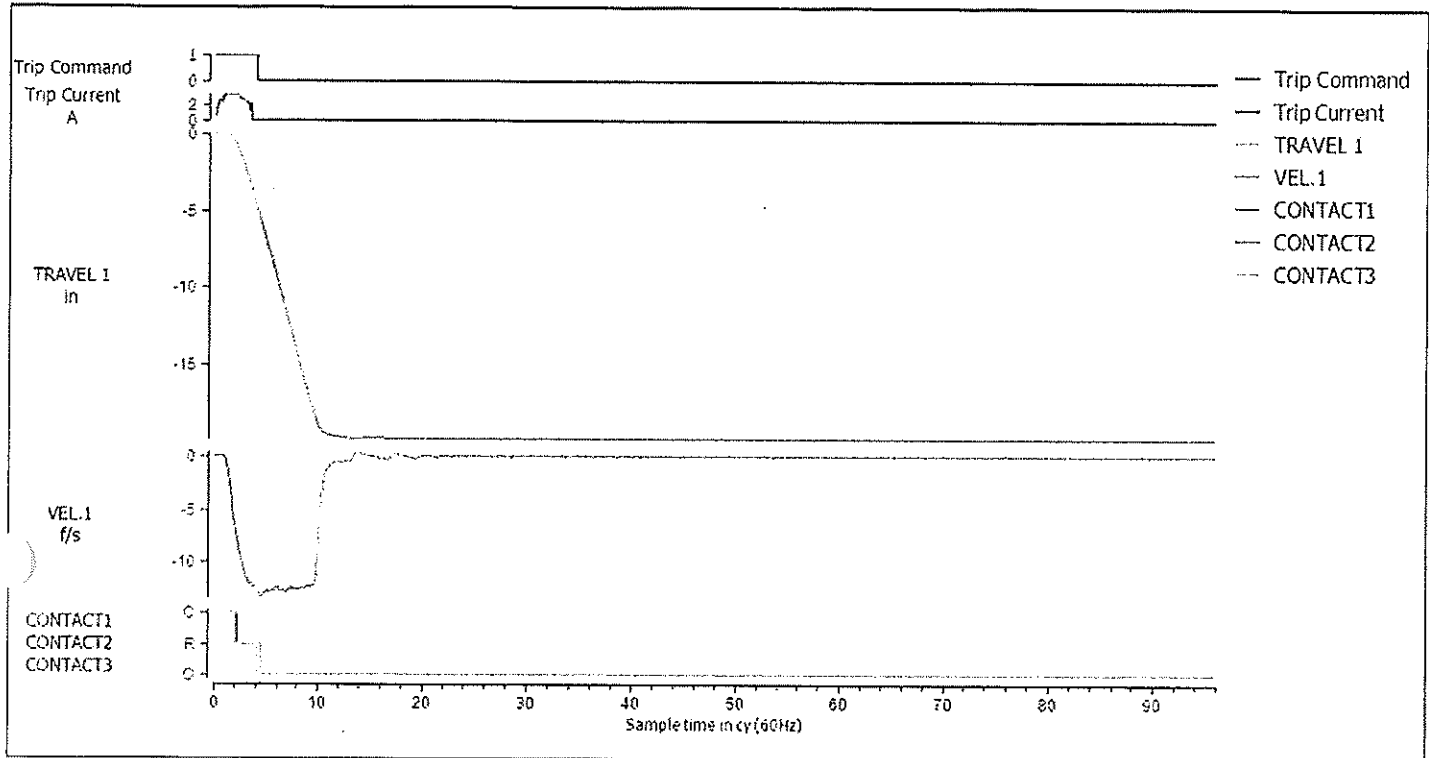
Channel	Motion-1	Zone Type	Velocity		Total Travel	Overtravel	Travel Rebound	Contact Wipe	Damping
			Zone 1	Zone 2					
			Distance; Distance	Distance; Distance					
(TRAVEL 1)	Measured		3.206 m/s		19.880 in	0.016 in	0.056 in		3546.00 cy
Phase Undefined	Limits - Max		3.658 m/s	3.658 m/s	20.750 in	0.500 in	0.500 in		
	Limits - Min		3.048 m/s		19.250 in	0.000 in	0.000 in

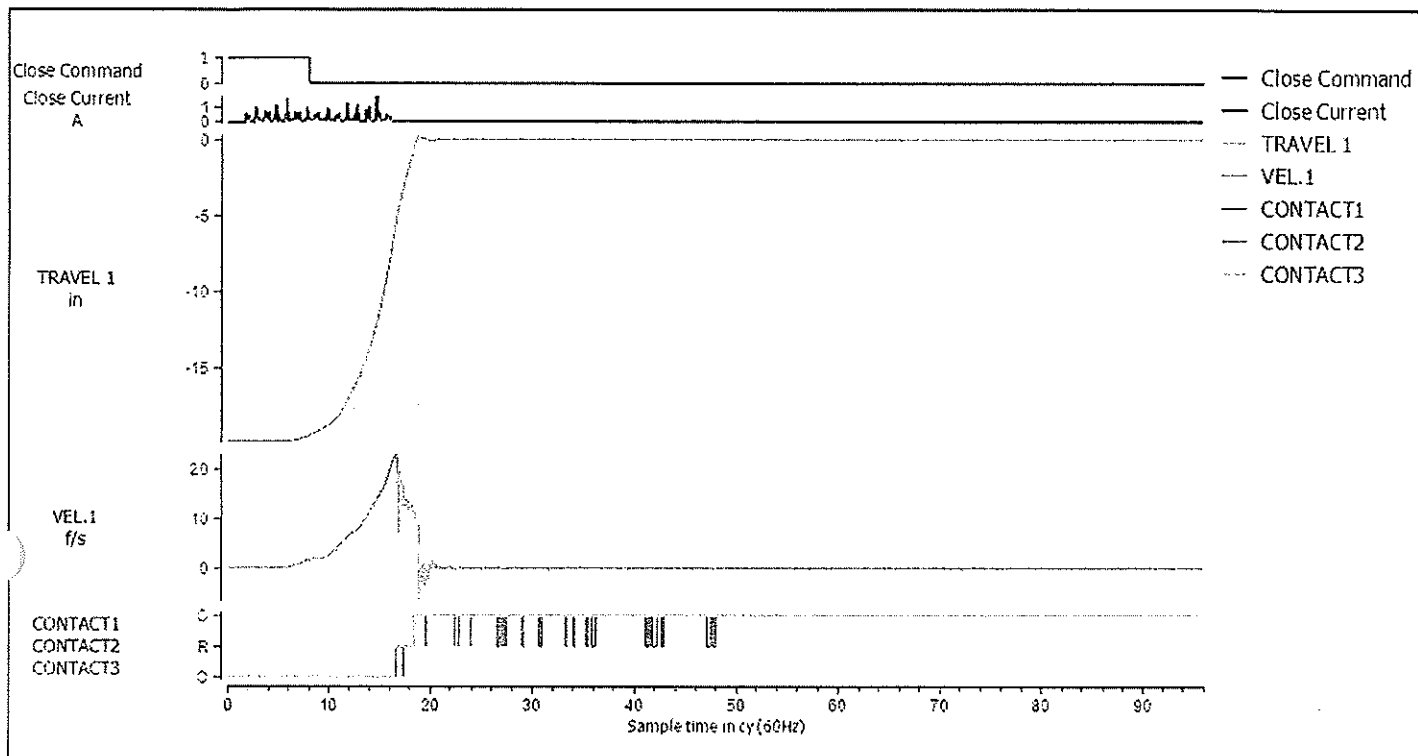
Channel	Zone Type	Velocity		Total Travel	Overtravel	Travel		
		Zone 1	Zone 2			Rebound	Contact Wipe	Damping
Motion-1		Distance; Distance	Distance; Distance					
(TRAVEL 1)	Measured	4.069 m/s		19.874 in	0.292 in	0.062 in	0.662 in	
Phase Undefined	Limits - Max	4.420 m/s	4.420 m/s	20.750 in	0.375 in	0.250 in	1.000 in	
	Limits - Min	3.658 m/s		19.250 in	0.000 in	0.000 in	0.500 in
