Submission of Public Version of Detailed Report on the February 21st Incident

# NEPR-IN-2022-0001

# Analysis for Disturbance Event on February 21, 2022

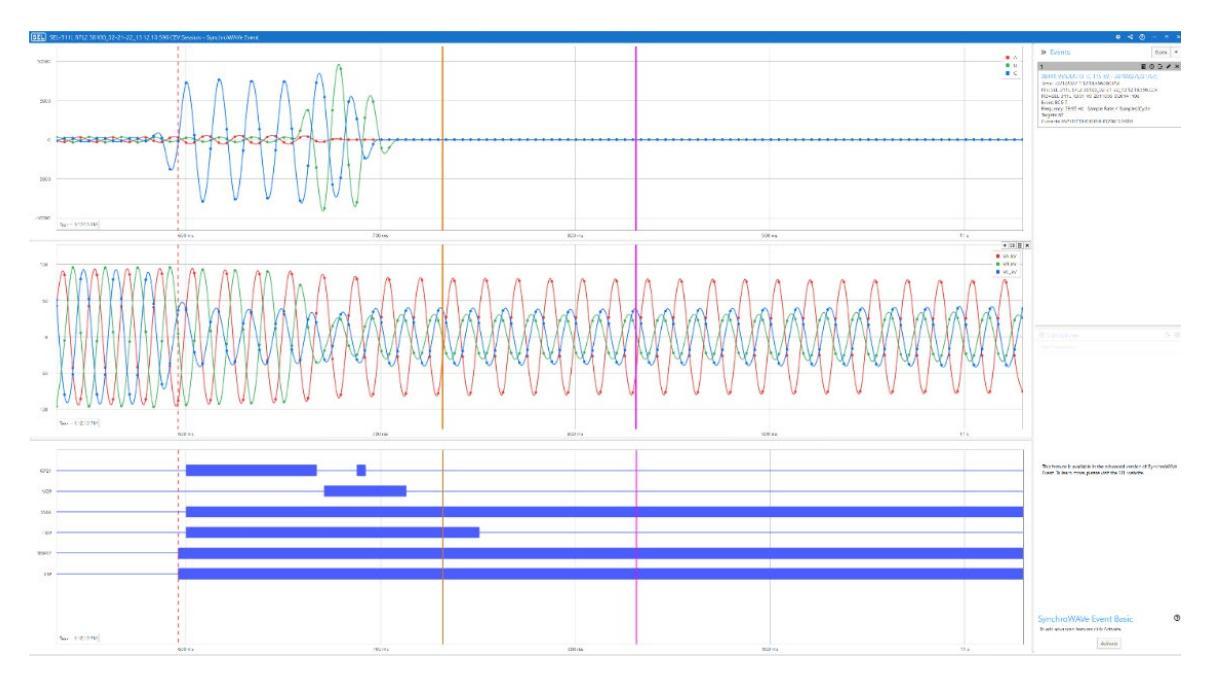
Figure 3-4 Fault Records Data from Viaducto Terminal

The review of the relay records from the Viaducto side confirms that the relay issued a trip command 16 ms after the fault started. The circuit breaker interrupted the fault current 112 ms after the trip was issued.

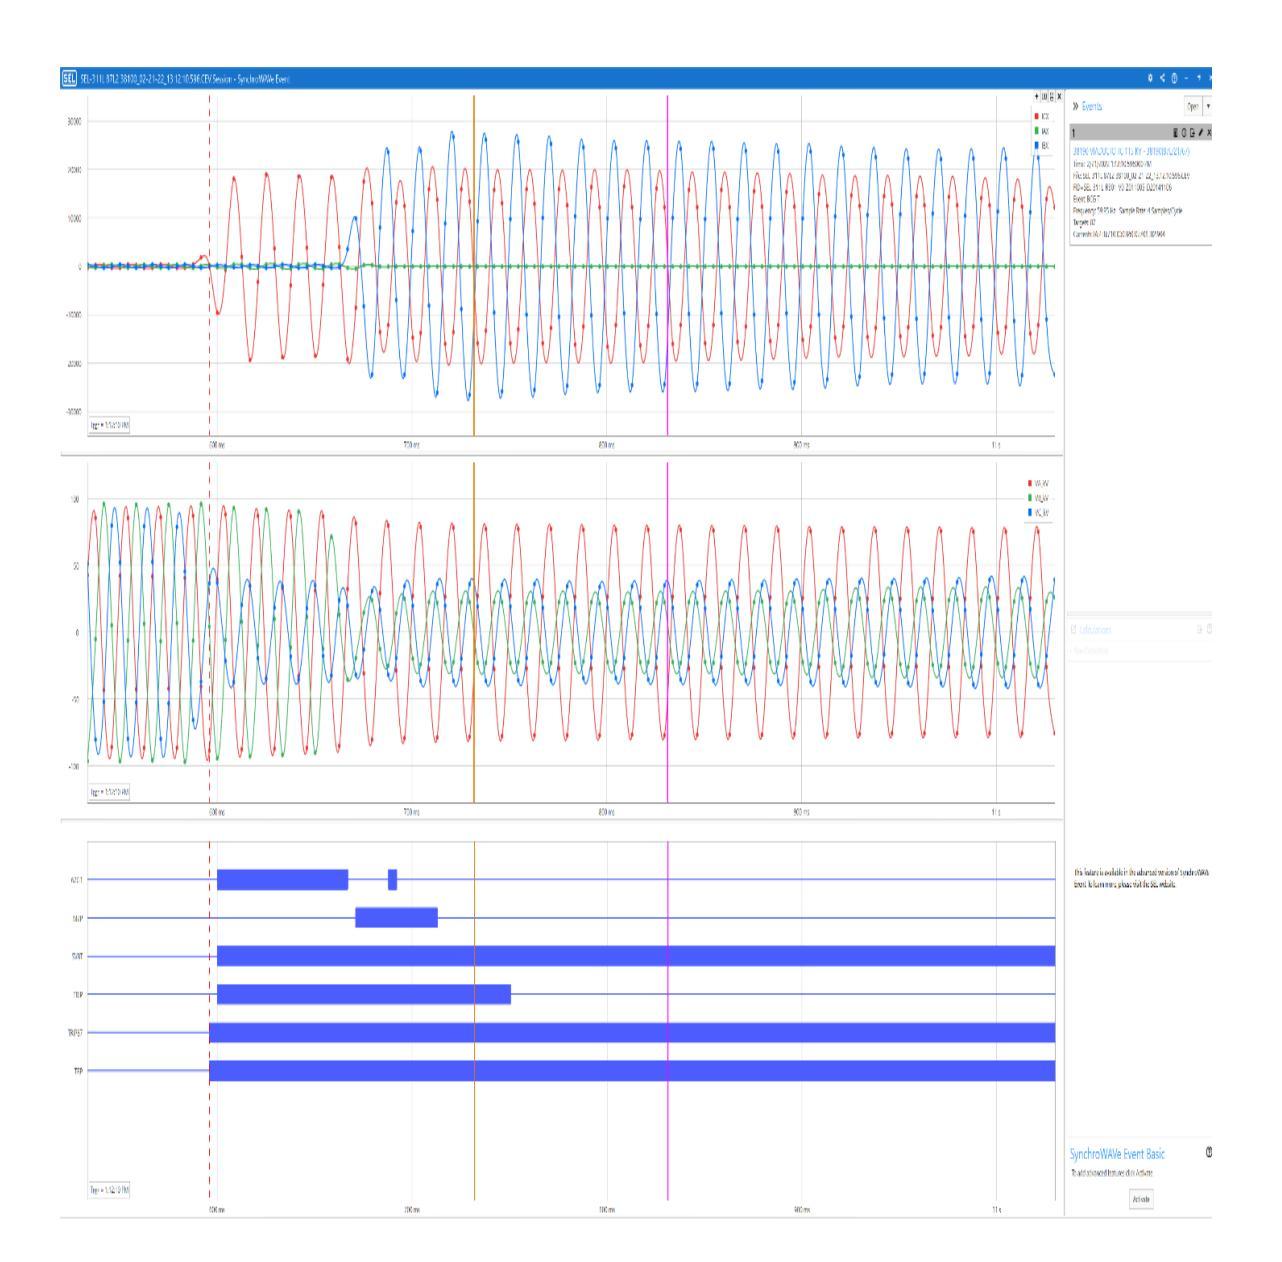
# Figure 3-5 Fault Records Data from Viaducto Terminal (Showing San Juan Fault Currents)

No relay records are available for the line 38100 from the San Juan terminal. However, the differential relay SEL-311L and the SEL-387L records typically record the local and the remote-terminal fault currents. Therefore, the records from the Viaducto terminal provided the current records from the remote terminal (San Juan) that were used for the analysis in this report.

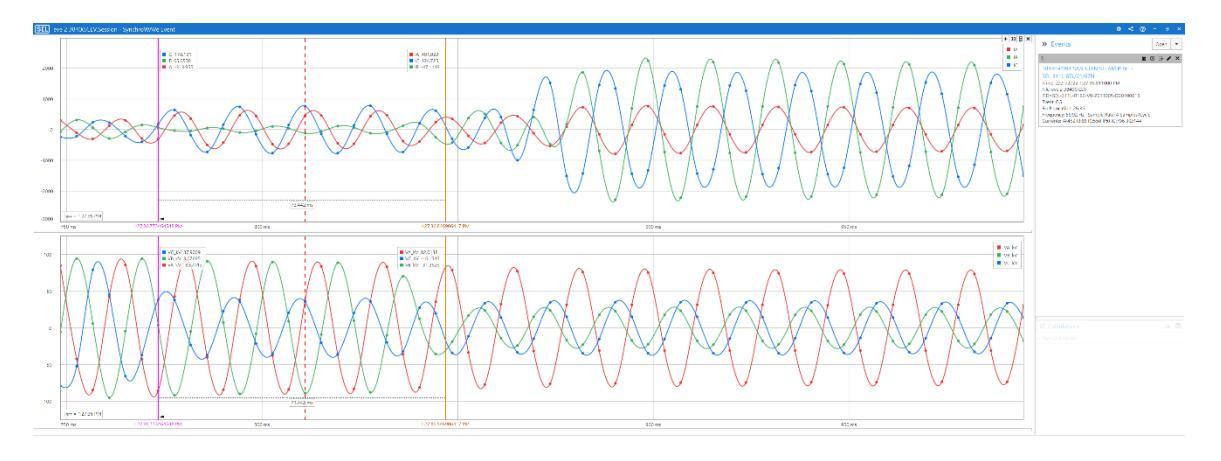
Figure 3-6 Fault Records Data from San Juan Terminal of Line 38400 - Initial Fault on 38100

The San Juan line side was tripped based on a ground fault that may be the result of an evolving fault caused by smoke or an arcing of the initial fault on line 38100 approximately 1.7 seconds after the initial fault started. The time was calculated based on two relay records from the San Juan line terminal of line 38400. The first record showed the start of the initial fault on line 38100 (see Figure 3-6) and was triggered by a Zone 2 pickup of a distance element. The second fault record (see Figure 3-7) was in response to a ground fault on line 38400. The second record also documents that the remote end must have been open at this time as no load current is visible.

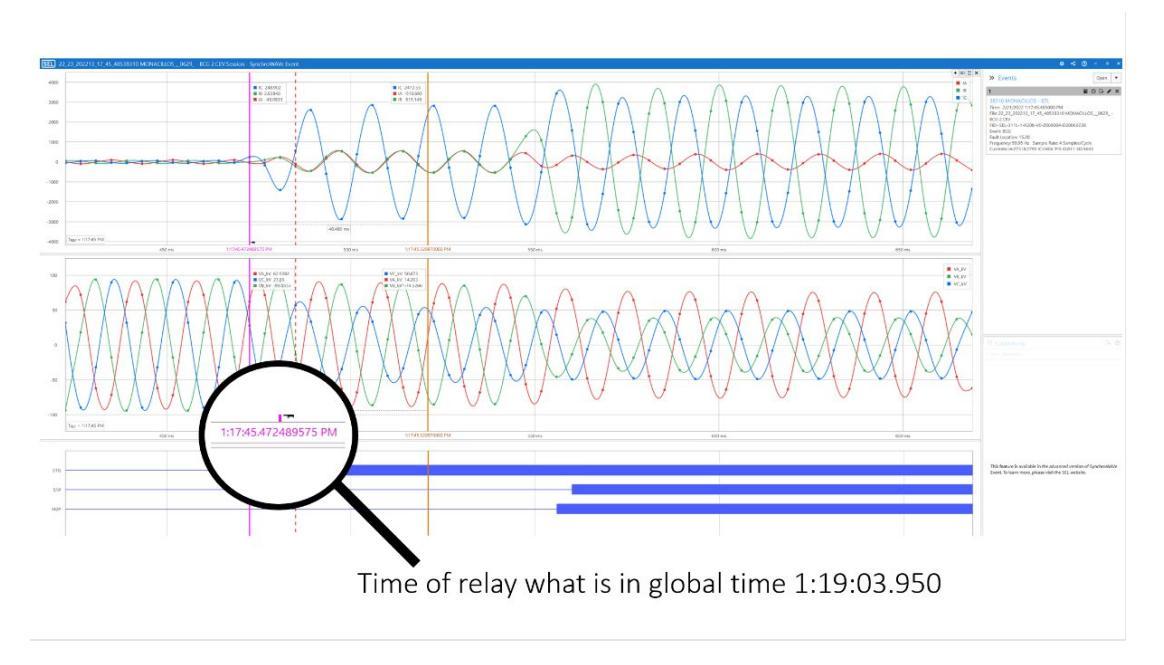
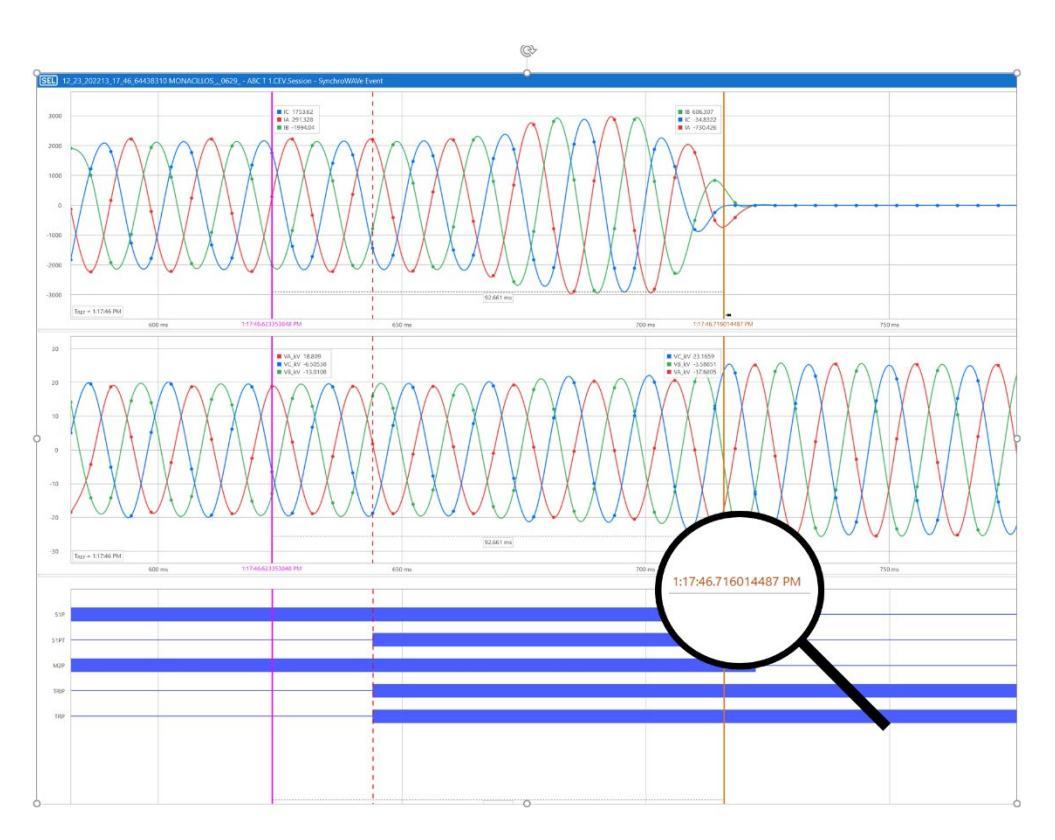
Figure 3-8 Fault Records Data from Monacillos Terminal of Line 38300 (Relay SEL-311L)

The correct operation from the protection located on the Monacillos terminal for line 38300 is documented by two records for relay SEL-311L. The first record recorded the start of the fault on line 38100 and provided a time reference for the internal relay time (see Figure 3-8). The fault start was time-stamped with a time of 1:17:45.472 P.M. based on the internal relay time. The second record documented the fault clearing by a 51P element after about 1.2 seconds (see Figure 3-9). The opening of the circuit breaker has a timestamp of 1:17:46.716 P.M. based on the internal relay time. Based on the two timestamps, the fault clearing can be calculated to 1.244 seconds.

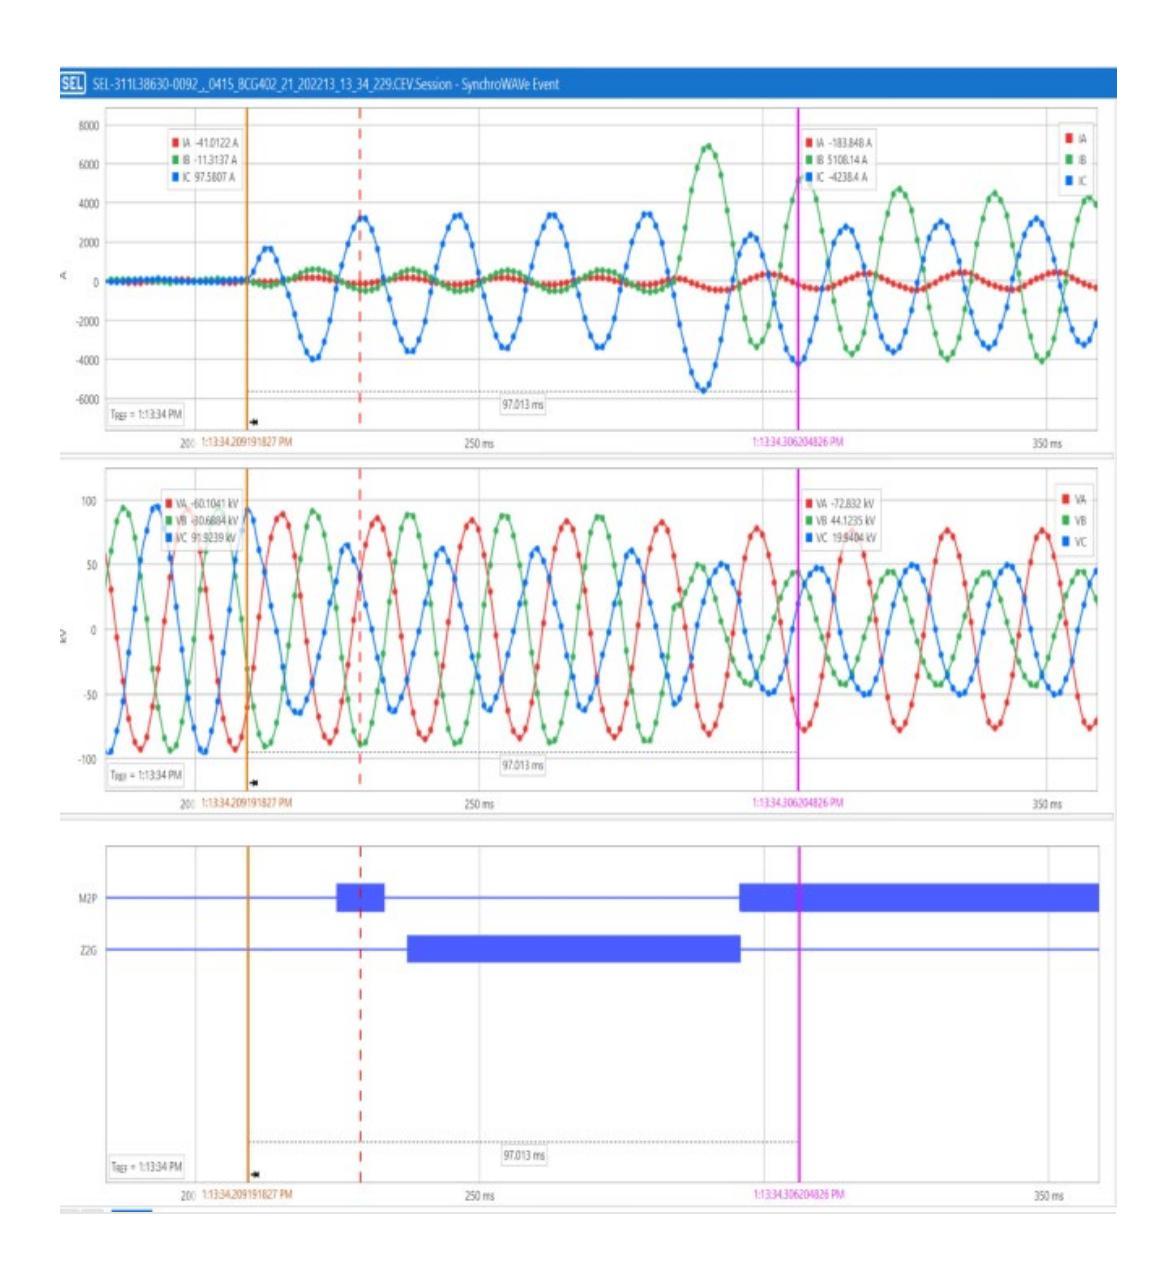
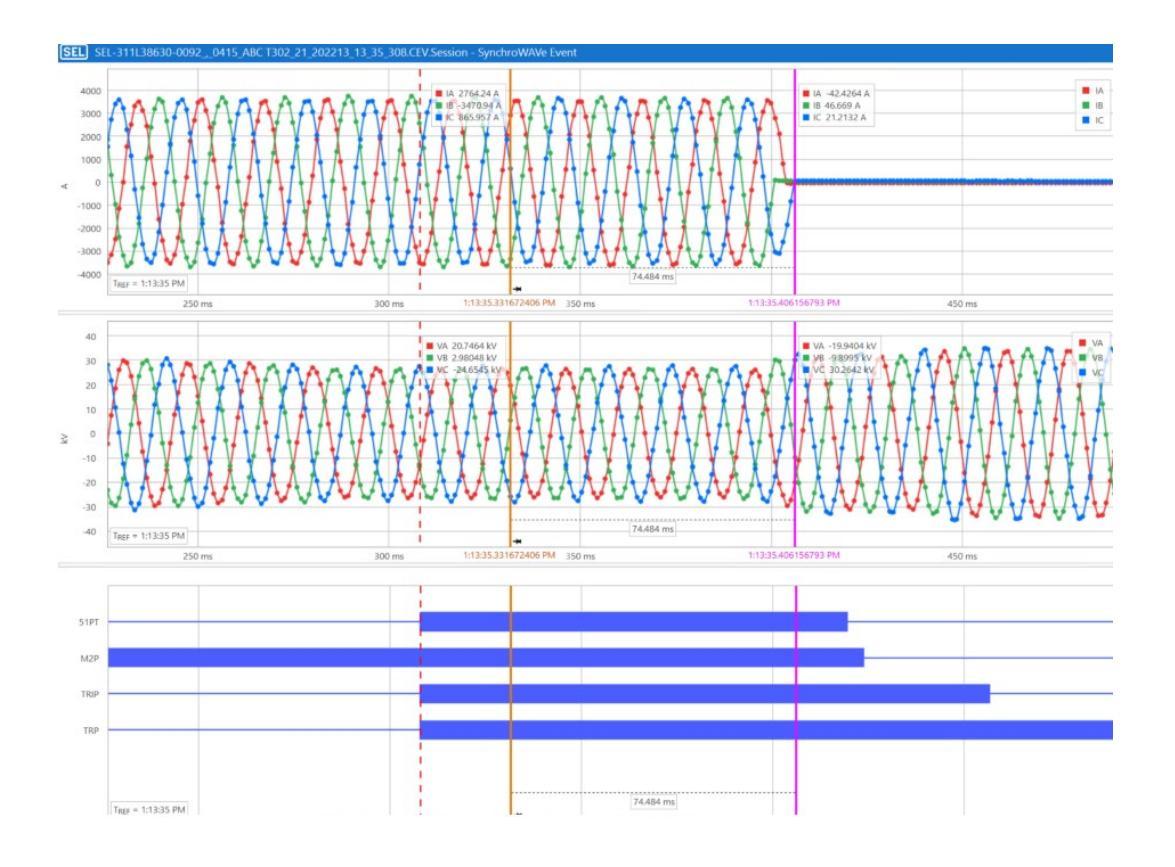
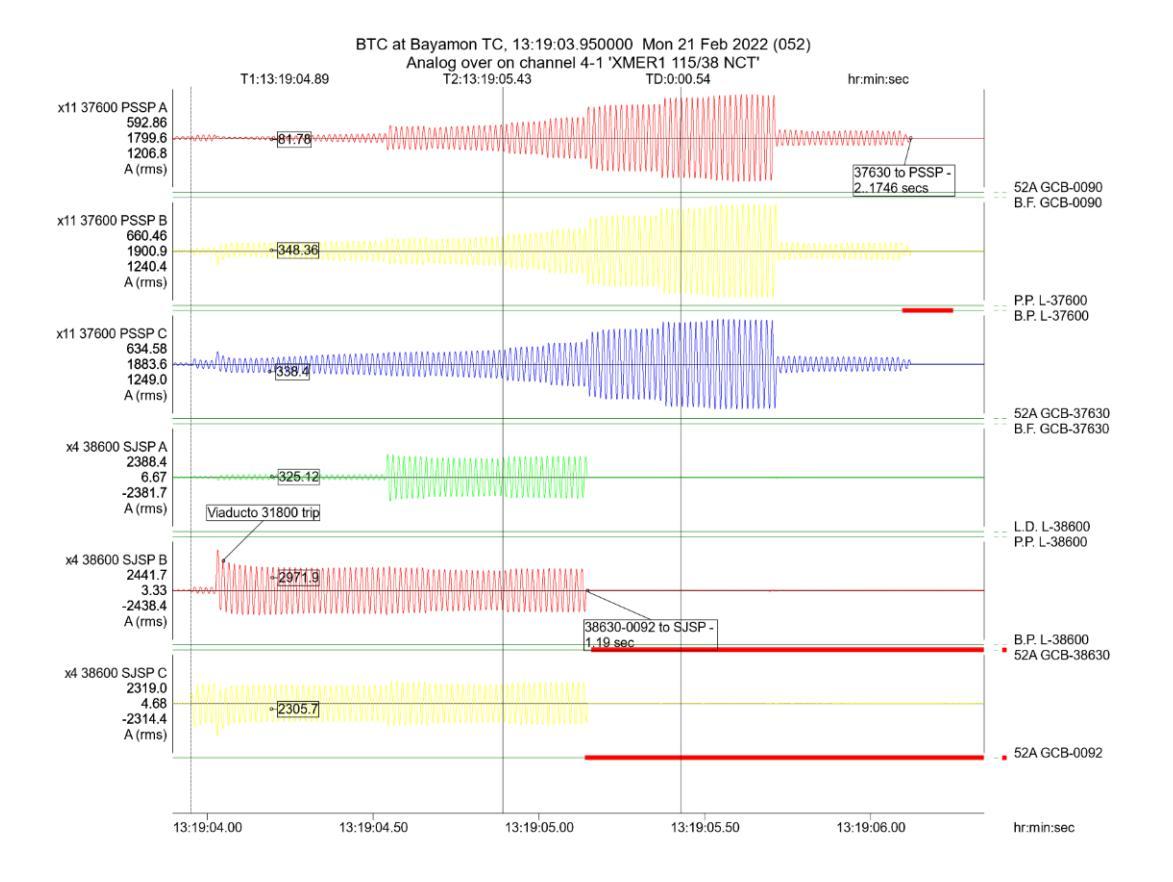
At 13:19:05.15, the remote terminal at Bayamón to San Juan tripped, 1.19 seconds after the fault at line 38100 from San Juan to Viaducto initiated. It was shown in the transient recorder and relay records that the fault changed from C-G to C-B and finally A-B-C. Short-circuit currents observed were  $I_a = 300 \text{ A}$ ,  $I_b = 3,056 \text{ A}$ ,  $I_c = 2,339 \text{ A}$ . The relay tripped with  $I_a = 2,524 \text{ A}$ ,  $I_b = 2,634 \text{ A}$ ,  $I_c = 2,539 \text{ A}$ .

## Figure 3-10 Fault Records Data at Line 31800 Initiation Sensed by 38630-0092 at Bayamón

Figure 3-11 Fault Records Data for Line 38600 trip at Bayamón

## Figure 3-12 Transient Recorder Fault Records Data for Line 38600

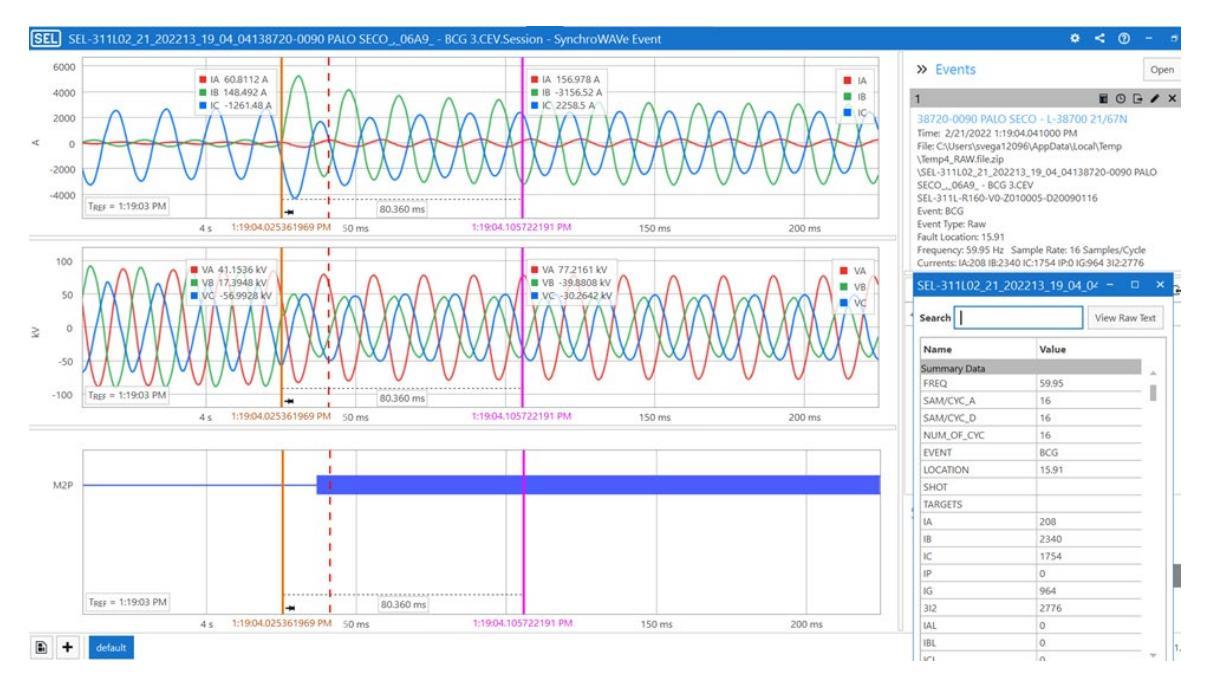
#### Figure 3-15 Fault Initiation at Recorded by 38720-0090 Protection at Palo Seco

The coordination check table below lists the tripping in 2.3 seconds with the original currents (see relay event below). Nevertheless, the current did double for 35 cycles, which should have the relay tripping in less time. The expected trip time when the current doubled was approximately 44 cycles. This relay should have tripped if the M2P and 51P signals did not reset.

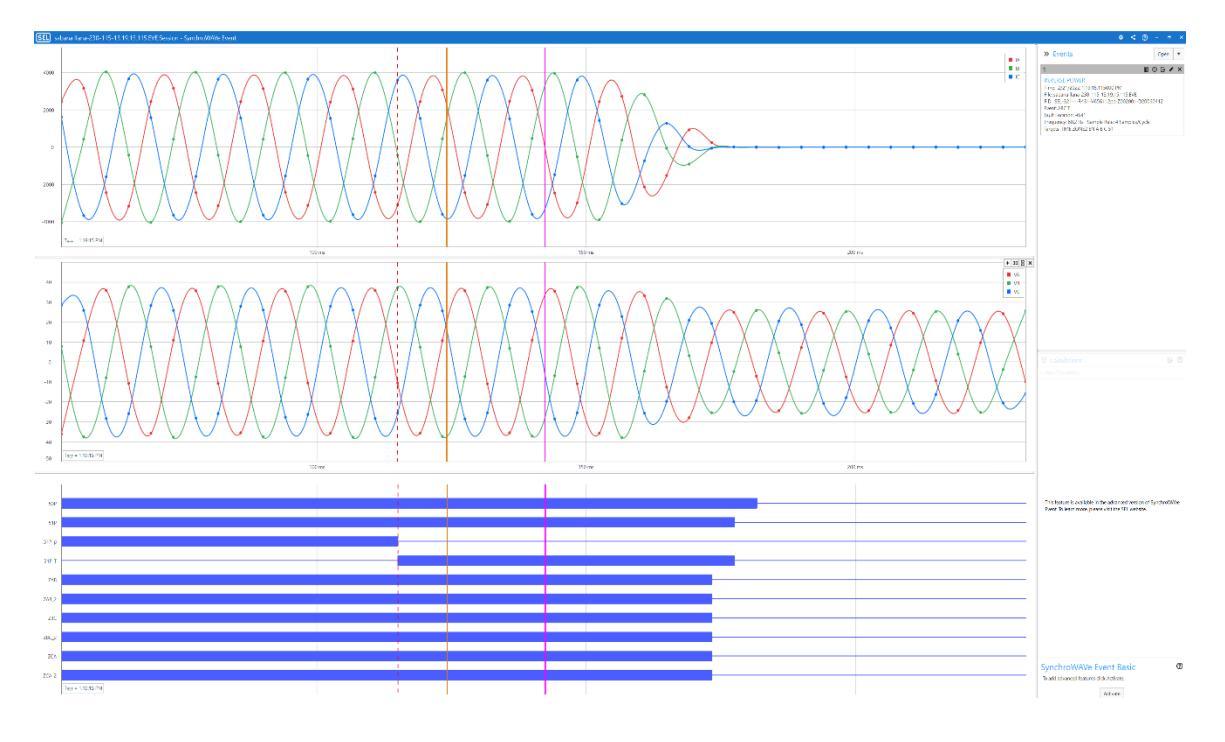
Figure 3-19 Fault Records Data

In Sabana Llana substation, only one of the two 230 kV/115 kV transformers was in service. The transformer in service (T1) is equipped with a backup SEL-321 relay on the 115 kV side. The fault record from the SEL-321 recorded the fault clearing and fault currents (see figure below).

In the recorded data, it is shown that the backup protection element 51P tripped based on the measured fault currents. To calculate the tripping time in relation to the start of the fault, the fault current measured when the relay issued the trip command was used. The fault current may have varied during the event that needs to be considered as an error source for the calculated time.

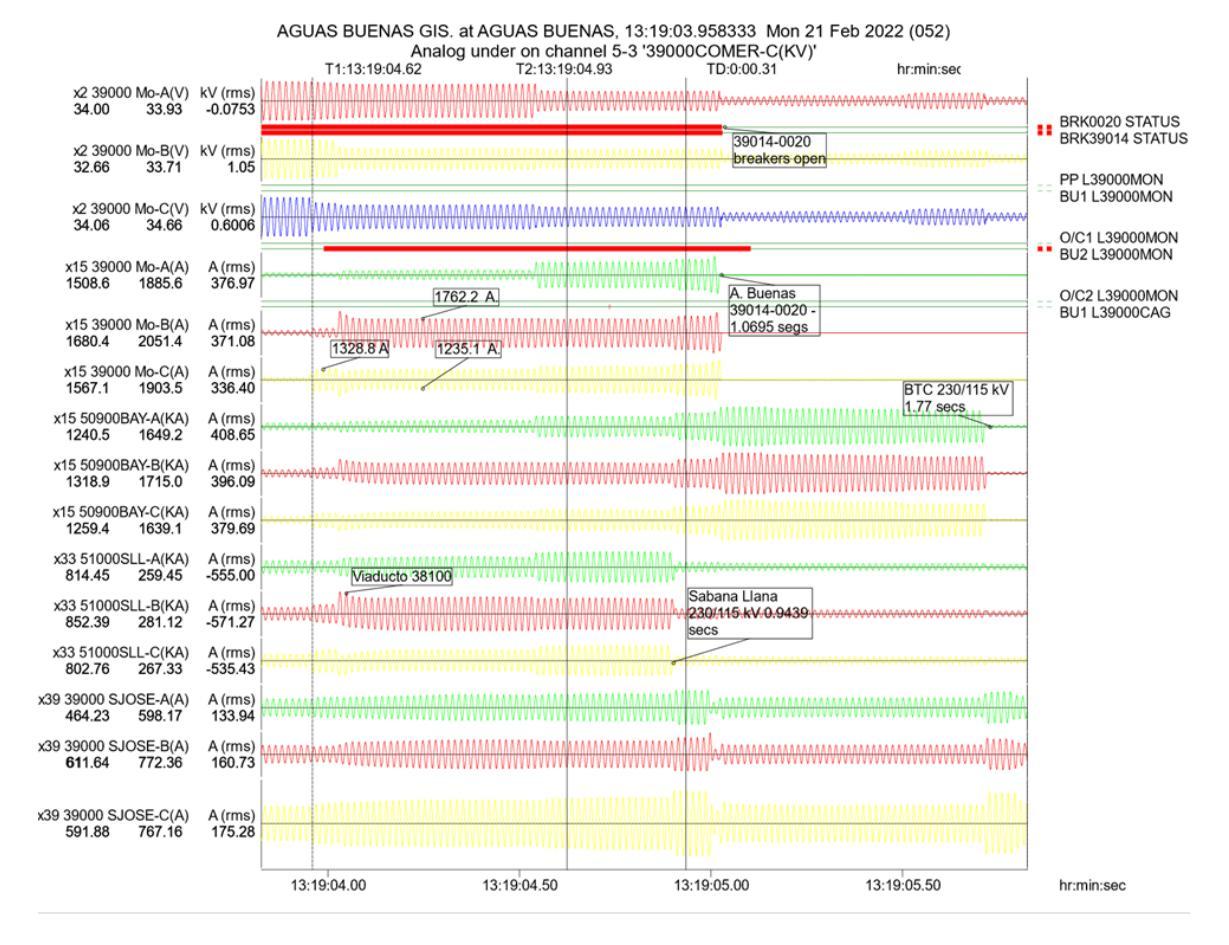
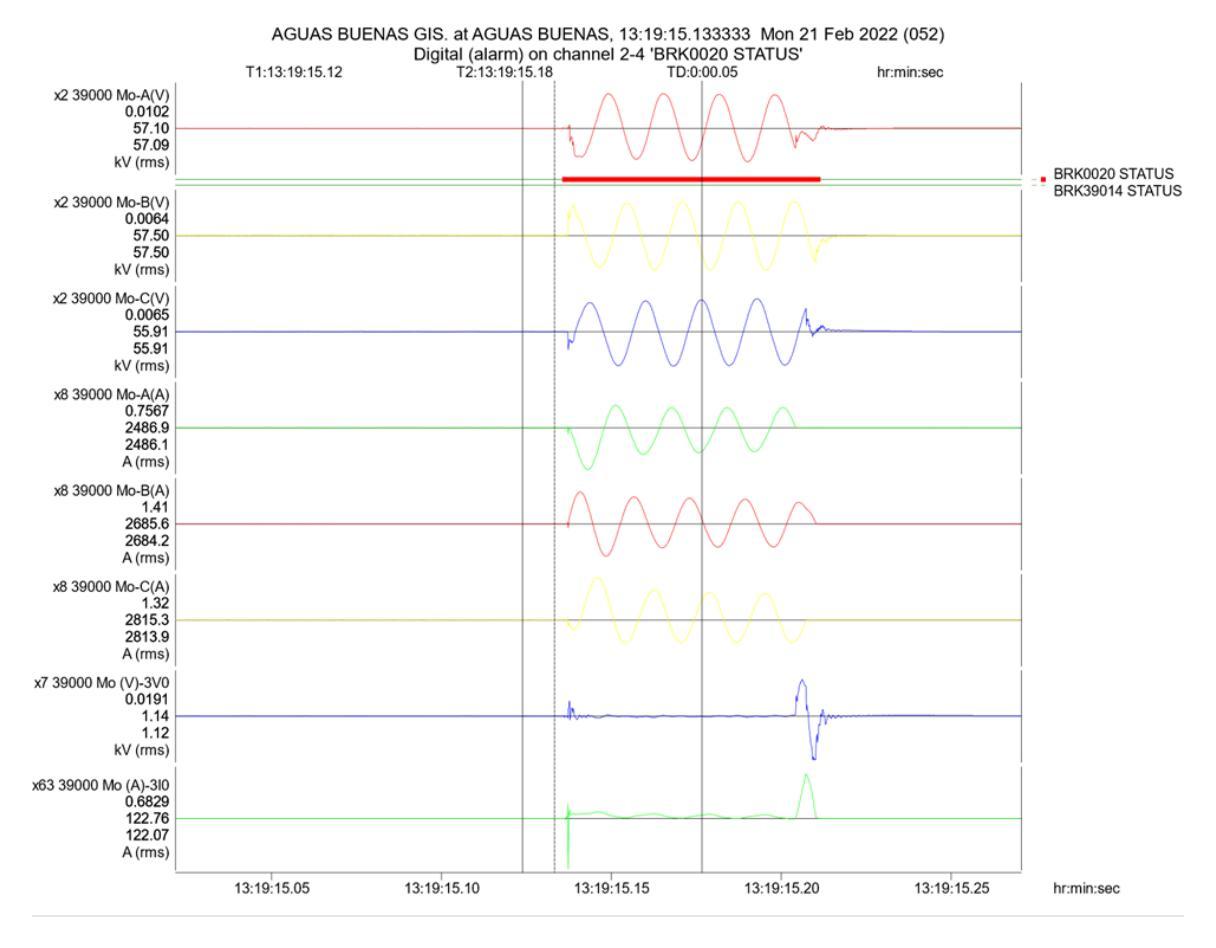
At 13:19:15:14, ten seconds after line 39100 from Aguas Buenas to Monacillos tripped, circuit breaker 0020 reclosed (in five cycles) to a three-phase fault still present in the system.  $I_a$ = 2,718 A,  $I_b$ =2,999 A, and  $I_c$ =3,132 A.

Figure 3-20 Line 39000 from Aguas Buenas to Monacillos Trip

Figure 3-21 Line 39000 from Aguas Buenas to Monacillos Reclose

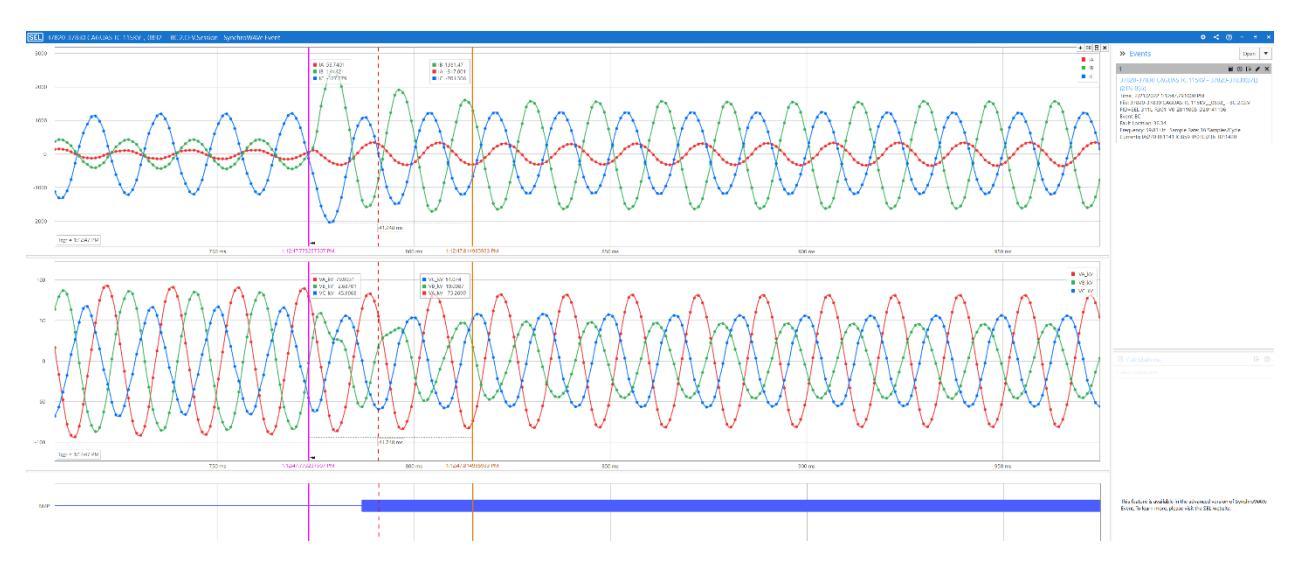
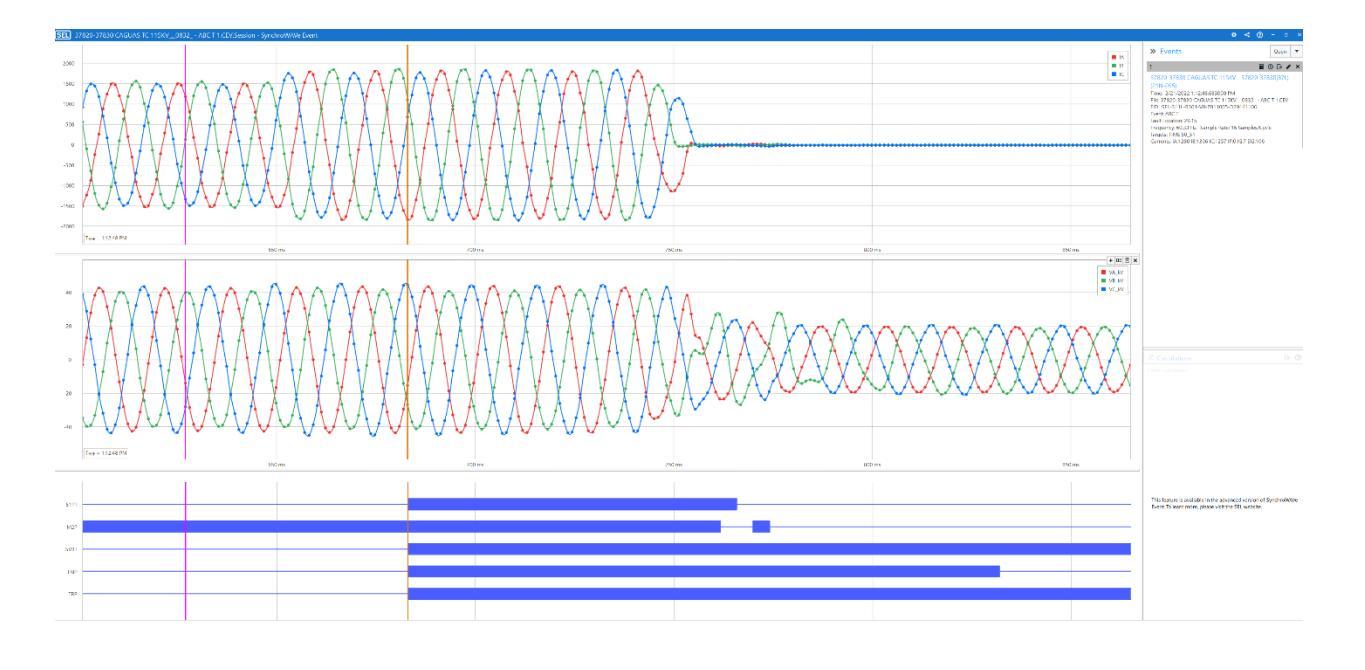
The line protection on line 37800 between Caguas and Monacillos operated 0.985 seconds after the start of the fault on line 38100. This is documented by the SEL-311L relay at the Caguas terminal on circuit breaker 20. The relay recoded the start of the fault (see Figure 3-27) as well as the moment the relay operated and interrupted the fault current (see Figure 3-28). The relay operated with a 51P element, and the relevant settings for the 51P element are shown below:

Based on this data and a fault current of 1,060 A (prim) result with a CT ratio of 120 to a secondary fault current of 8.8 A, the anticipated tripping time is 0.995 seconds. The actual trip time of 0.985 confirms a correct relay operation.

Figure 3-27 Fault Records Data from Caguas Terminal of Line 37800 – Start of Fault

Figure 3-28 Fault Records Data from Caguas Terminal of Line 37800 – Operation of Line

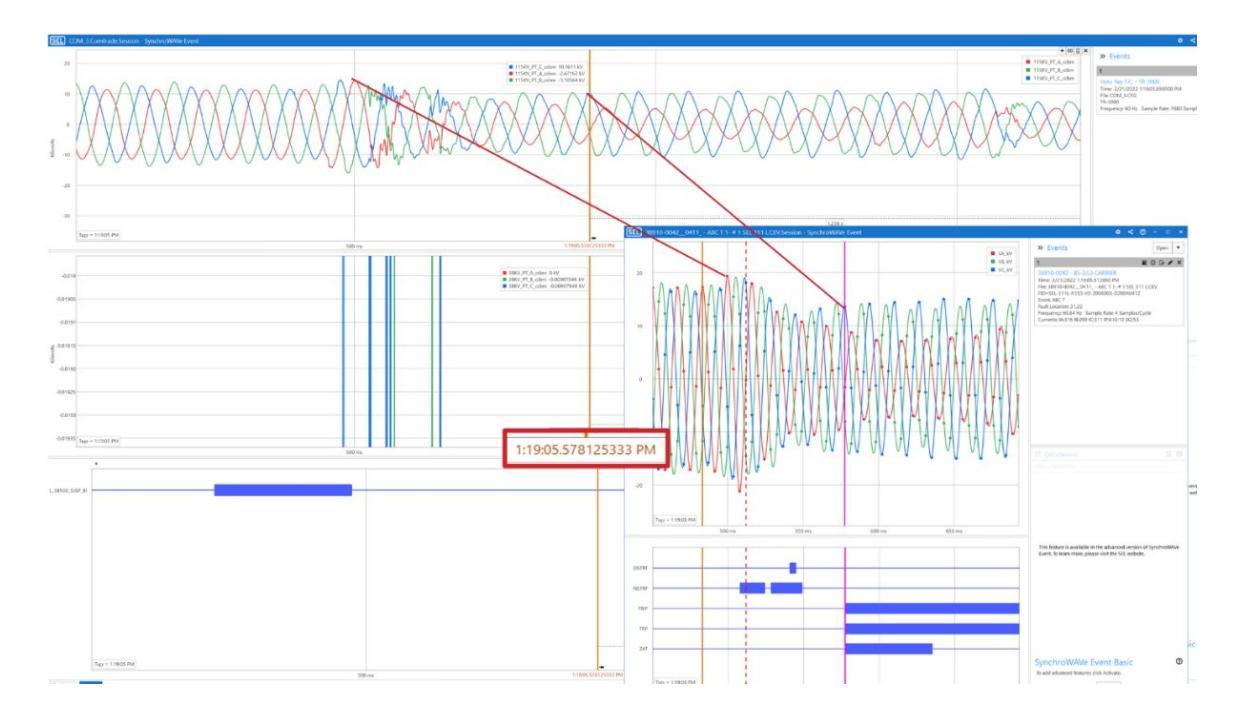
#### Figure 3-39 Fault Records Data from Martin Peña Terminal of Line 38900 – Trip Command

The protection relay on line 38900 at the Martín Peña terminal tripped the line correctly with a Zone 2 and Zone 4 operation, 1.5 seconds after the BC-ground fault started. The relay's time is not synchronized to a common time base. The time relation to a GPS clock was performed by manually synchronizing the voltage profile recorded in the relay record with the voltage profile recorded by the fault recorder in the Hato Rey substation. The fault-recorder time is synchronized with a GPS clock. The change from symmetrical three-phase depressed voltages to an even more decline voltage in A-phase was used to synchronize the two records.

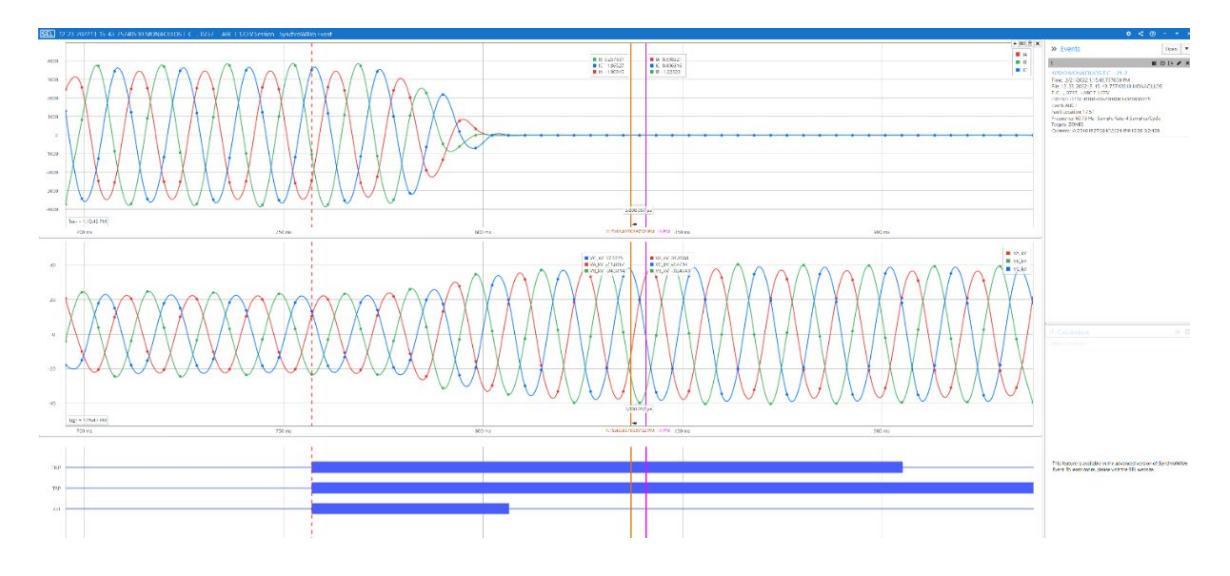
Figure 3-40 Fault Records Data from Monacillos Terminal of Line 40500 – Operation of Line

The protection relays located on the Monacillos terminal of line 40500 operated with a Zone 3 distance element after 1.5 seconds. Both relays, the SEL-311L, and the SEL-311C, have the same backup protection settings and issued a trip command at the same time. The tripping time was synchronized with the global time based on voltage comparison of the voltage in the relay record and the voltage recorded by a fault recorder in the Monacillos substation. The increase of symmetrical voltages from 16.6 kV to 27 kV after the line tripping was used to synchronize the timing. The result was that it could be confirmed that the relays indeed tripped 1.5 seconds after the fault on line 38100 started.

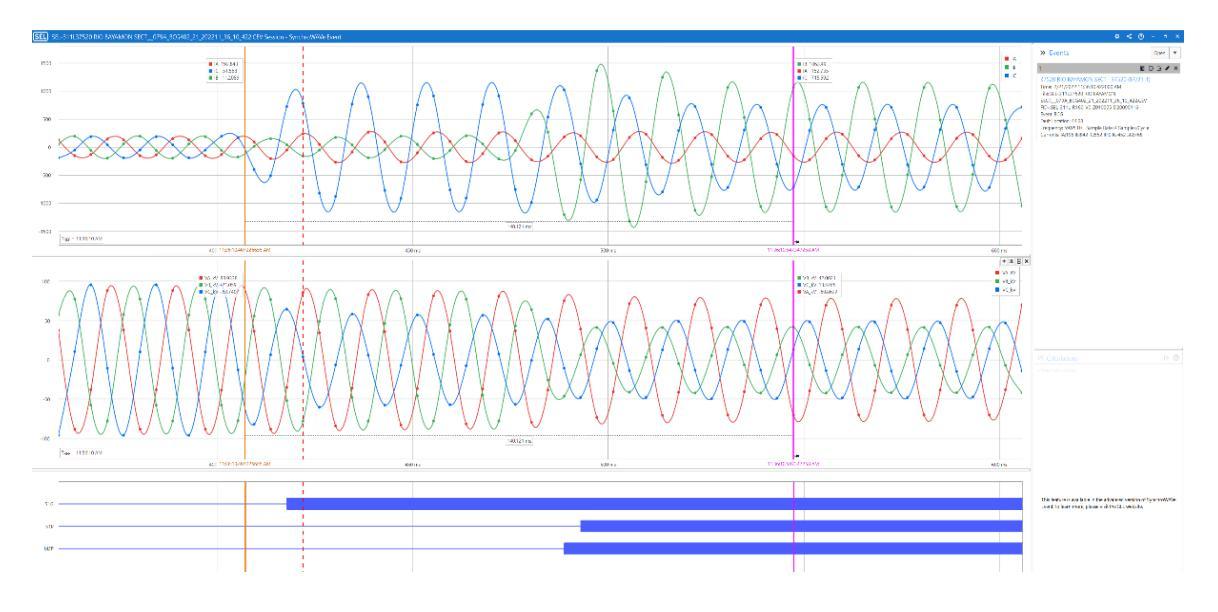
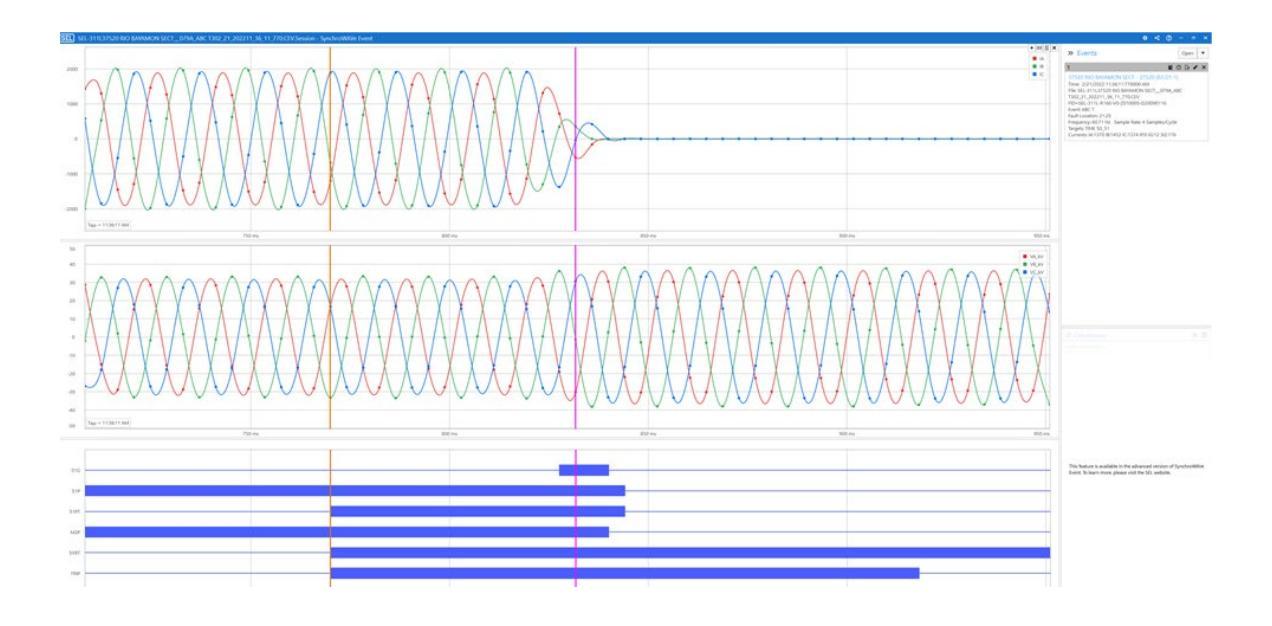
The line protection on line 37500 between Rio Bayamón and Monacillos operated 1.363 seconds after the start of the fault on line 38100. This is documented by the SEL-311L relay at the Rio Bayamón terminal on circuit breaker 20. The relay recoded the start of the fault (see figure 3-41) as well as the moment, the relay operated and interrupted the fault current (see figure 3-42). The relay operated with a 51P element, and the relevant settings for the 51P element are shown below:

Based on this data and a fault current of 1,420 A (prim), which results in a CT ratio of 400 to a secondary fault current of 3.55 A, the anticipated tripping time is 0.91 seconds. The actual trip time of 1.363 can be explained by the fact that the fault current varied during the fault, as visible in the two records. At the beginning of the fault, the fault current was 780 A (prim) or 1.95 A (sec), which would have resulted in a tripping time of 1.32 seconds.

Figure 3-41 Fault Records Data from Monacillos Terminal of Line 37500 – Start of Fault

Figure 3-42 Fault Records Data from Monacillos Terminal of Line 37500 – Operation of Line

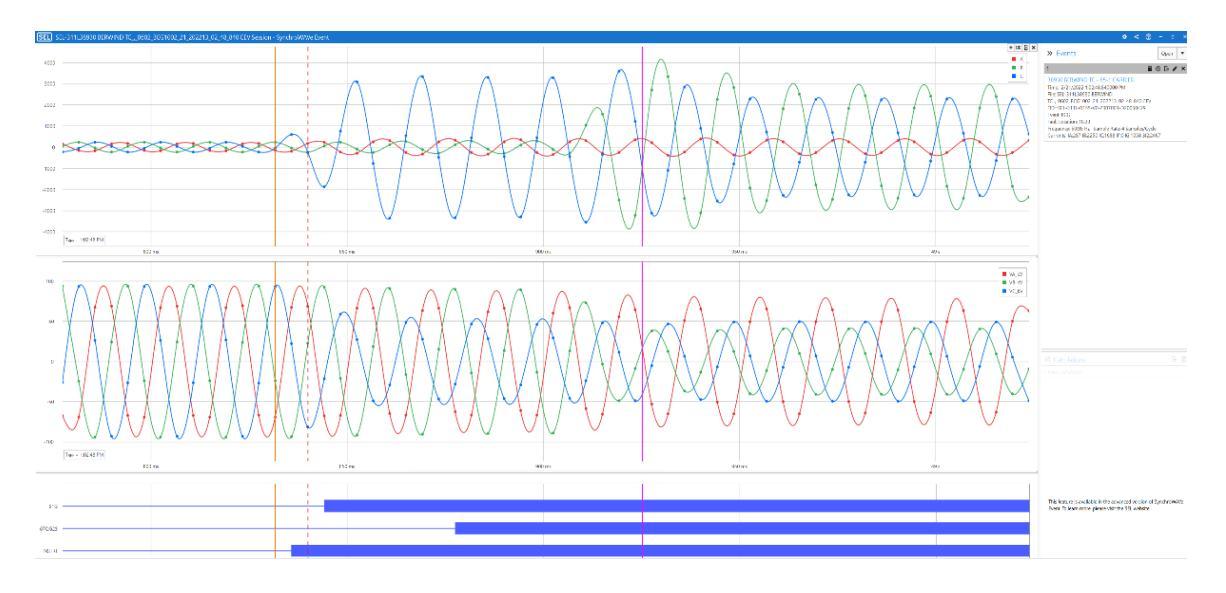
Figure 3-43 Fault Records Data from Berwind Terminal of Line 38900 – Fault Start

The line protection on line 38900 between Berwind to Martin Peña operated 1.5 seconds after the start of the fault on line 38100. This is documented by the SEL-311L relay at the Berwind terminal on circuit breaker 30. The relay recoded the start of the fault (see Figure 3-43) as well as the moment the relay operated and interrupted the fault current (see Figure 3-44). The relay operated correctly with a Z4 distance element that is set with a 1.5 second delay and a zone reach of 16.41 ohms.

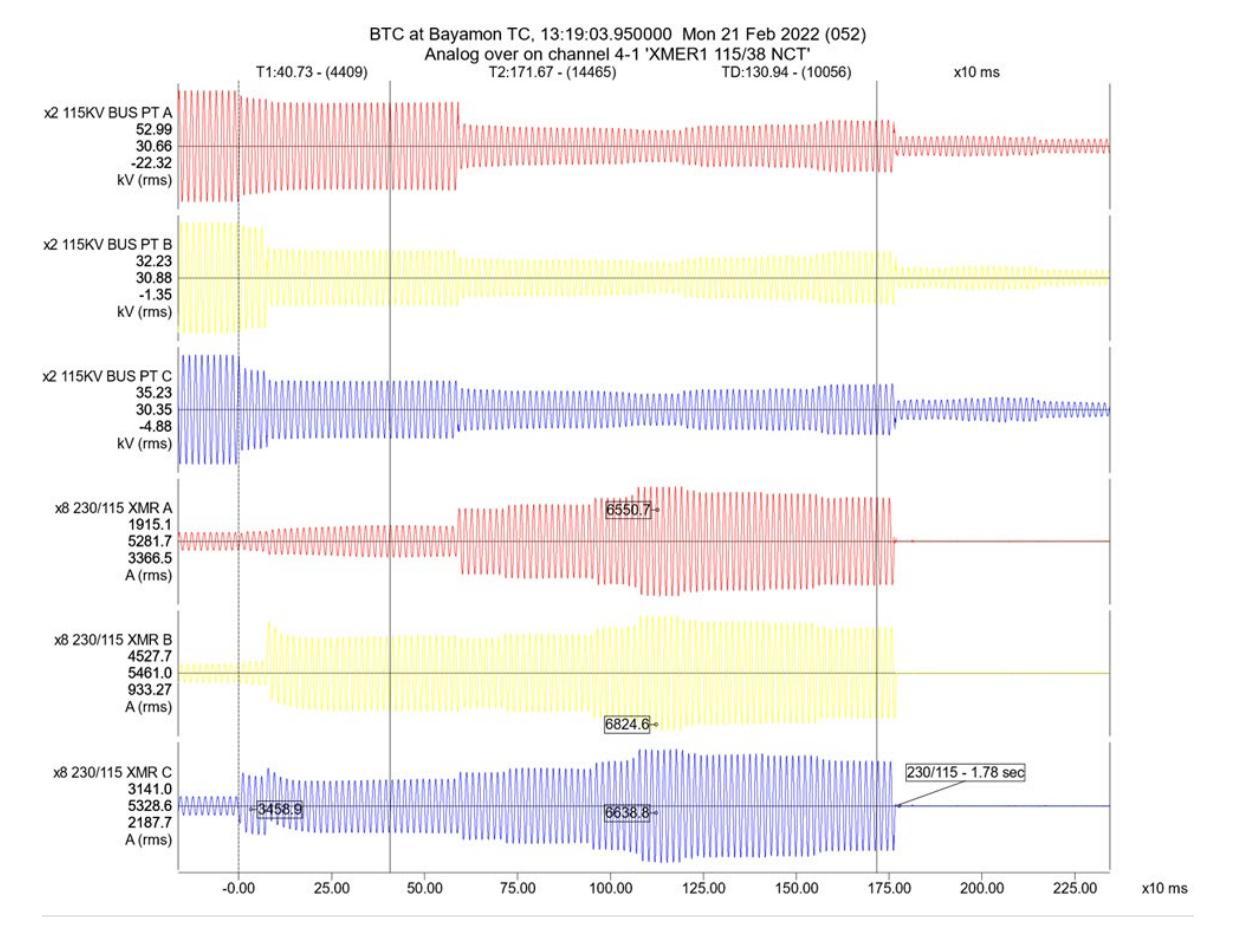
Figure 3-48 Fault Records Data

At 13:19:06.077, the 230/115 kV transformer at Bayamón Transmission Center and circuit breakers 50230-0096/0084-0092 tripped. Targets found were 230 kV phase backup (51P) from the IGCV-51 relay. From the transient recorder, the transformer tripped 1.777 seconds after the fault at line 38100 from San Juan to Viaducto initiated.

The main cause for this unwanted trip was the loss of coordination of the overcurrent element due to increase in short-circuit current at the transformer when key elements trip unexpectedly as follows:

It is recommended that the coordination of this 230/115 kV transformer be reviewed with priority.
