**DR-4339-PR Public Assistance**

**PROJECT SCOPE OF WORK WITH COST ESTIMATES**

***FAAS<sub>t</sub> - Dams Minor Repairs***  
***(Dams/Hydro)***

***GM #436621***

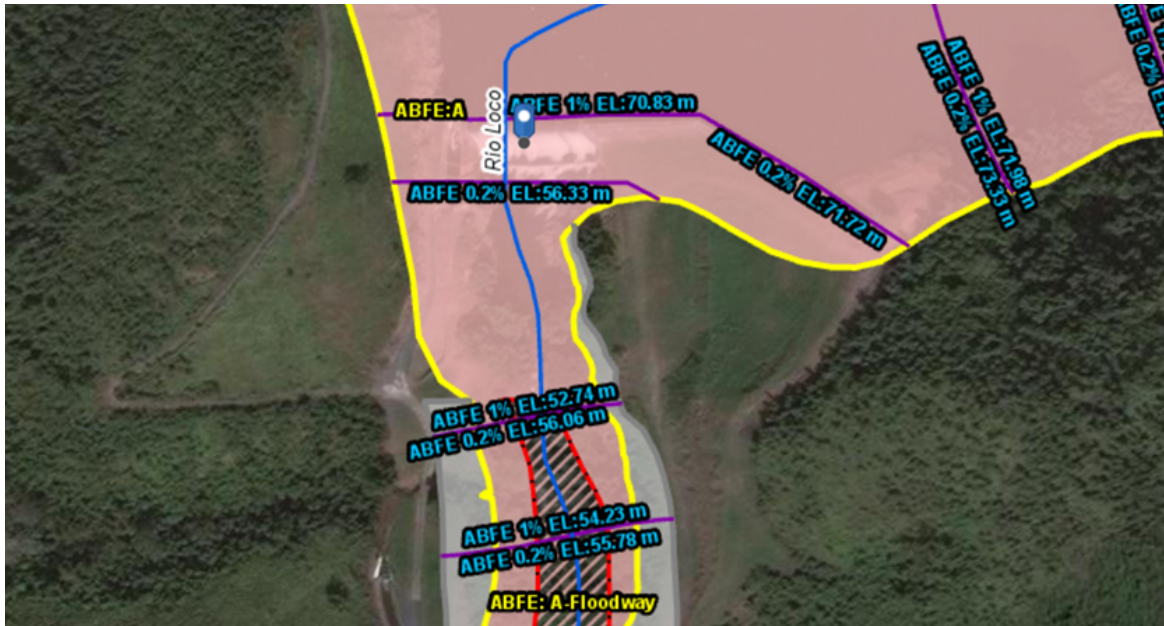
**Luchetti Dam** – Lucchetti Dam is a gravity dam located in Yauco, Puerto Rico. The dam was built on the Yauco River in 1952 to support irrigation. Hurricane-damaged assets include electrical components, utility poles, cracked gallery, hydraulic unit motor and oil pump, pressure gauges, actuator, and control gate operator.

- Dam's Right Abutment, Left Abutment, & Dam's Crest Walkway - 18.092049, -66.865260; 18.091293, -66.863823; & 18.091756, -66.864437
  - Remove and replace a 45 FT H wooden utility pole along the dam's right abutment. Remove and replace three (3) fuse cutouts and two (2) lightning arrestors attached to the pole.

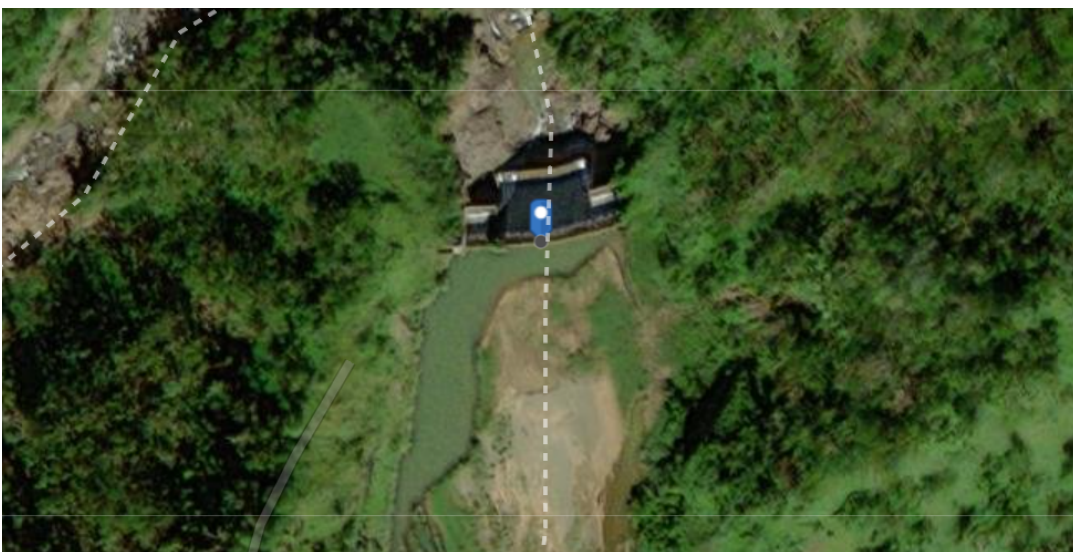
**Vivi Dam** – Vivi Dam is a gravity dam located in Utuado, Puerto Rico. The dam was built on the Vivi River in 1950 to support hydroelectric power production. Damages include site erosion, structure doors and windows, electrical components, sluice gate hydraulic hoist and power unit, railings, fencing, access road and parking area, and intake rack structure and surroundings.

- Access Road - 18.229455, -66.678516
  - Reconstruct roadway to codes and standards. 5,850 SF (450 LF L x 13 FT W – total length is 900 LF) of 4 IN thick asphalt access road that was damaged by high velocity run-off during the storm. See typical, Figure 2.
