**REQUEST FOR PROPOSALS FOR
TEMPORARY EMERGENCY
GENERATION**

COSTA SUR RECOVERY PROJECT REPORT

Strategic Action Plan
Condition Assessment, Value Engineering and Decision Making
Restoration of Lost Power Capacity at Costa Sur Power Plant (CSPP) due
to Earthquake Damages

***Emergency Structural Inspection and Assessment
Preliminary Report of Immediate Remediation Needs
And Repair Approach
1-30-20***

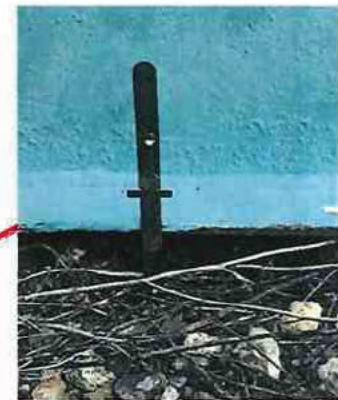
Demineralized Water Tank (DEMI)

Differential settlement of about 2" between the East and West side of tank was observed. An apparent deformation on the West side upper shell level and roof was observed. Water leakage observed from nozzles and flanges.

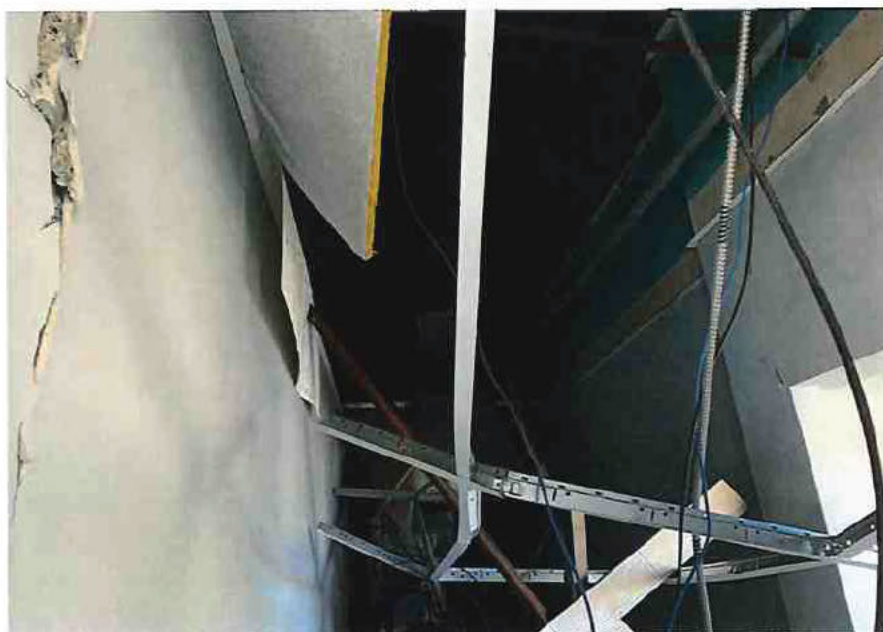
Interior 3rd floor

Damages in administration building (interior)

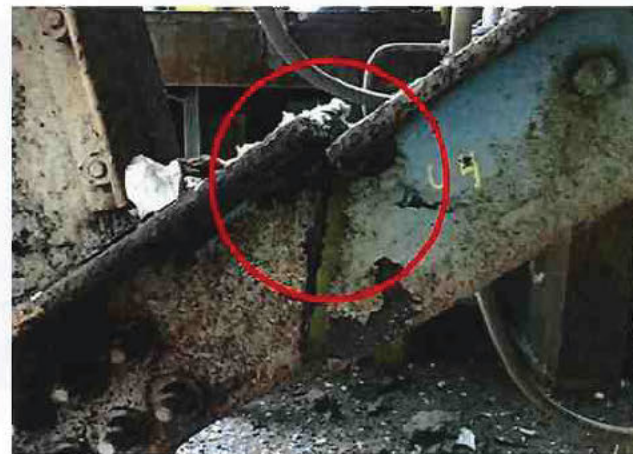
Unit #3 & 4 Boiler structural damage

Apparent fracture or cut to element.

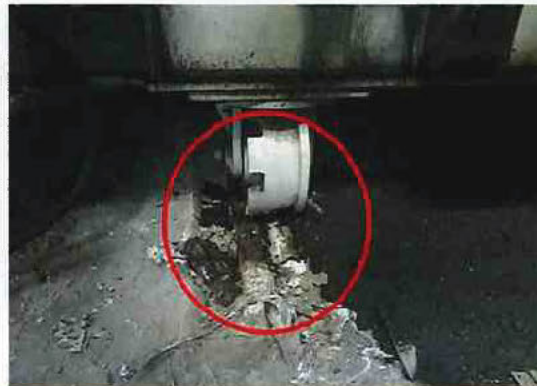
**Transformer is derailed or out
of supporting base, railing
system compromised.**

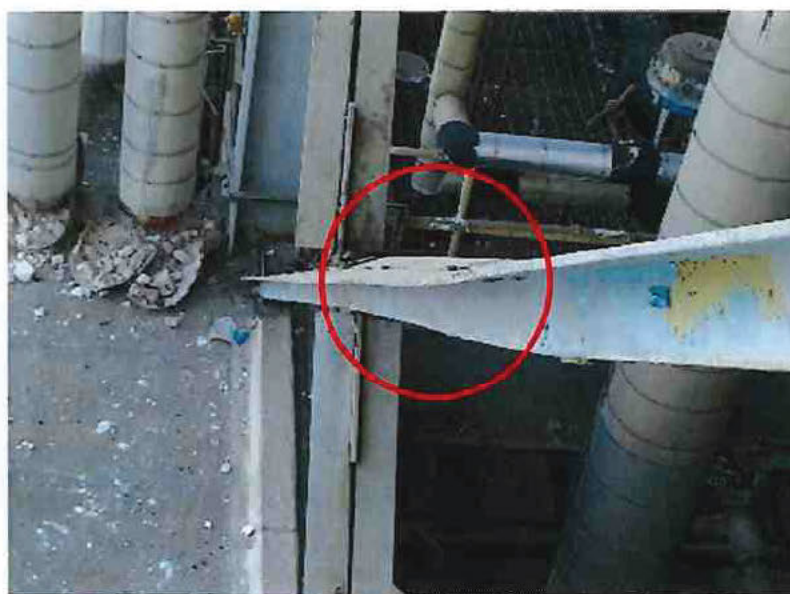
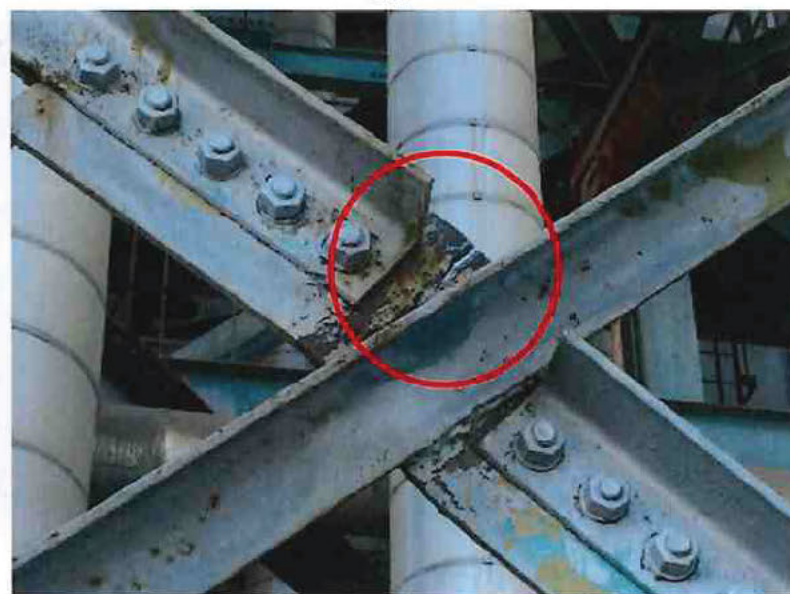
Unit #5 Boiler structural damage

Deaerator Support Structure. Failed cross-braces. Increased risk of more damage to deaerator support structure during major wind or seismic event.

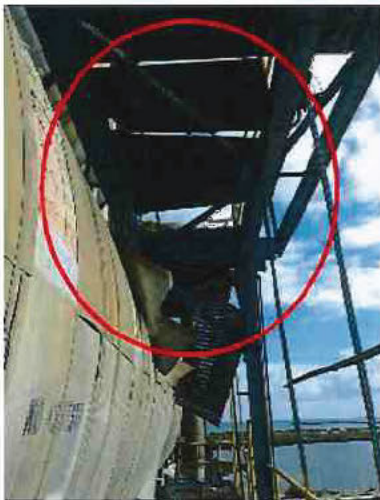
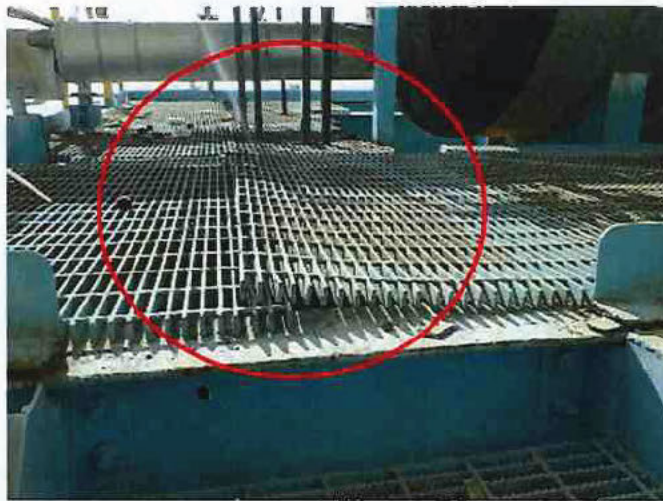
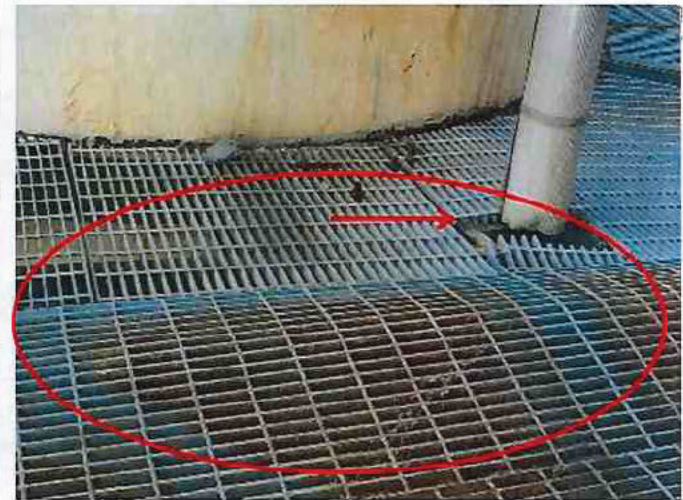
Unit #5 Boiler structural damage

Loose, buckled and missing grating is unsafe to plant personnel

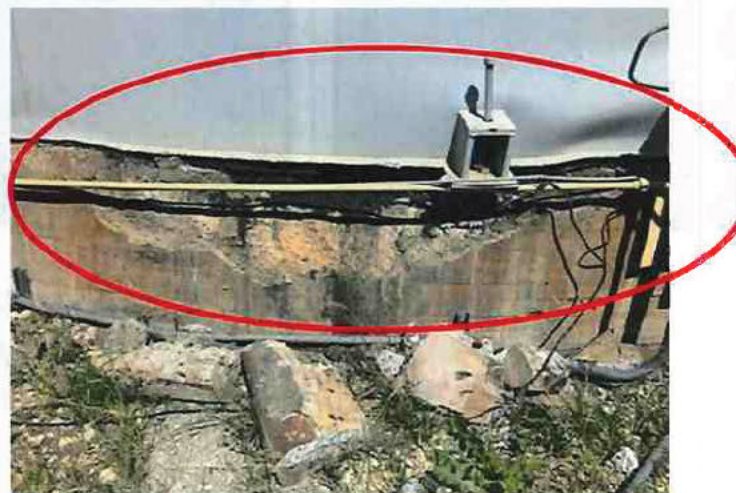
Damaged foundation and buckled tank

Units 5 & 6 Condensate tank damages

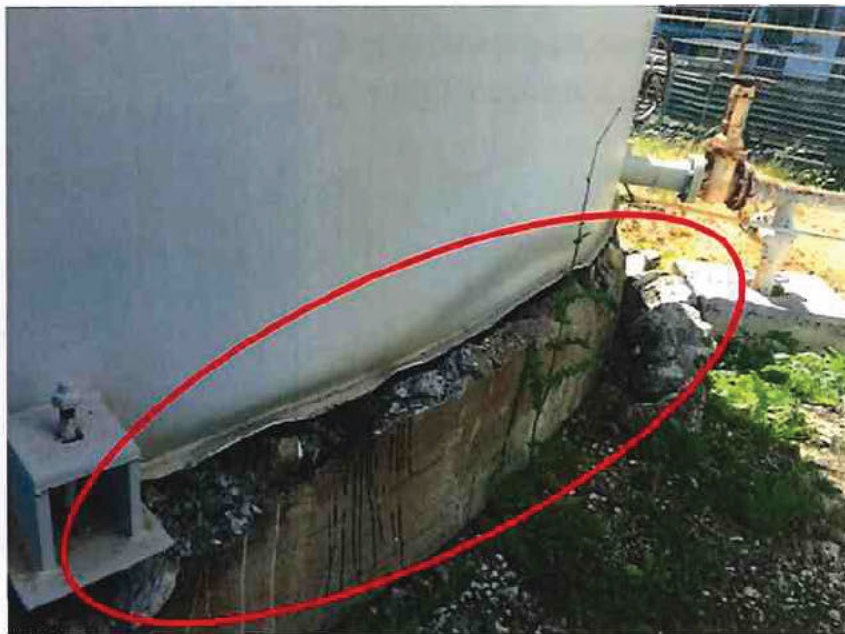
Damaged foundation and buckled tank

Units 5 & 6 Condensate tank area

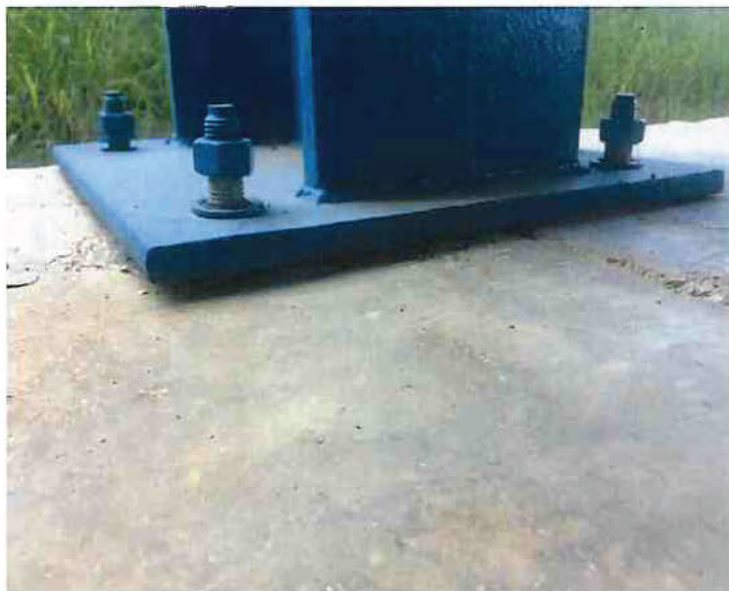
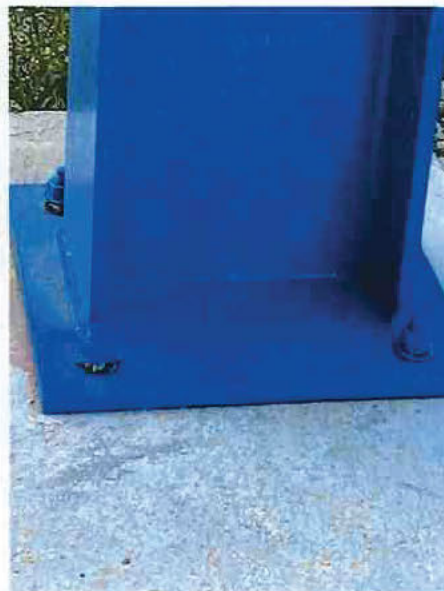
**Building columns base plates
footings anchor bolts up-lifted
and damaged**

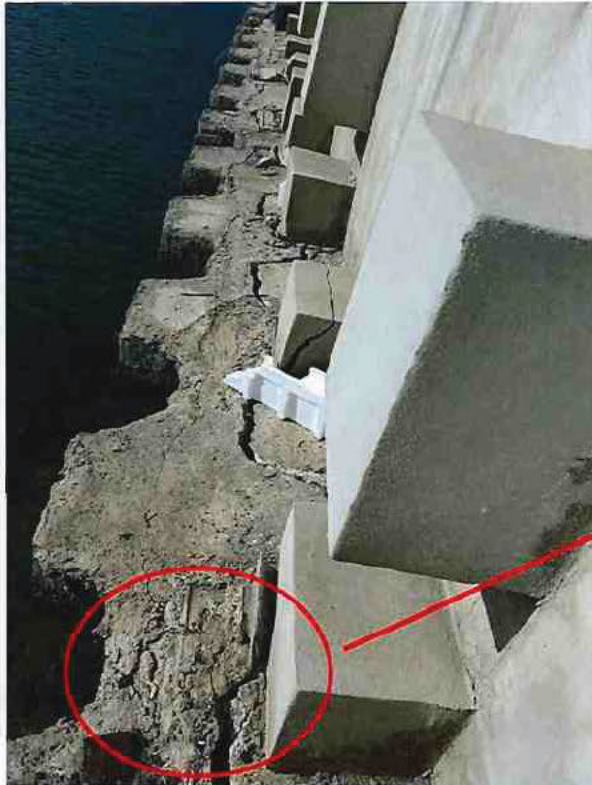
Costa Sur discharge channel structure damaged

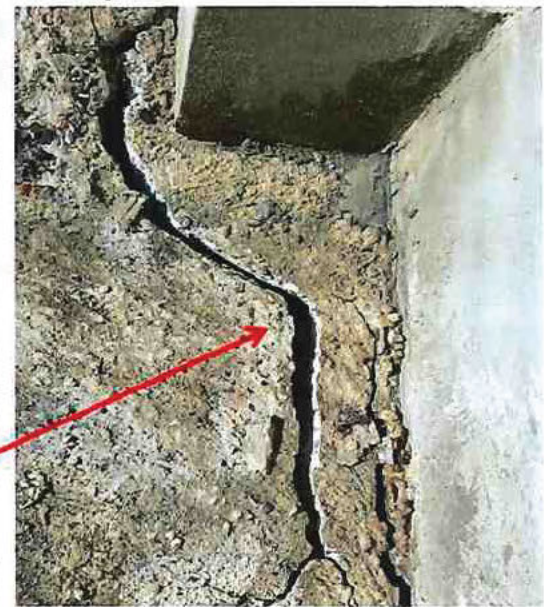
Sheet pile displaced two inches
from wall.

Costa Sur discharge channel structure damaged

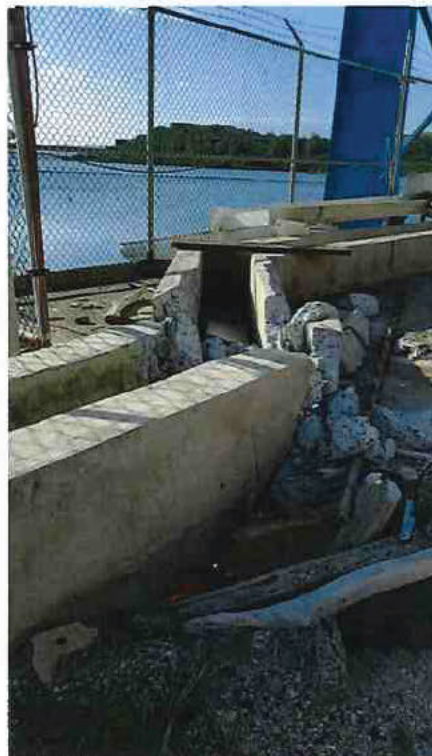
Overhead gantry crane support structural damage

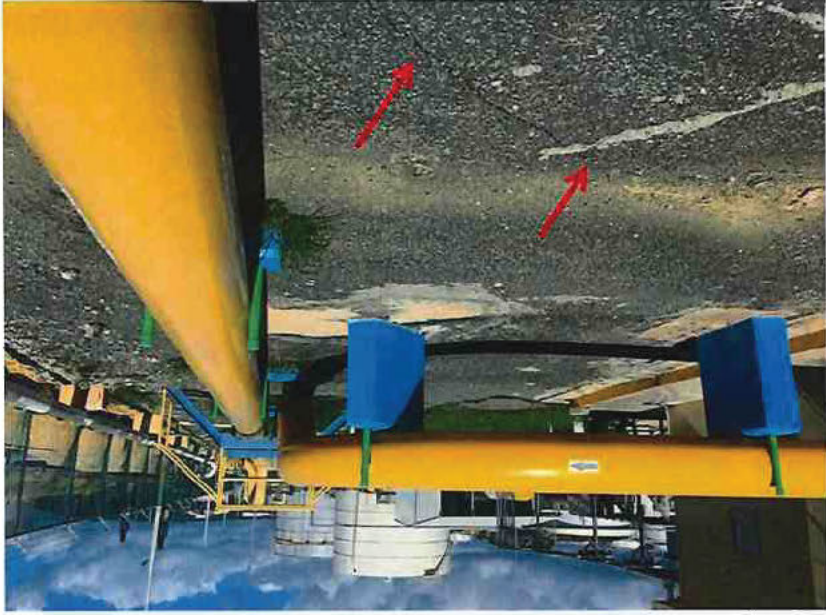
Gas pipeline structural support damage

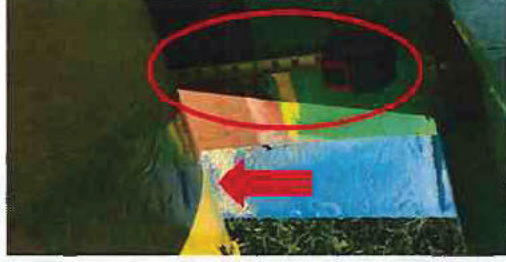
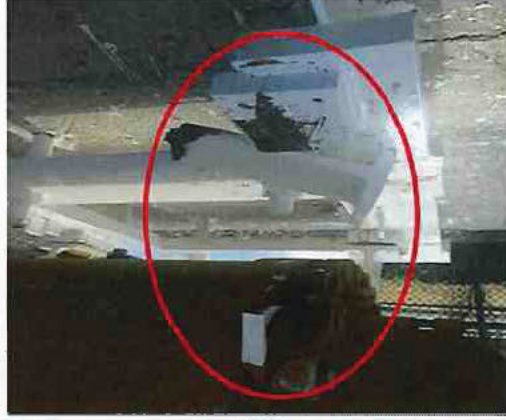
Gas pipeline structural support damage

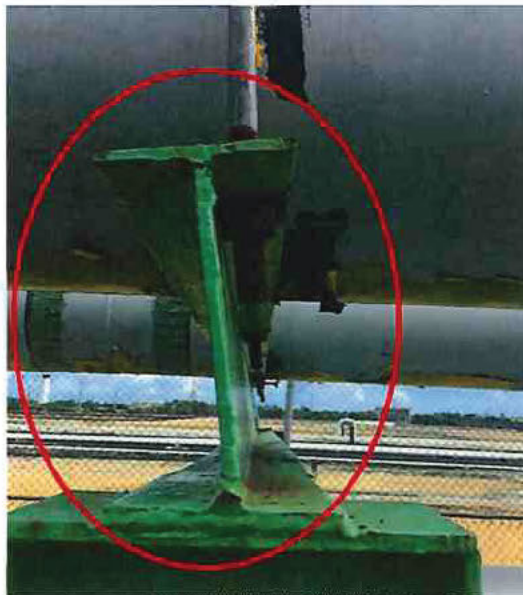
Displacement of gas pipeline, bending of top beam, columns and U-bolts

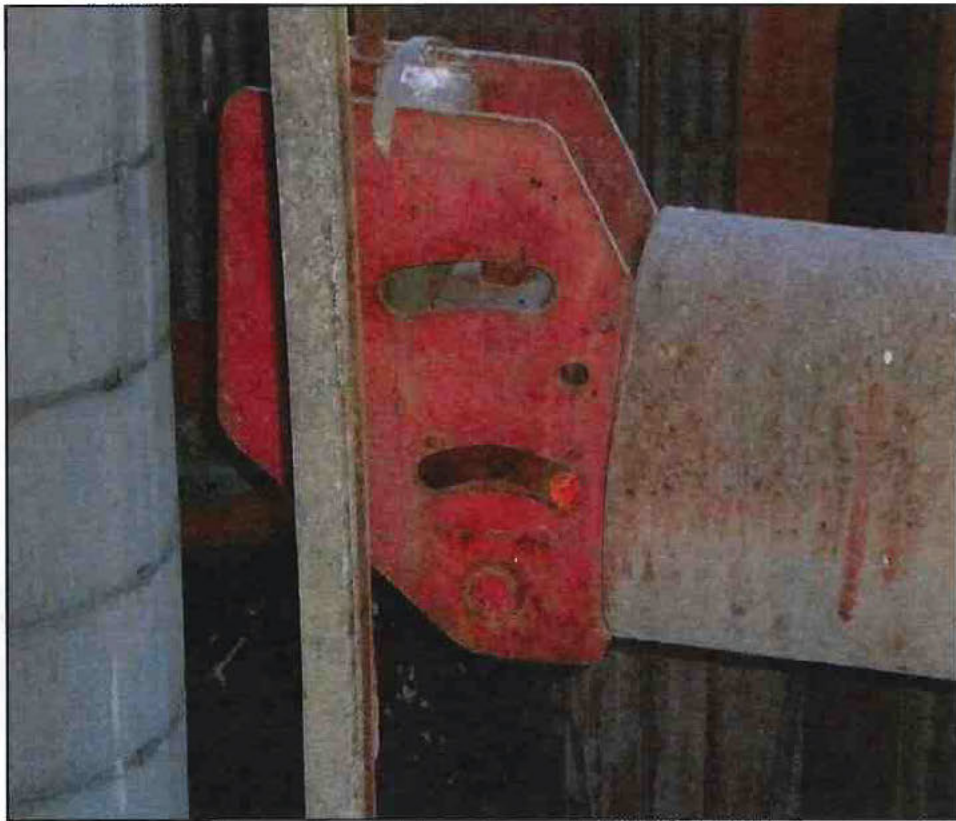
Photo 9 - U-5 Topped out Hanger CR- 15

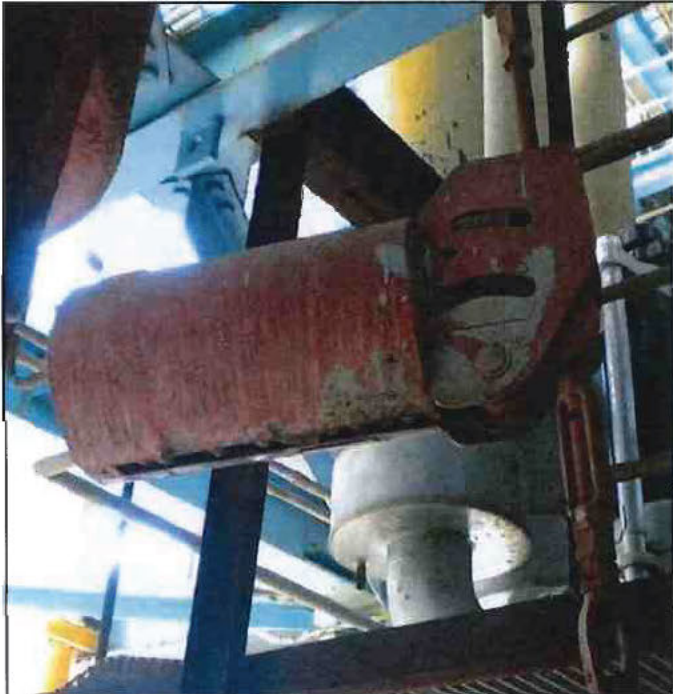
Photo 10 - U-5 Boiler Feed Hangers BF-1 and BF-2

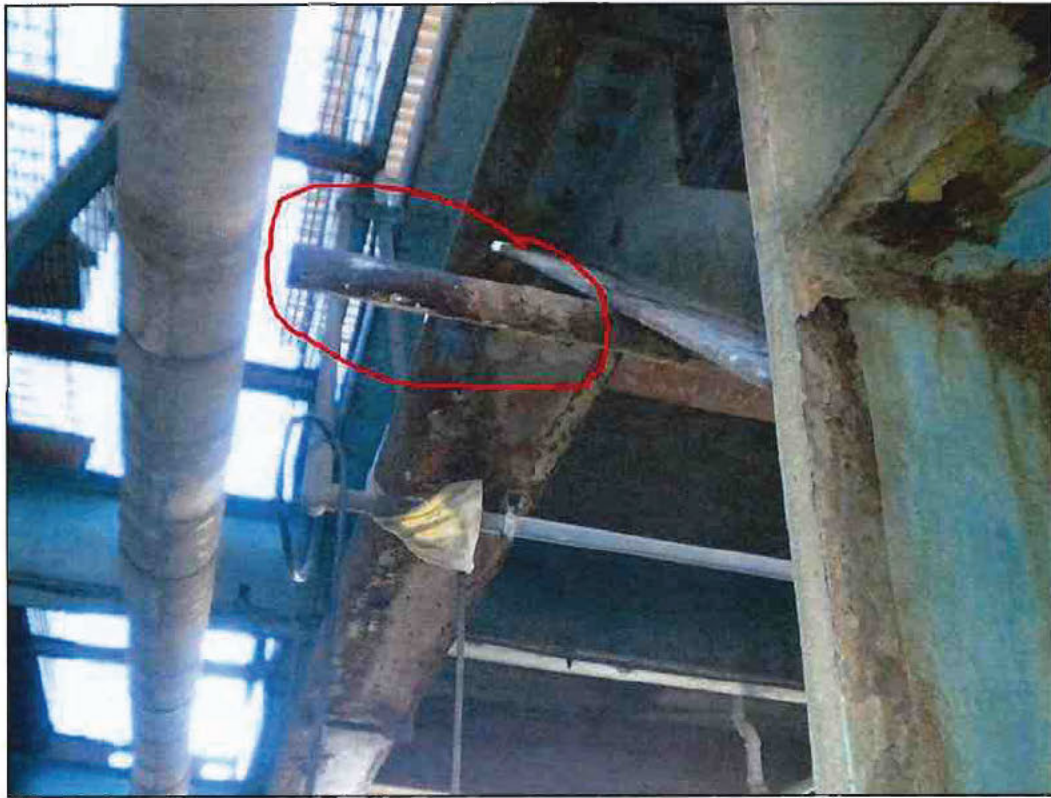
Photo 20 - U-5 Unidentified Line Support

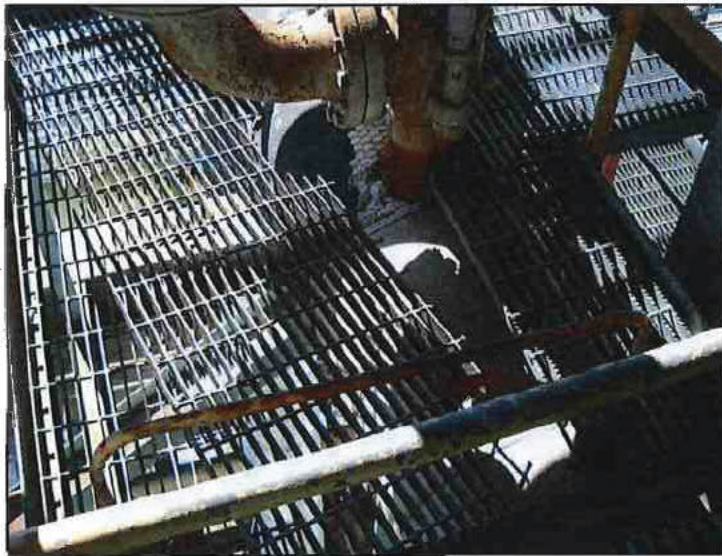
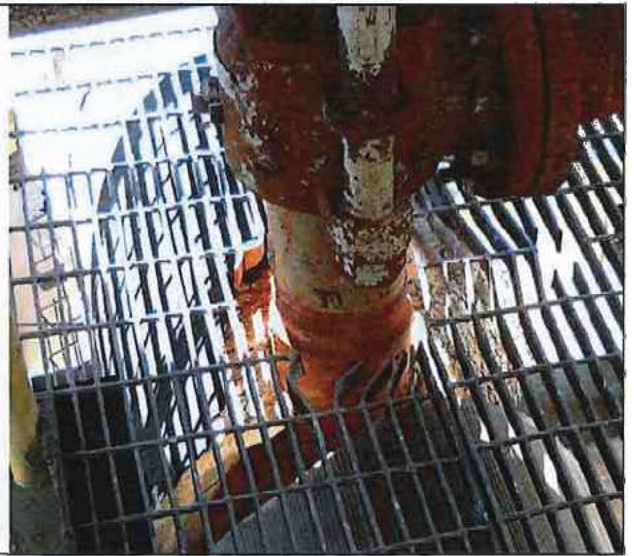
Photo 24 - U-6 Dislodged Grating and Bent Grating at the two Main Steam SRV Locations

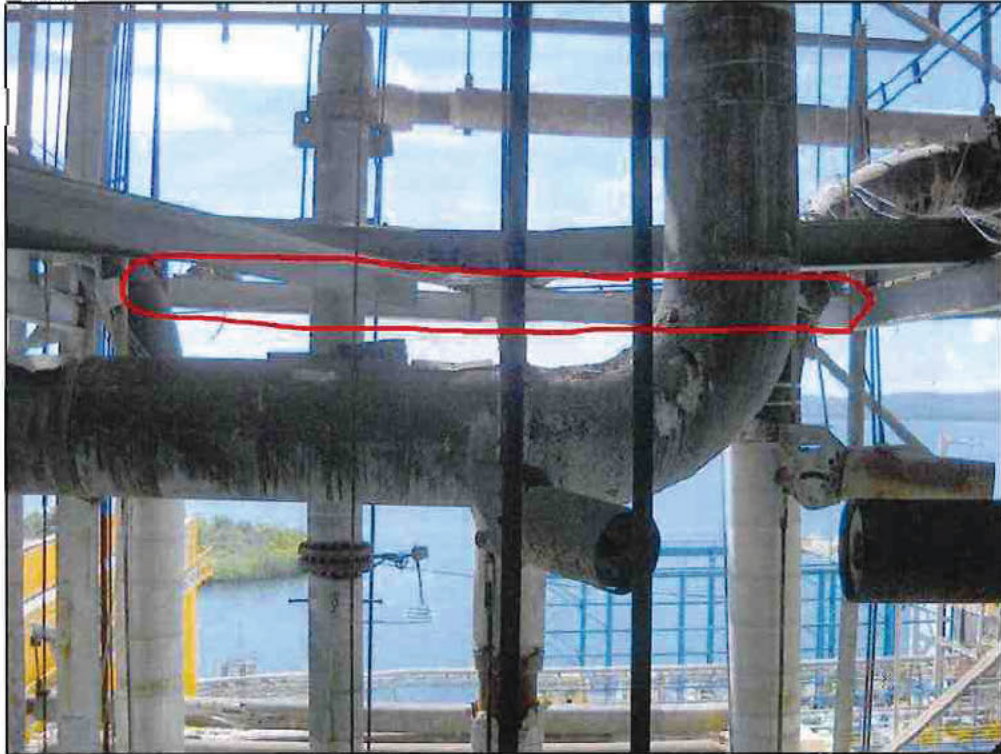
Photo 27 - U-6 Bent Beam that Supports the Hot Suction Riser

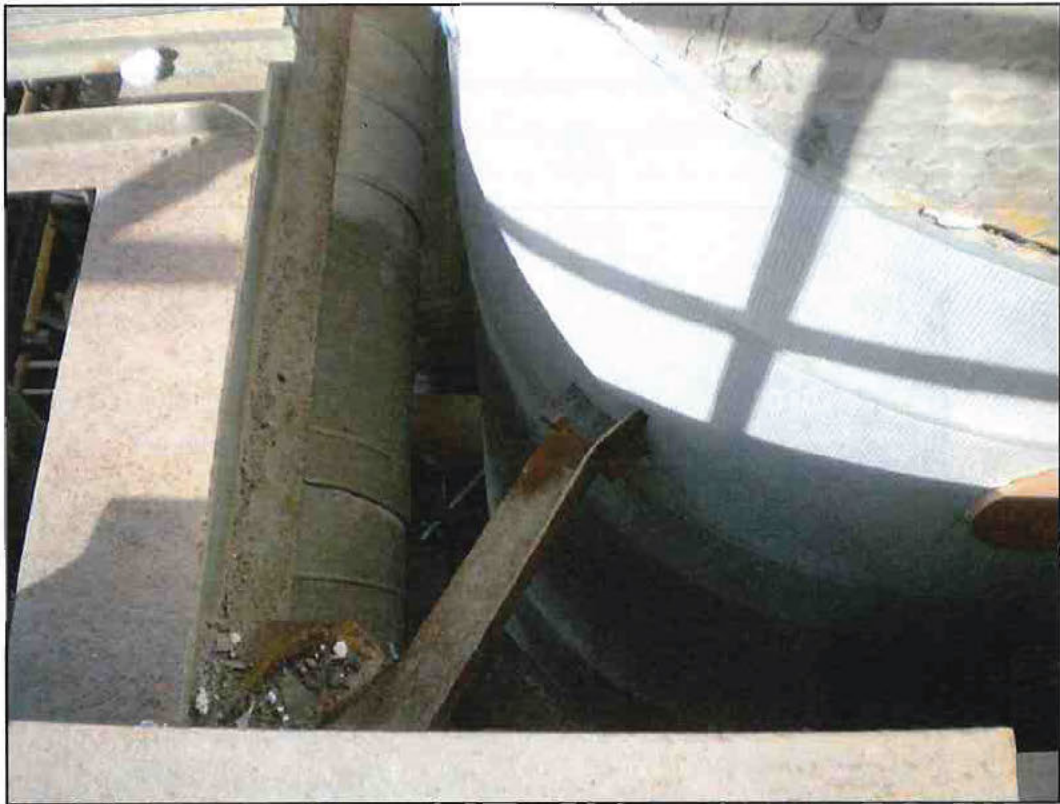
Photo 35 - U-6 Bent Heater 6 Lateral Restraint

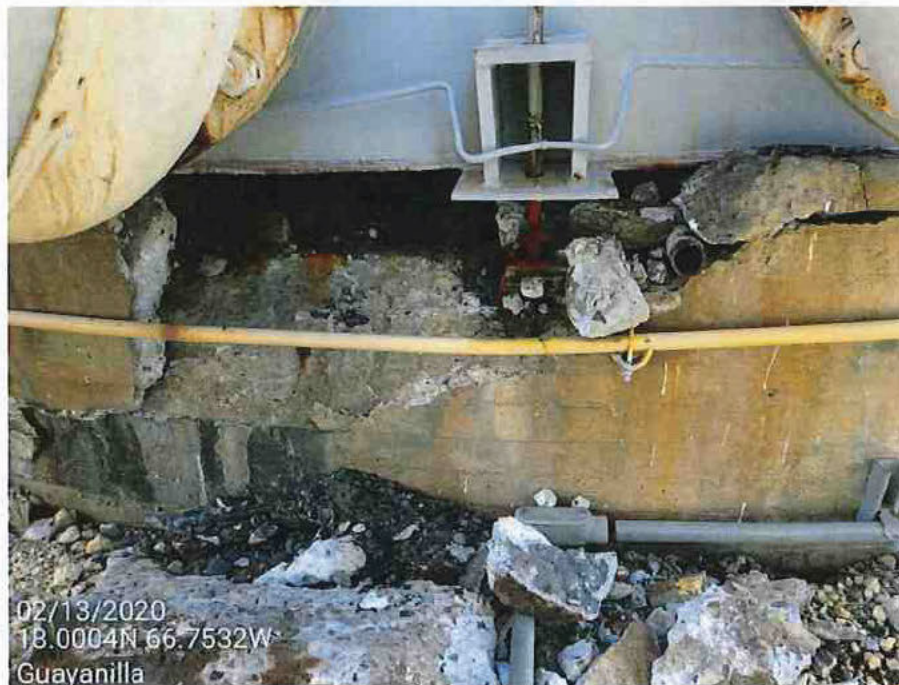
Picture 29 – Foundation concrete base and shell support ring crushed and anchor bolt ripped off from concrete base, due to seismic overturning moment.

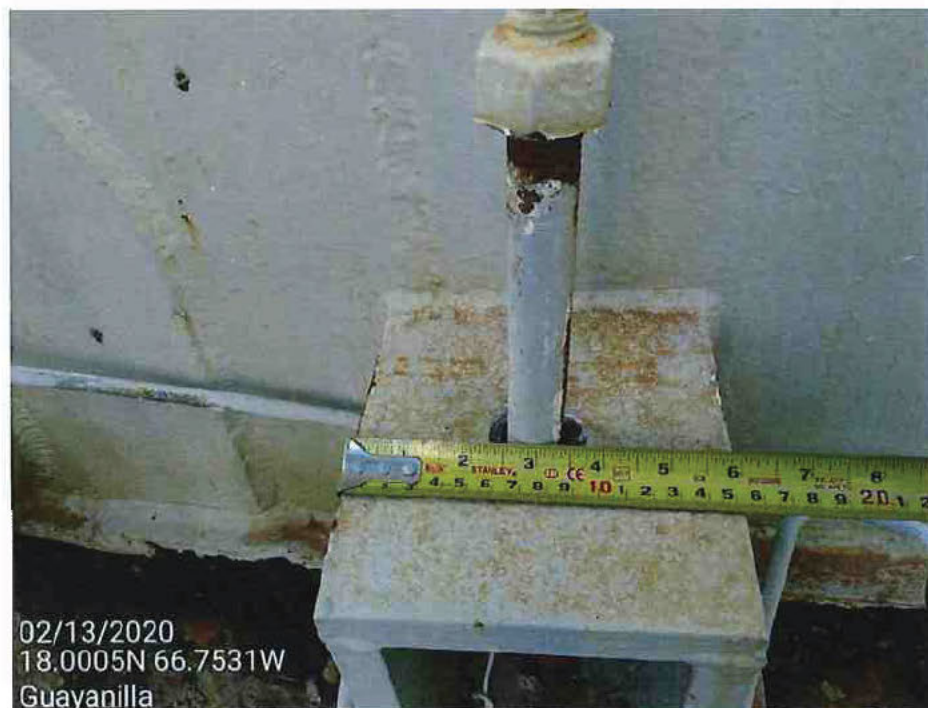
Picture 31 – Anchor assembly chair top plate measurements.

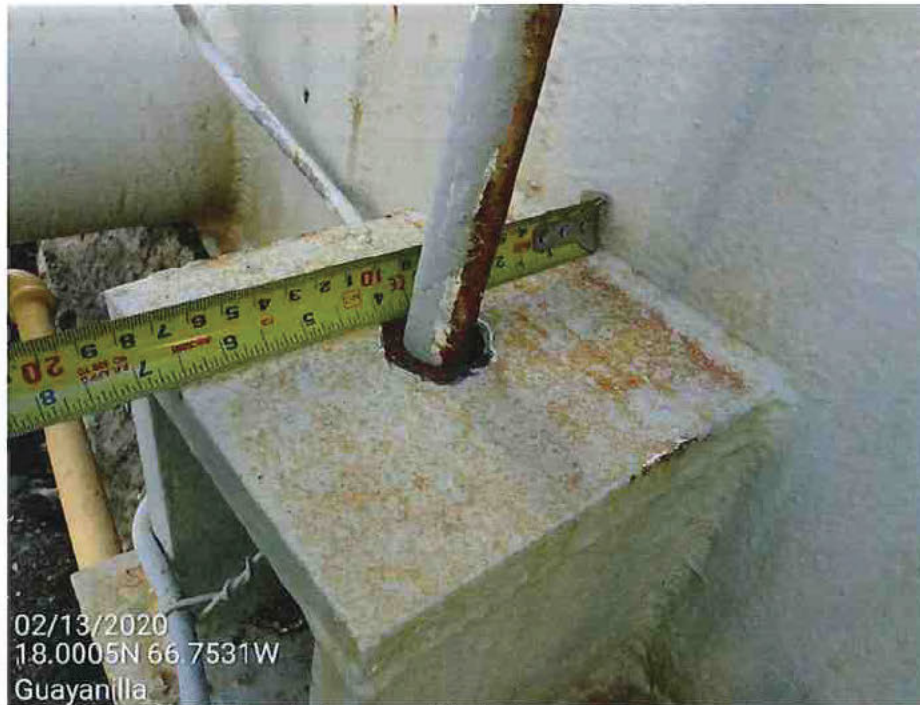
Picture 32 – Anchor assembly chair top plate measurements.

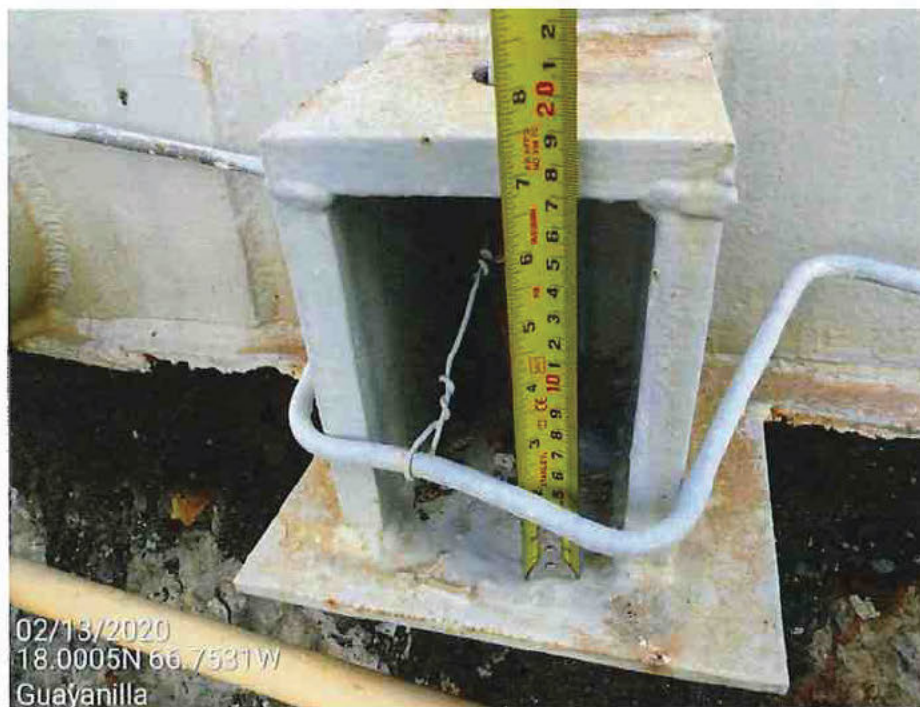
Picture 33 – Anchor assembly chair top plate measurements.

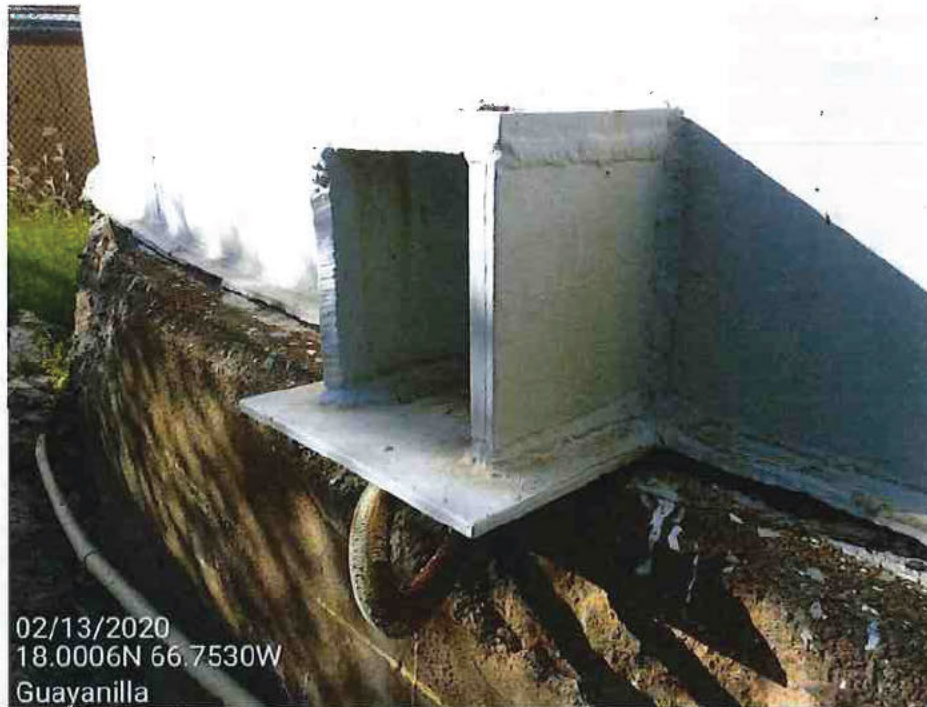
Picture 38 – Anchor bolt completely bent by tank's anchor chair assembly. It is evident that the tank underwent high tension forces during the seismic event.
