**REQUEST FOR PROPOSALS FOR
TEMPORARY EMERGENCY
GENERATION**

NEPR-AP-2020-0001

**SUPPLEMENT TO NOTIFICATION AND URGENT REQUEST
FOR APPROVAL OF REQUEST FOR PROPOSALS FOR
TEMPORARY EMERGENCY GENERATION**

COSTA SUR RECOVERY PROJECT REPORT

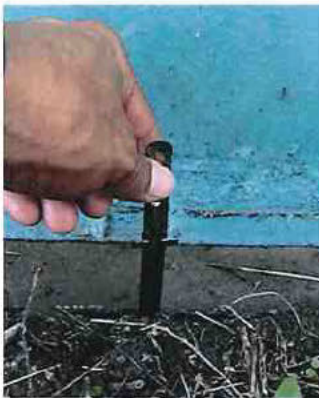
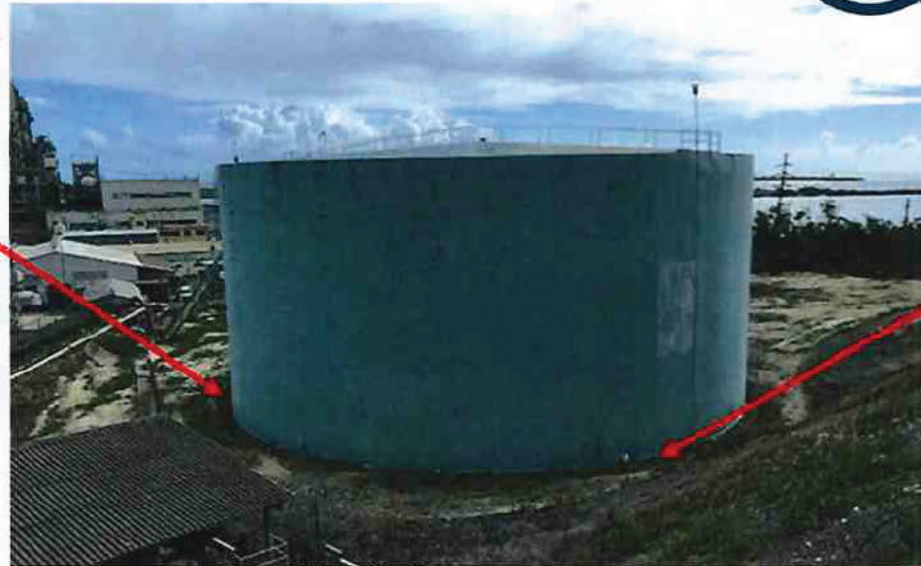
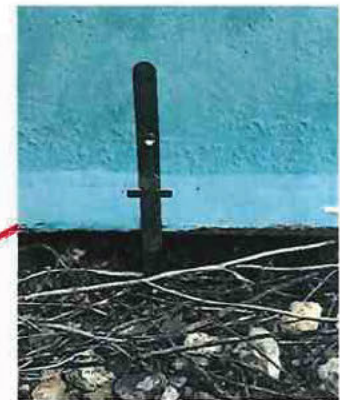
Demineralized Water Tank (DEMI)

Differential settlement of about 2" between the East and West side of tank was observed. An apparent deformation on the West side upper shell level and roof was observed. Water leakage observed from nozzles and flanges.

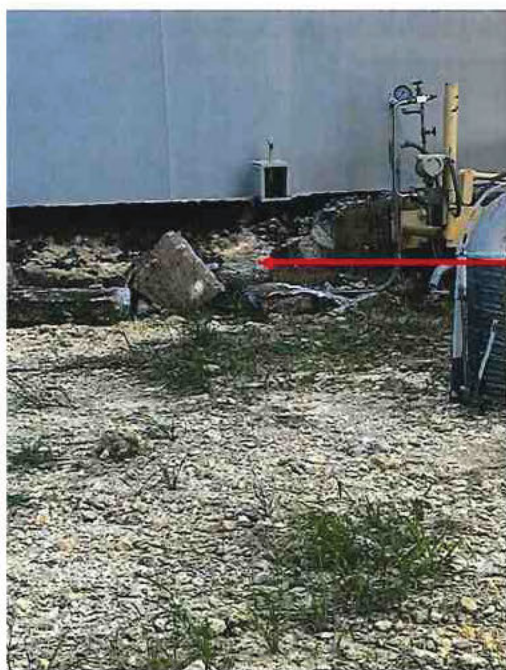
**Damaged Unit #5
DEMI tank
foundation**

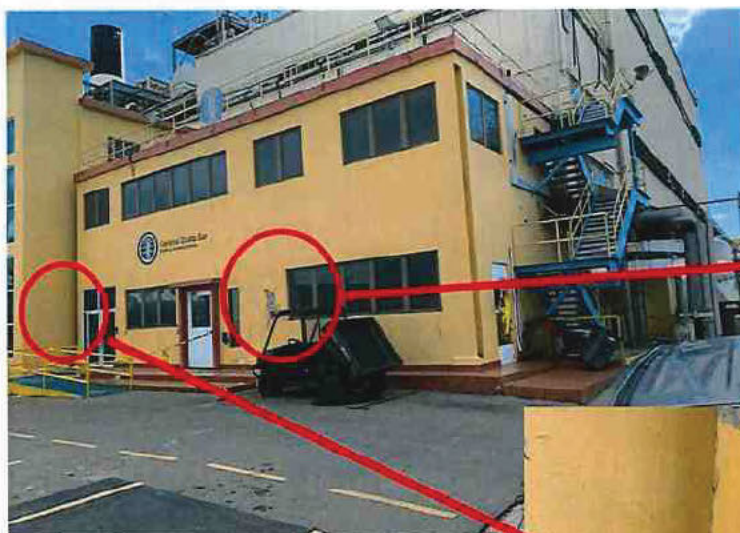
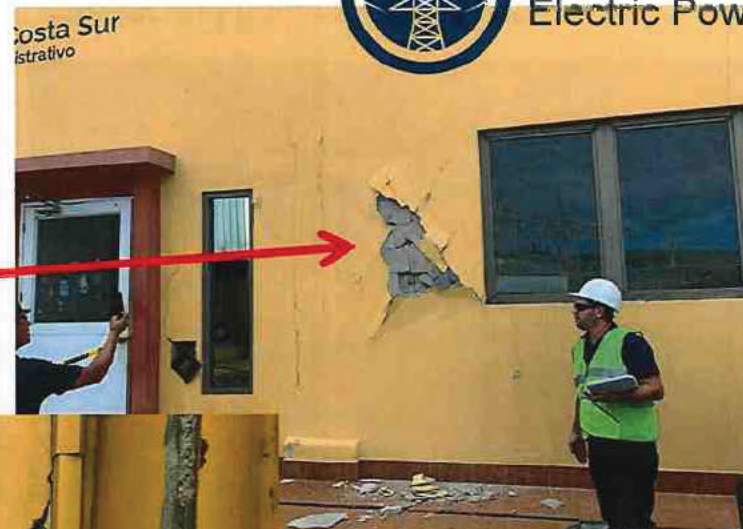
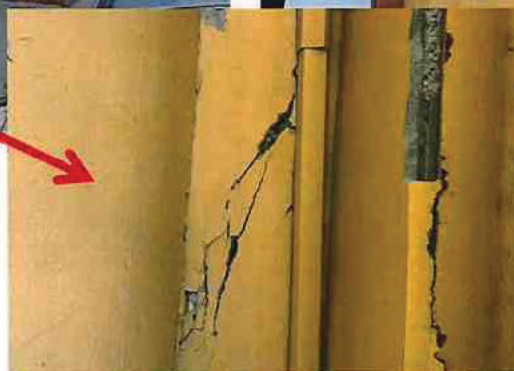
Front and lateral walls

Damages in administration building (exterior)

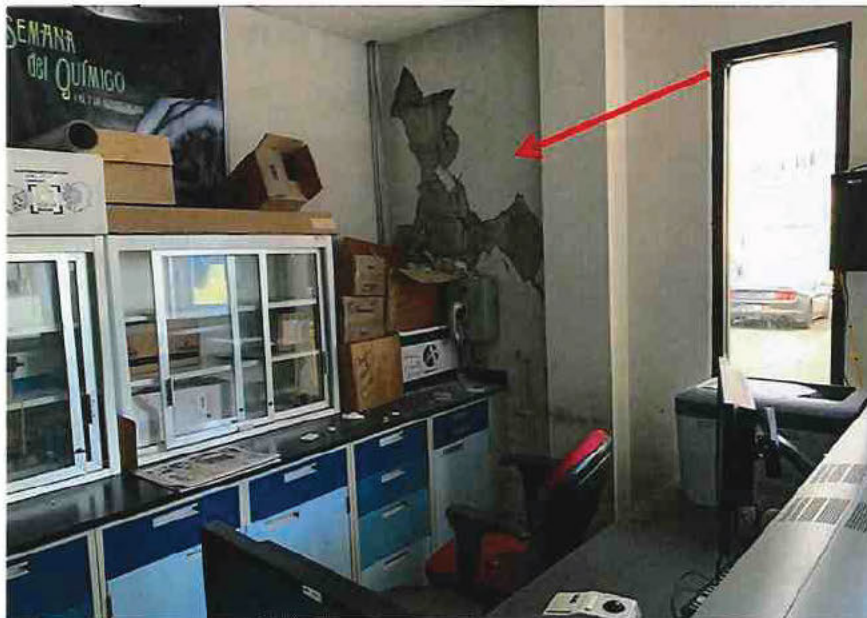
Interior 1st floor (LAB)

Damages in laboratory / administration building (interior)

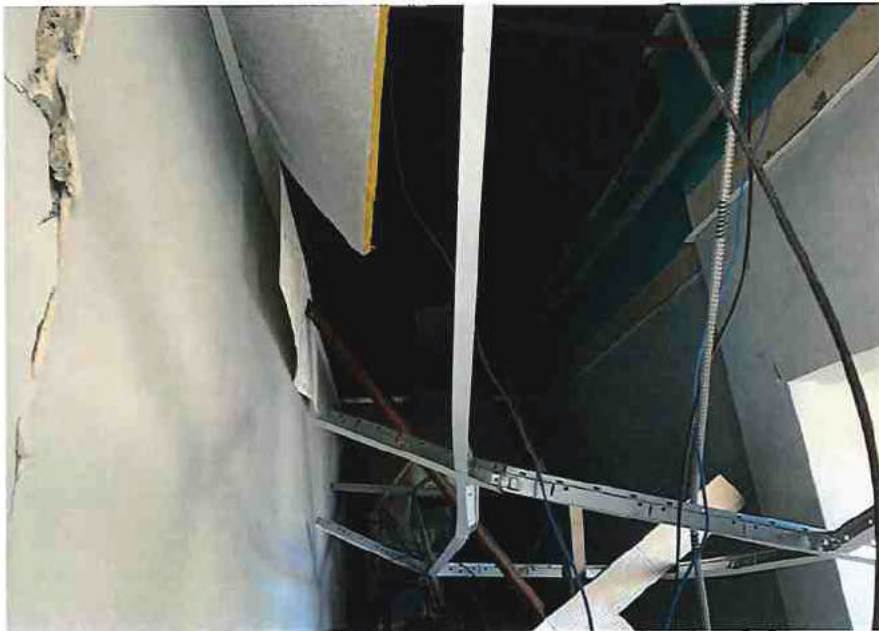
Interior 3rd floor

Damages in administration building (interior)

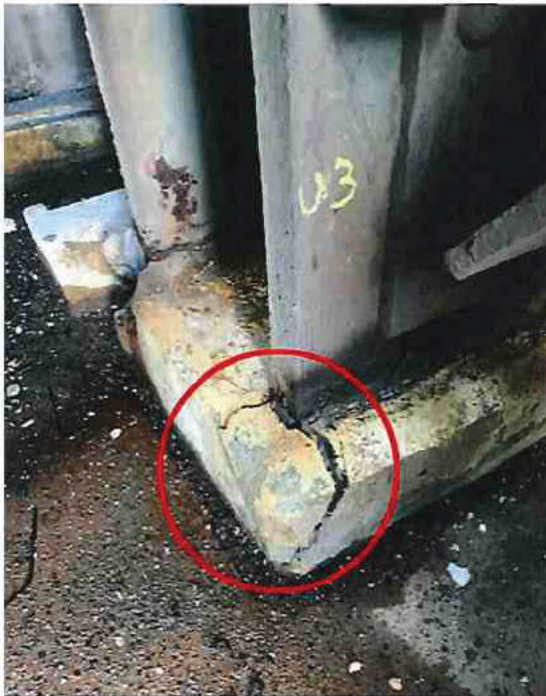
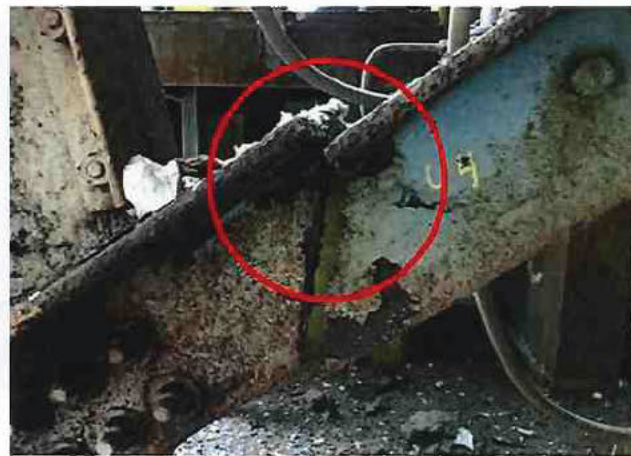
Unit #3 & 4 Boiler structural damage

Apparent fracture or cut to element.

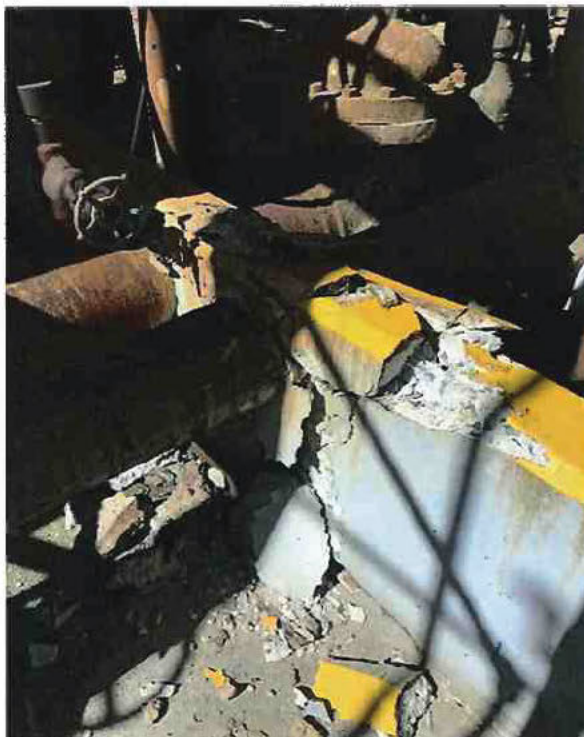
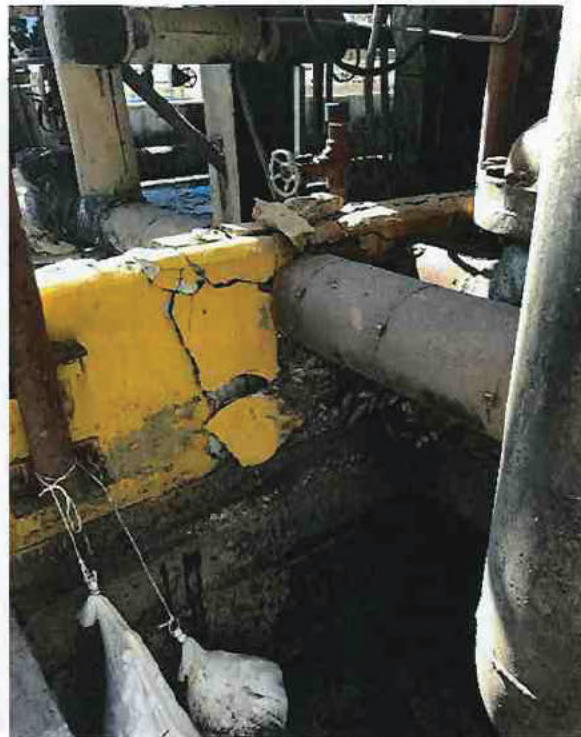
Unit #6 secondary wall fuel oil heaters (under turbine deck area)

Concrete secondary containment was broken at piping sleeve section due to movement or vibration of piping.

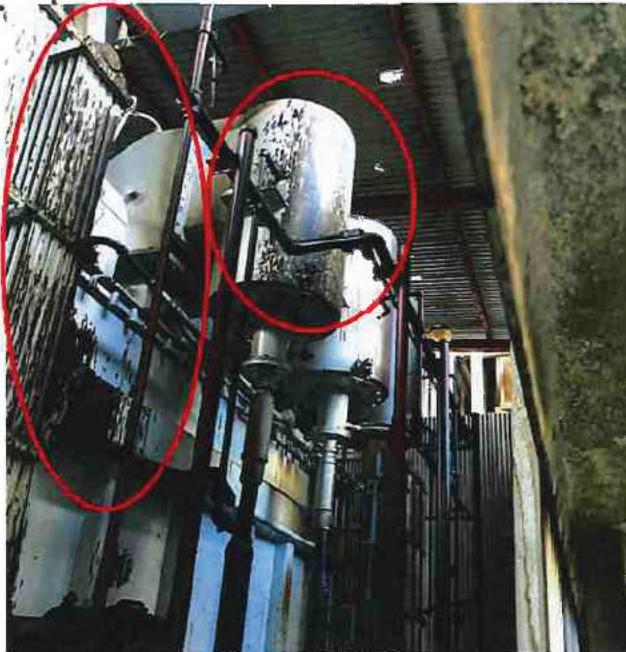
Unit #5 Emergency service transformer (under turbine deck and

Oil was expelled from the transformer.
Transformer oil containment has possible
internal damage.

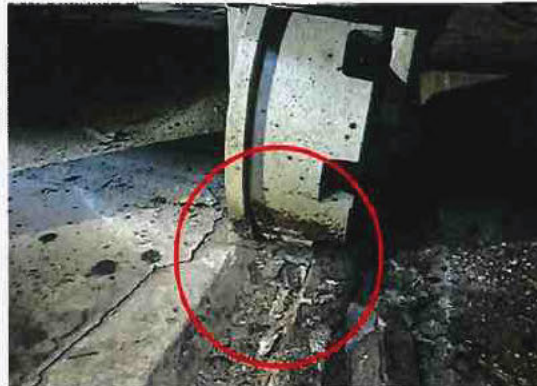
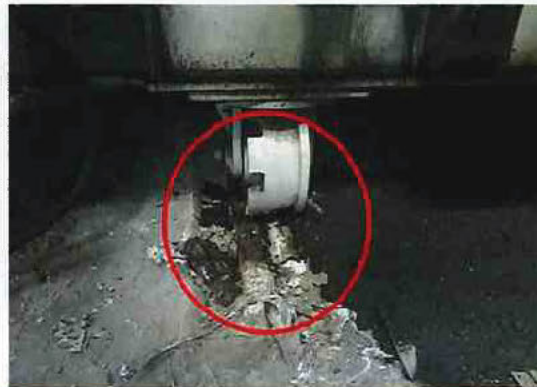
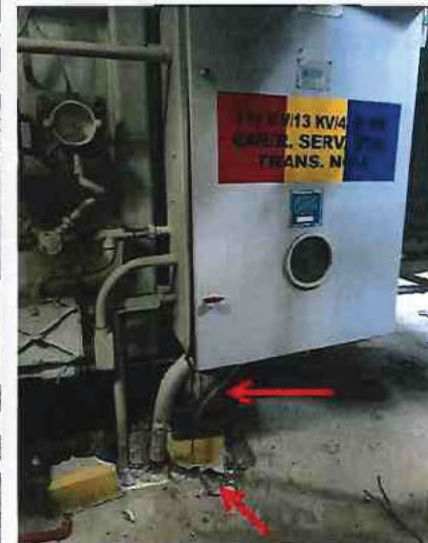
Transformer is derailed or out
of supporting base, railing
system compromised.

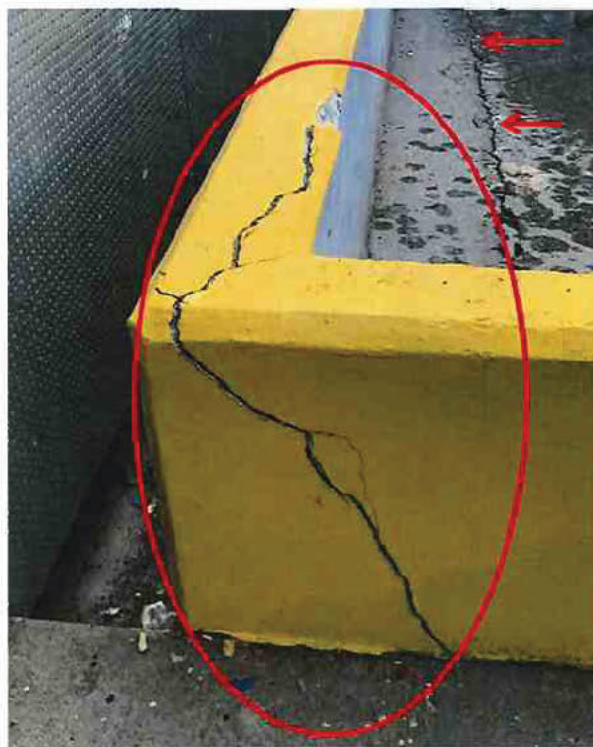
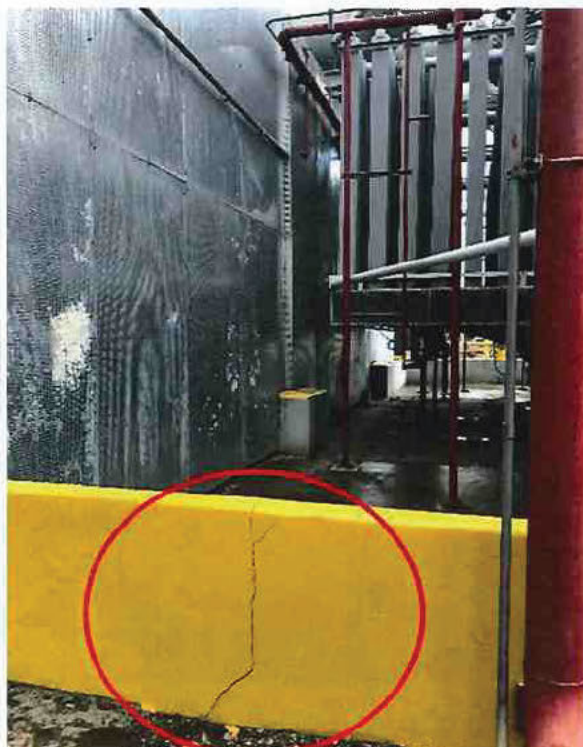
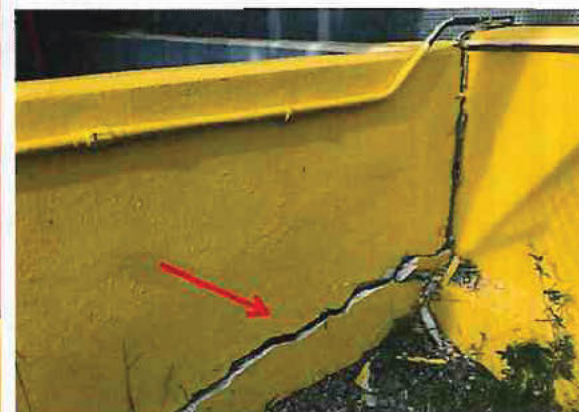
Secondary containment Unit #5 main generator transformer

Several cracks on secondary
containment's concrete walls.

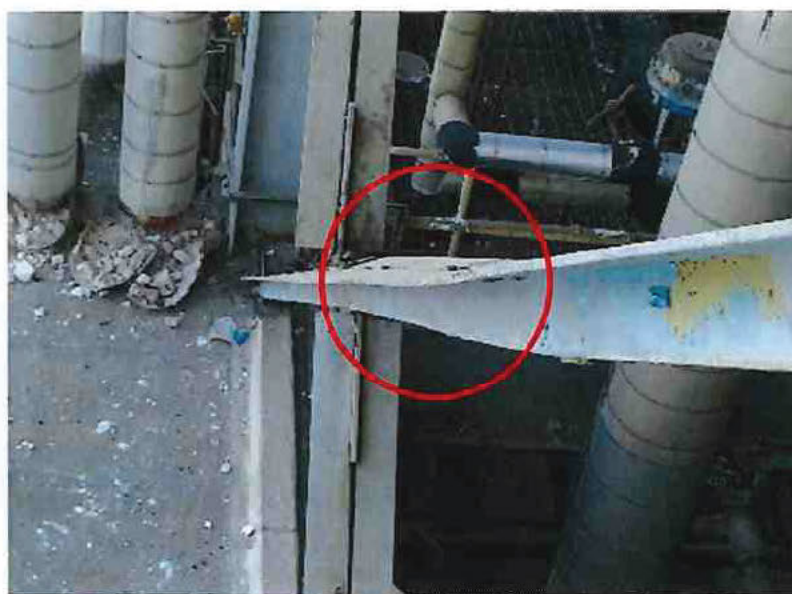
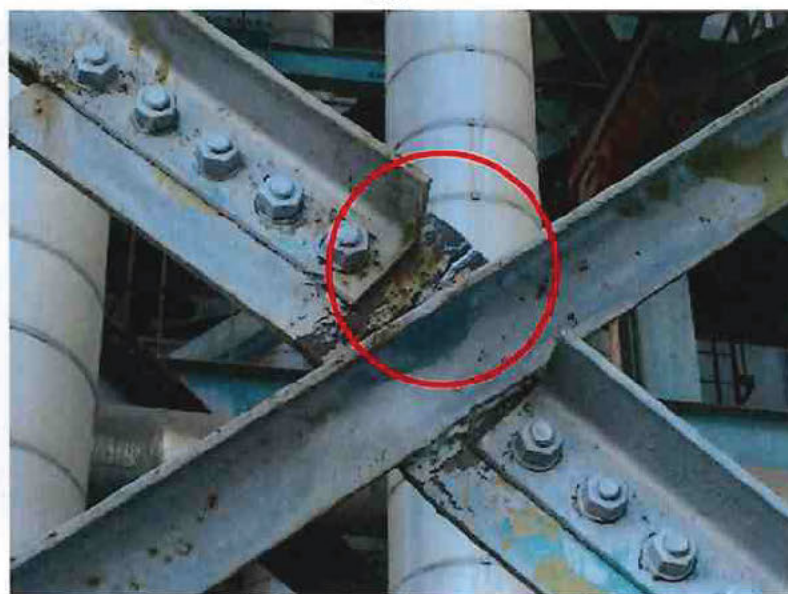
Deaerator Support Structure. Failed cross-braces. Increased risk of more damage to deaerator support structure during major wind or seismic event.

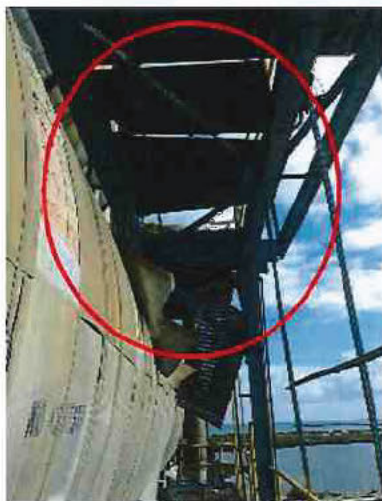
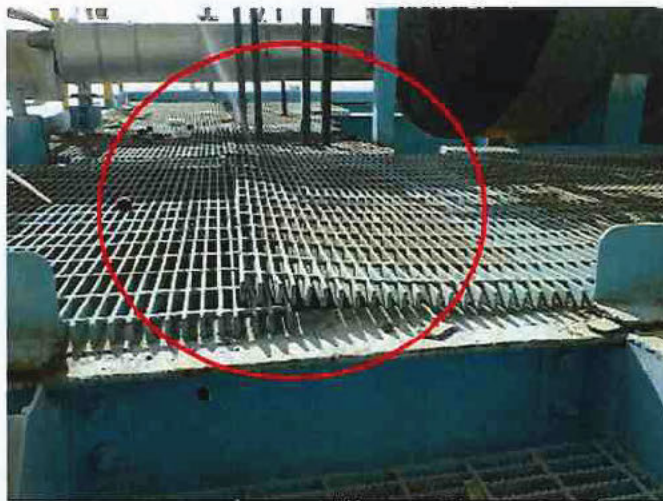
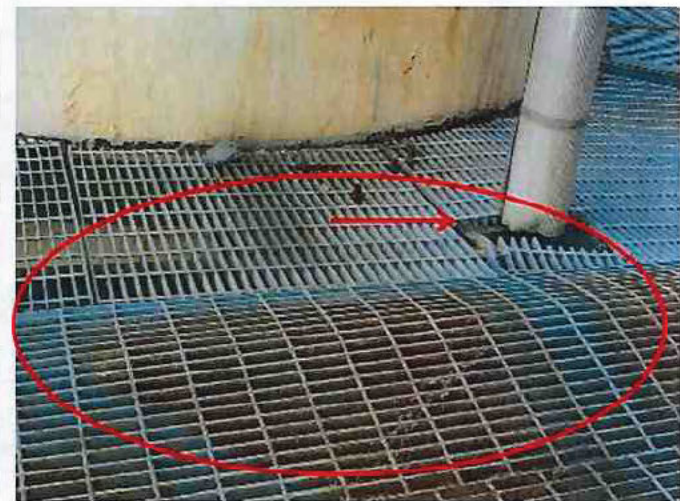
Unit #5 Boiler structural damage

Loose, buckled and missing grating is unsafe to plant personnel

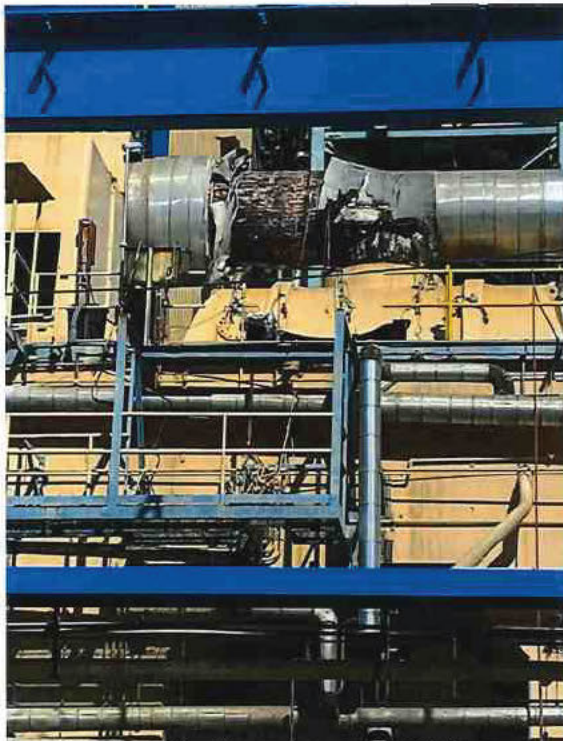
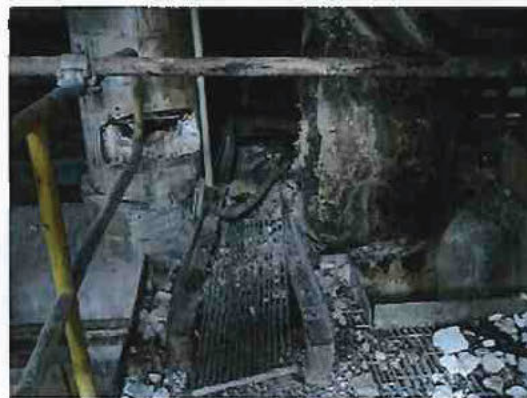
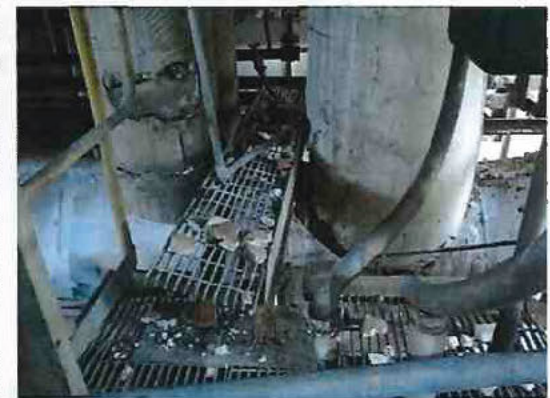
Insulation and refractory material compromised

**Insulation and refractory material
compromised and broken down in various
pipes, duct walls, conduits and boiler walls.**

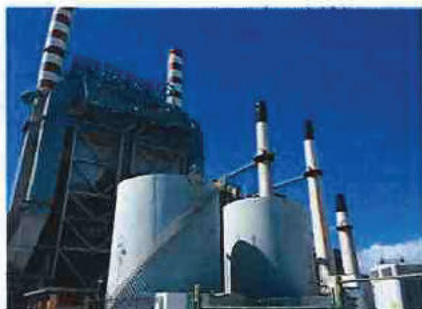
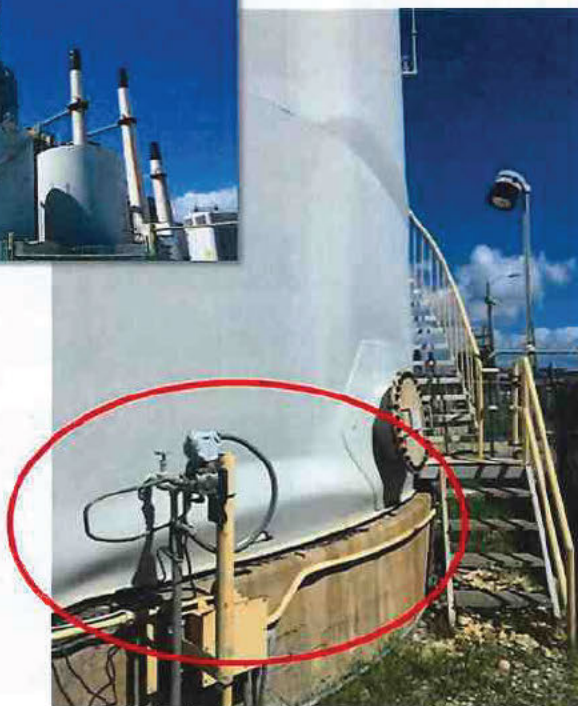
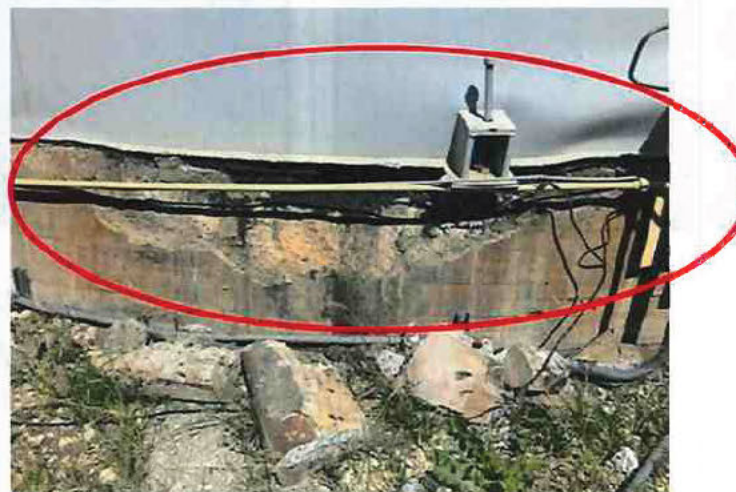
Units 5 & 6 Condensate tank damages

Damaged foundation and buckled tank

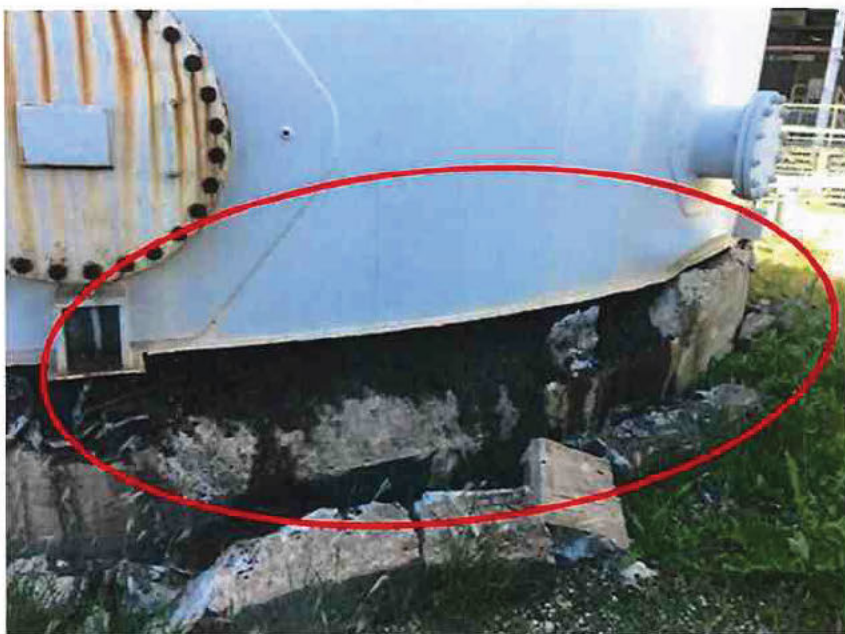
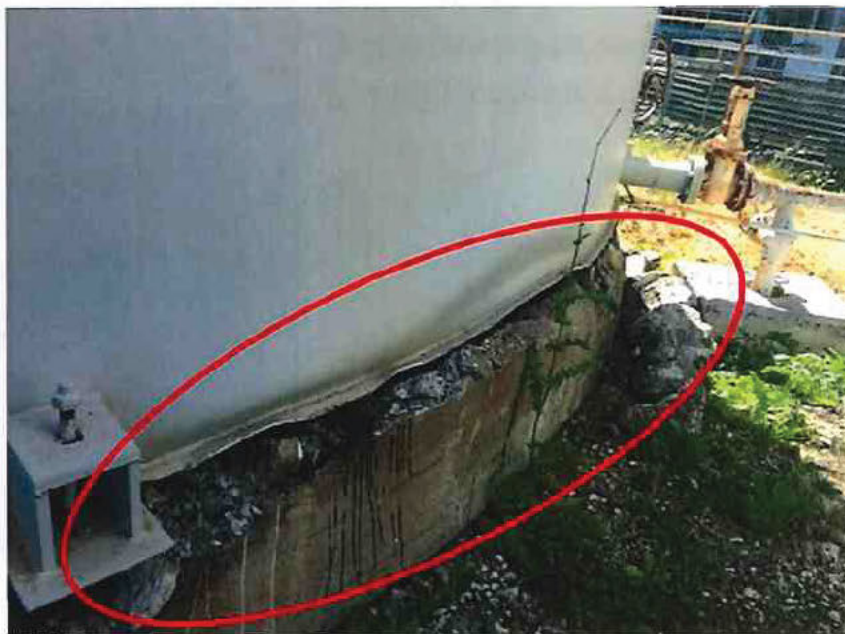
Units 5 & 6 Condensate tank area

Damaged foundation and buckled tank

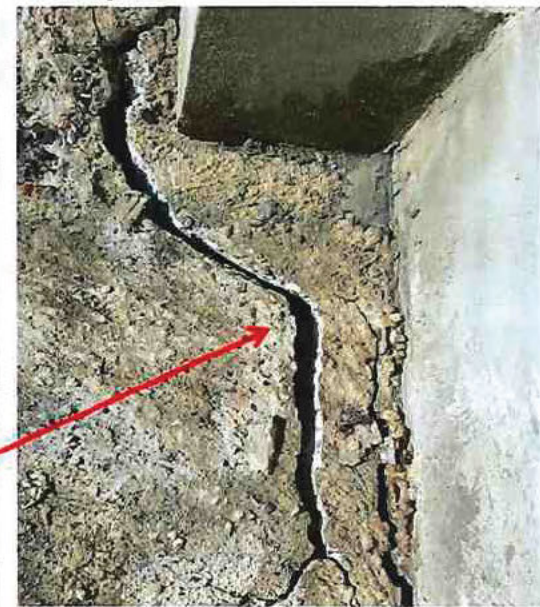
Costa Sur discharge channel structure damaged

Sheet pile displaced two inches
from wall.

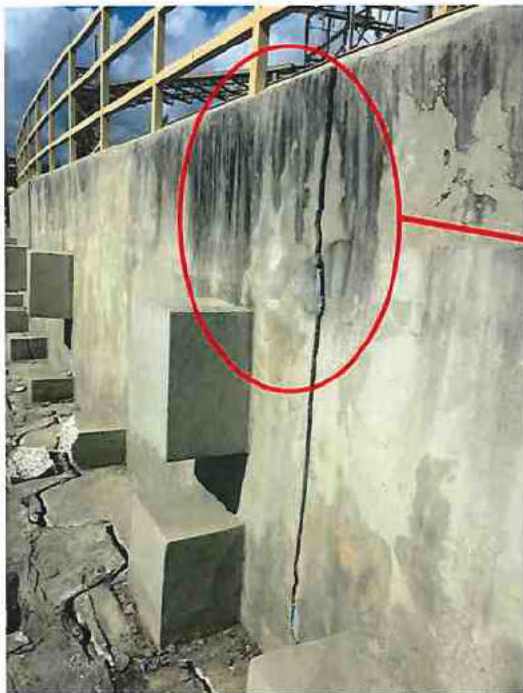
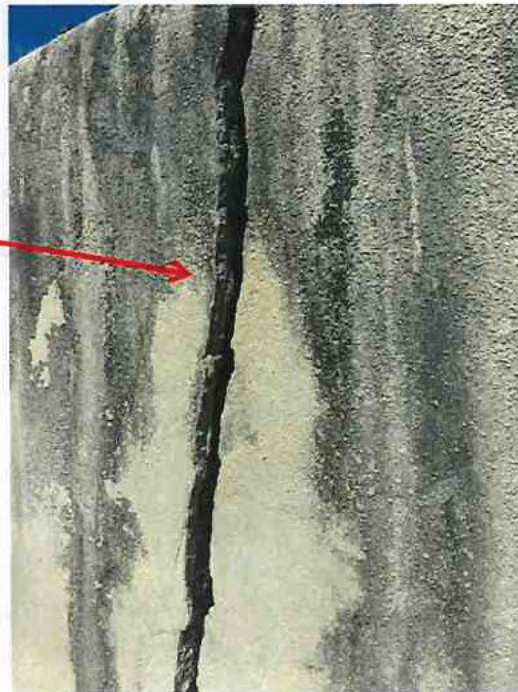
Costa Sur discharge channel structure damaged

20 ft wall segment with structural damage. Structural cracks form top to bottom on cold joints at both ends.

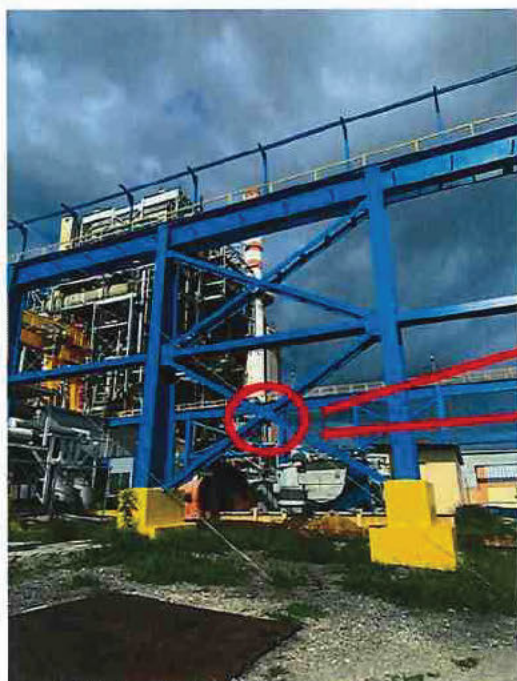
Overhead gantry crane support structural damage

Bracing members on the lower level show excessive deformation on the East side of the structure. On the extension overhead crane structure, the bracings (on both sides) of the lower last segments show bending on the bracing plate connections.

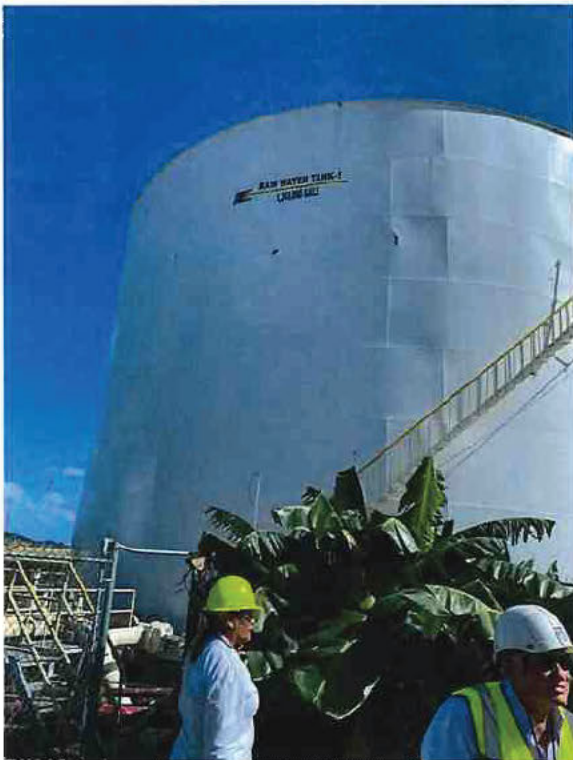
Raw Water Storage Tank

Foundation damage with
differential settlement

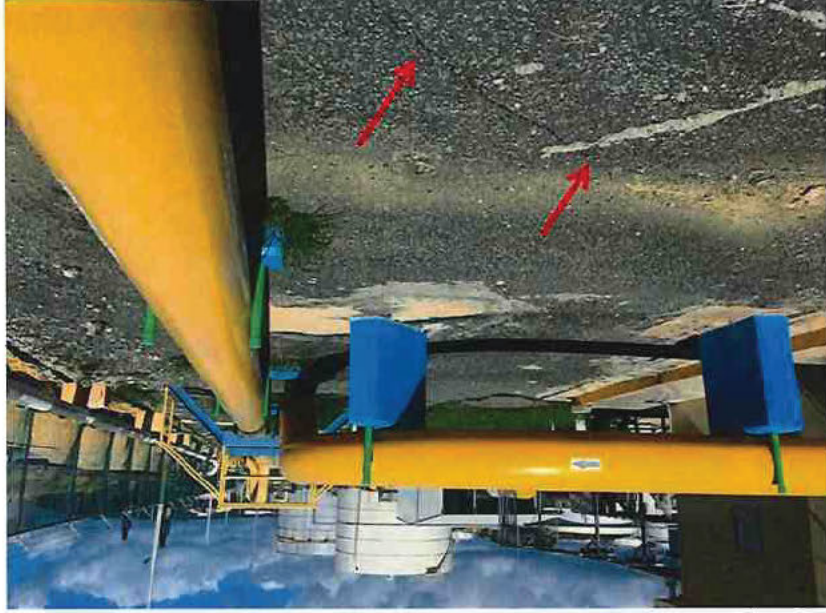
Major crack under gas metering station area

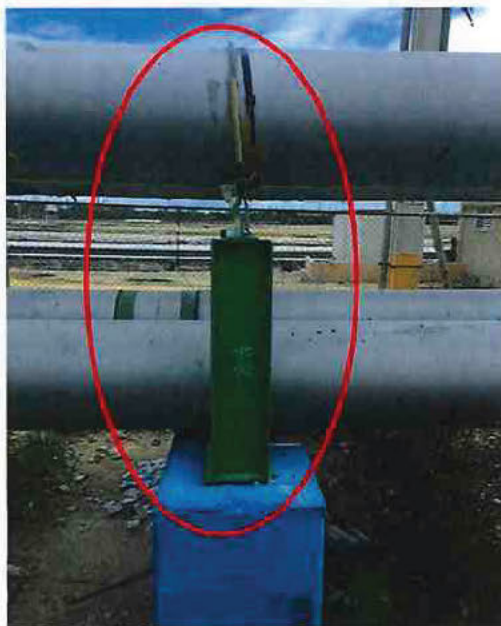
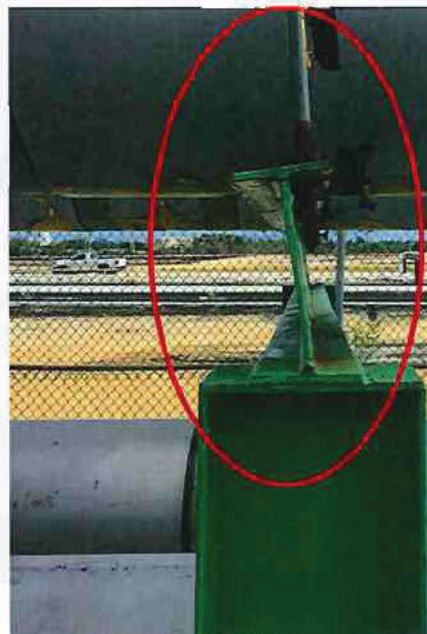
Gas pipeline structural support damage

Displacement of gas pipeline, bending of top beam, columns and U-bolts

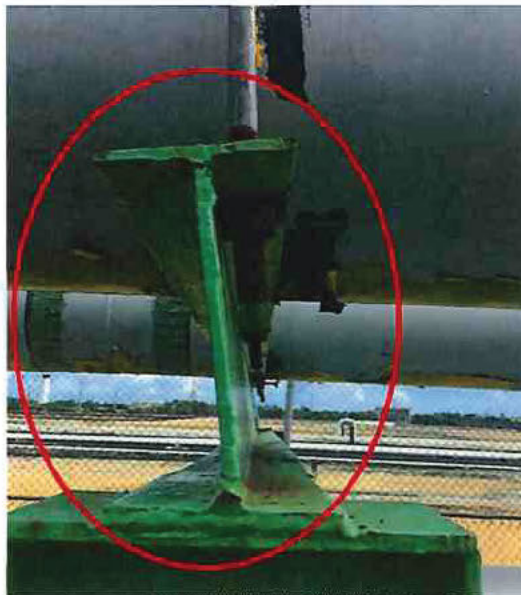
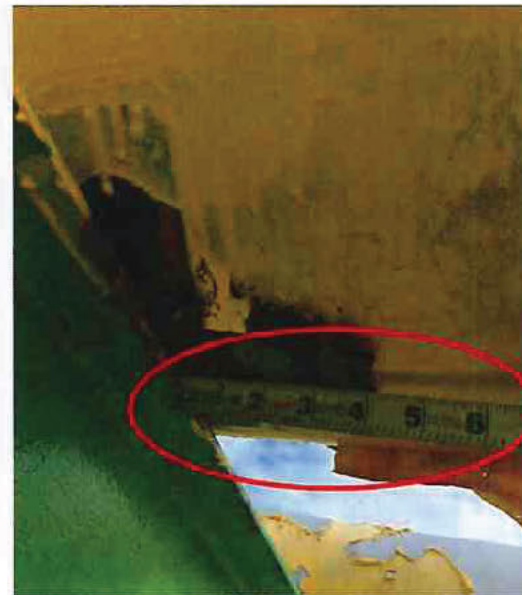
Displacement of gas pipeline, bending of top beam, columns and U-bolts

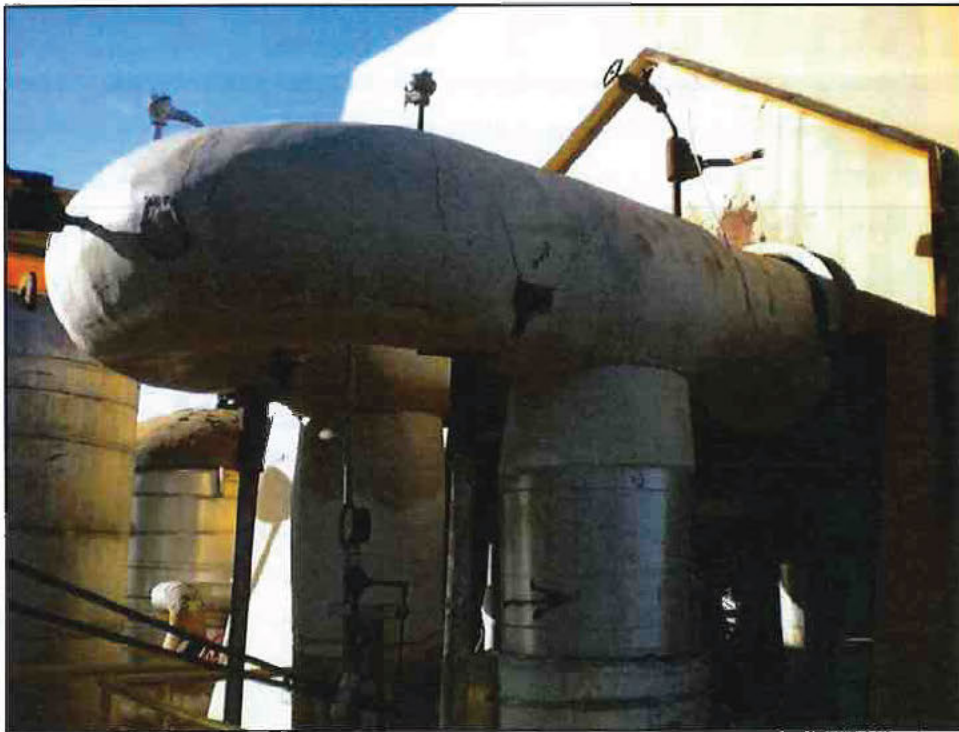
Photo 3 - Main Steam Crossover Tees (U-6 shown)

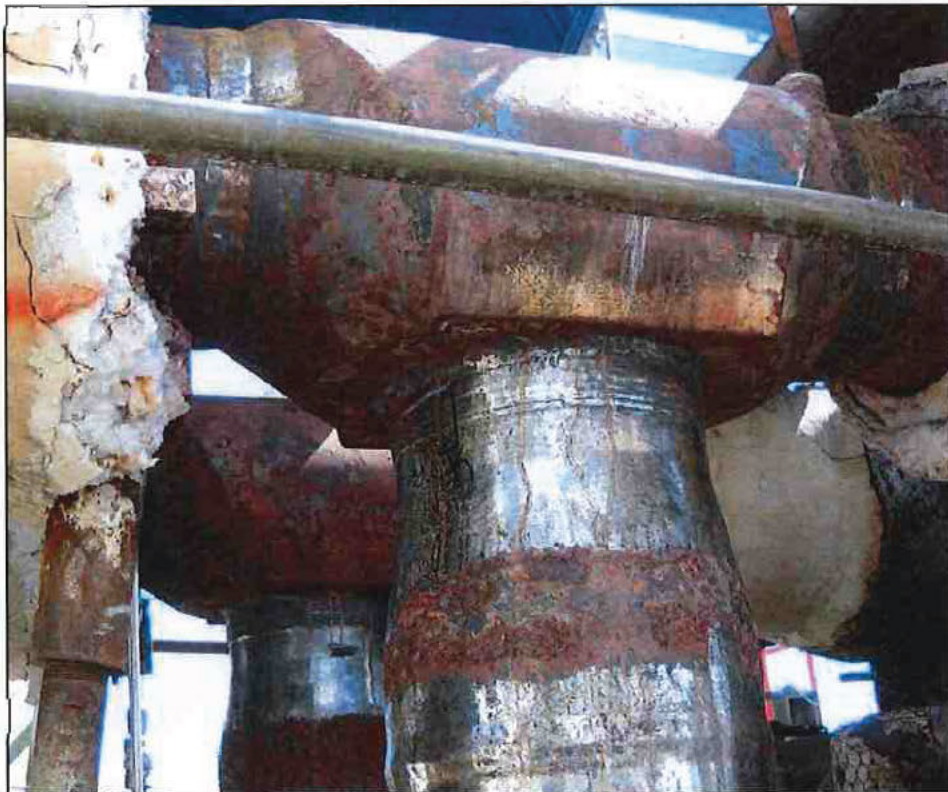
Photo 4 - Crossover Tee Weld Repairs (Archive Photo)

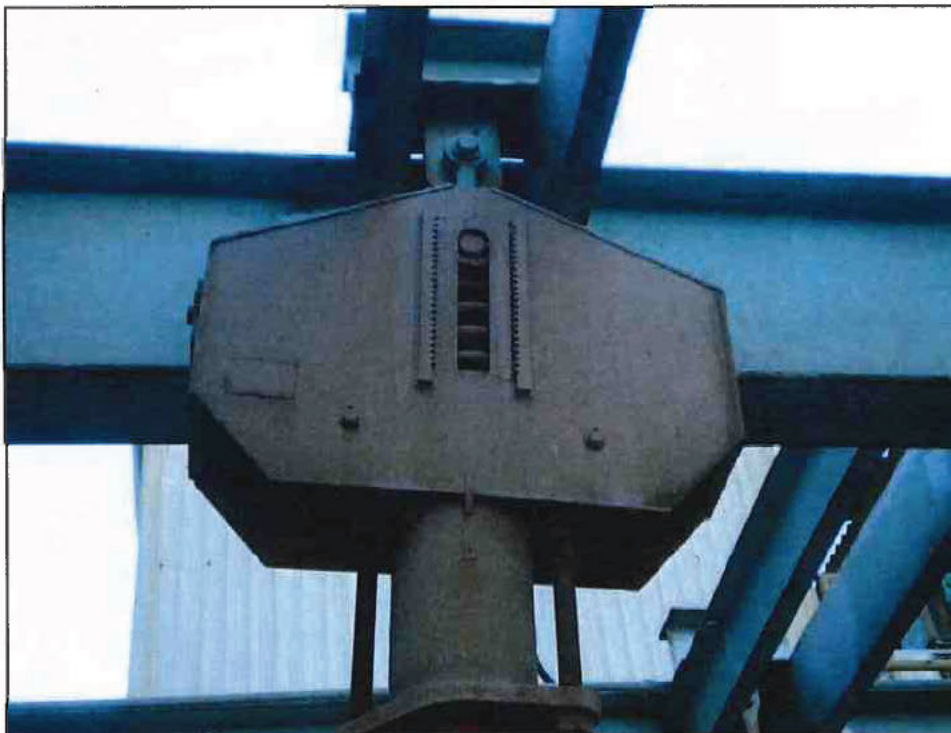
Photo 6 - U-5 Hot Reheat Hanger HR-13

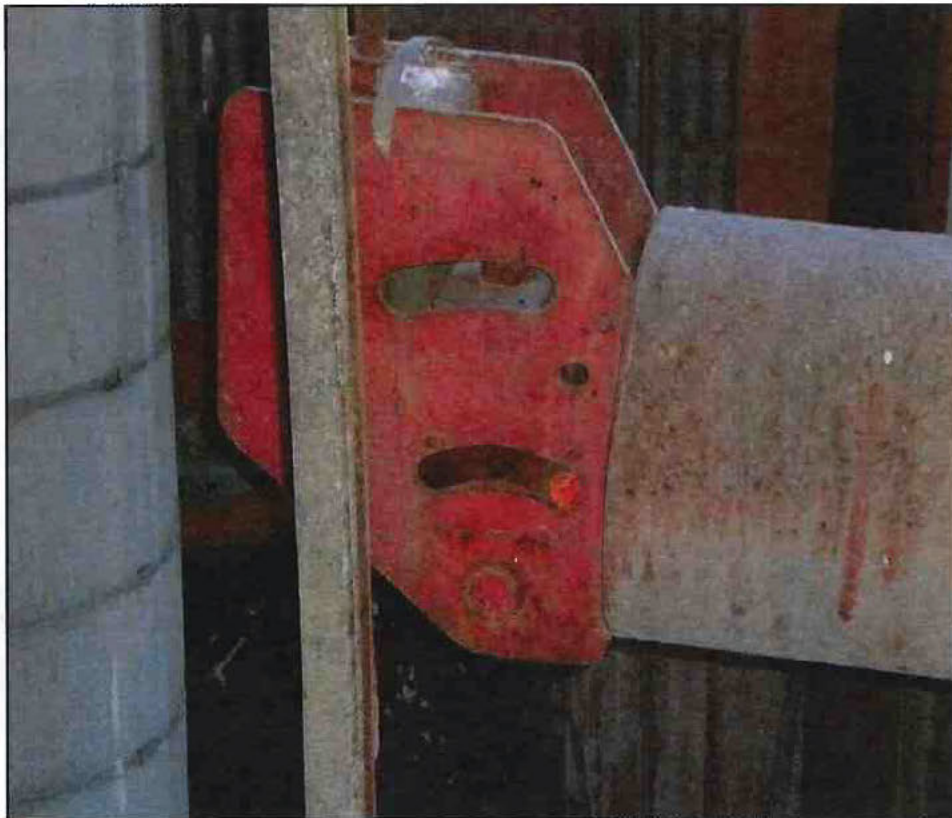
Photo 9 - U-5 Topped out Hanger CR- 15

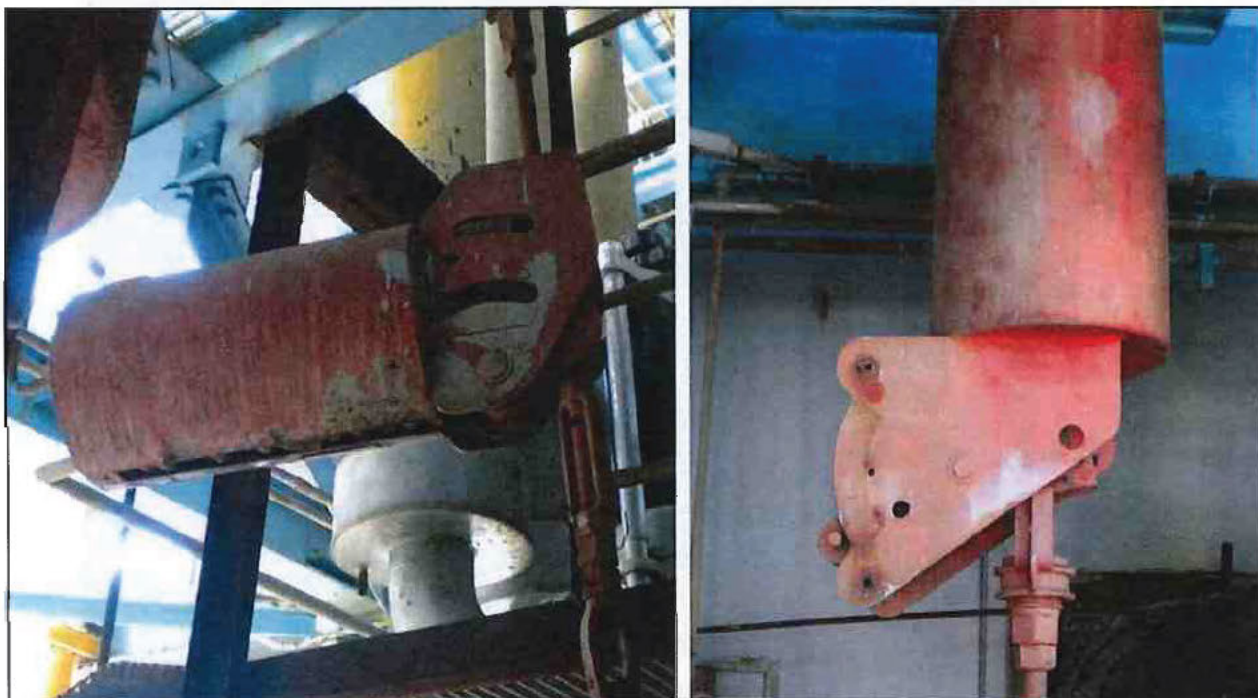
Photo 10 - U-5 Boiler Feed Hangers BF-1 and BF-2

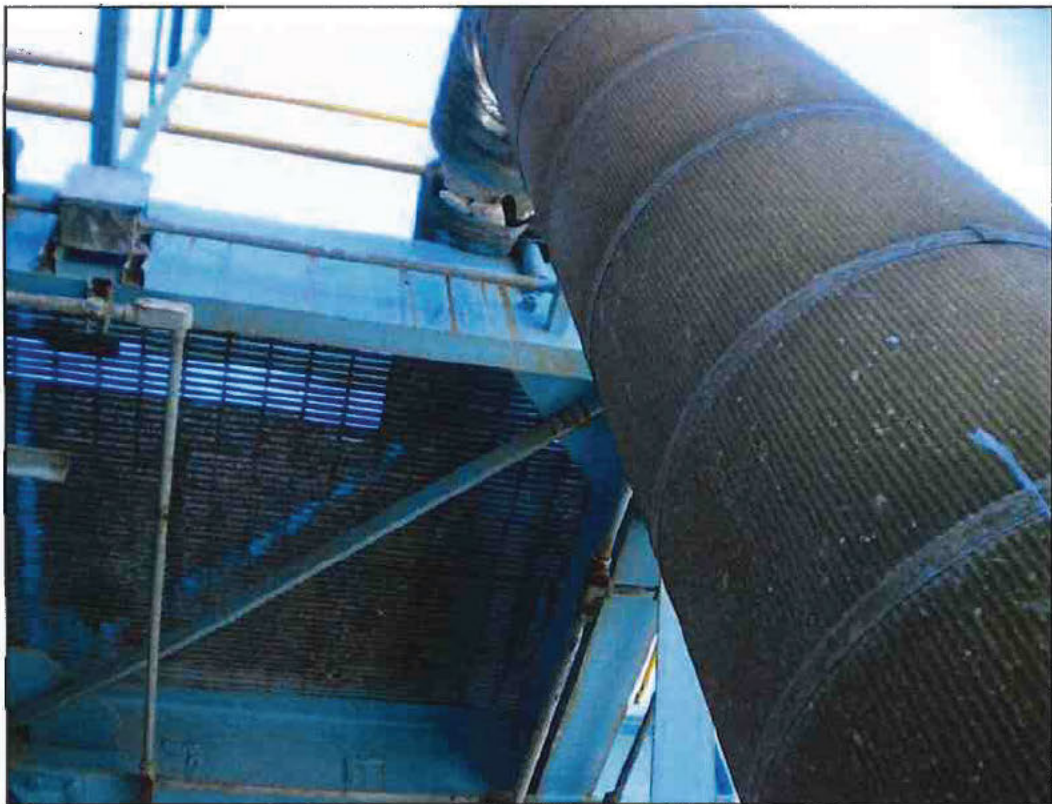
Photo 16 - U-5 Condensate Piping to Deaerator

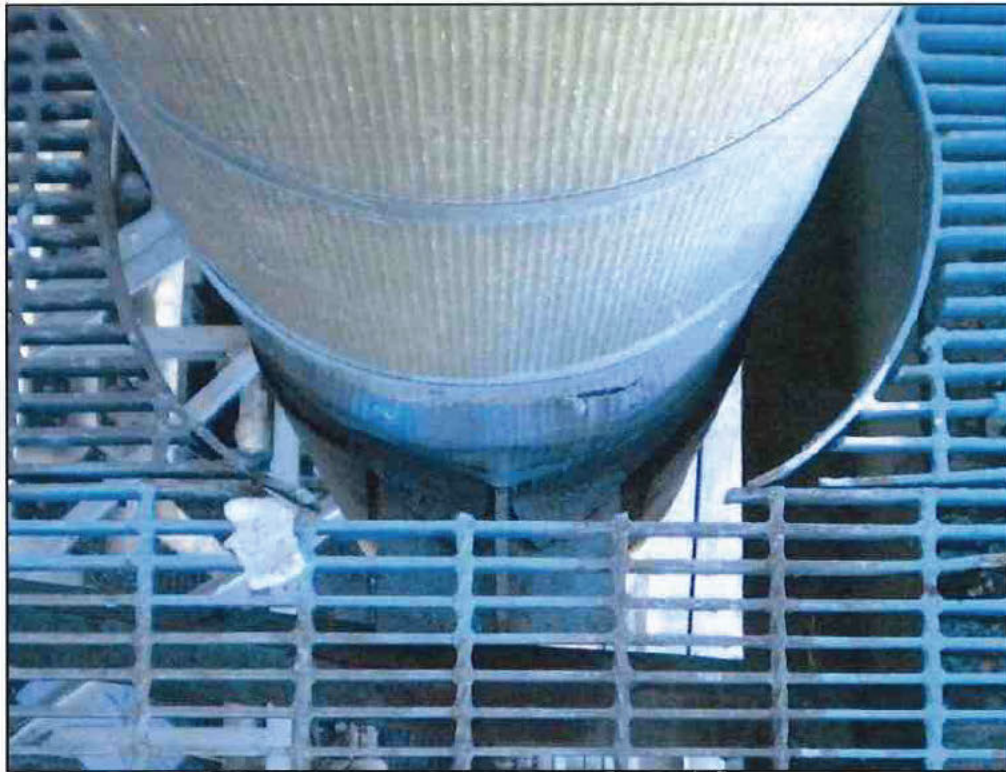
Photo 17 - U-5 Condensate Riser Support

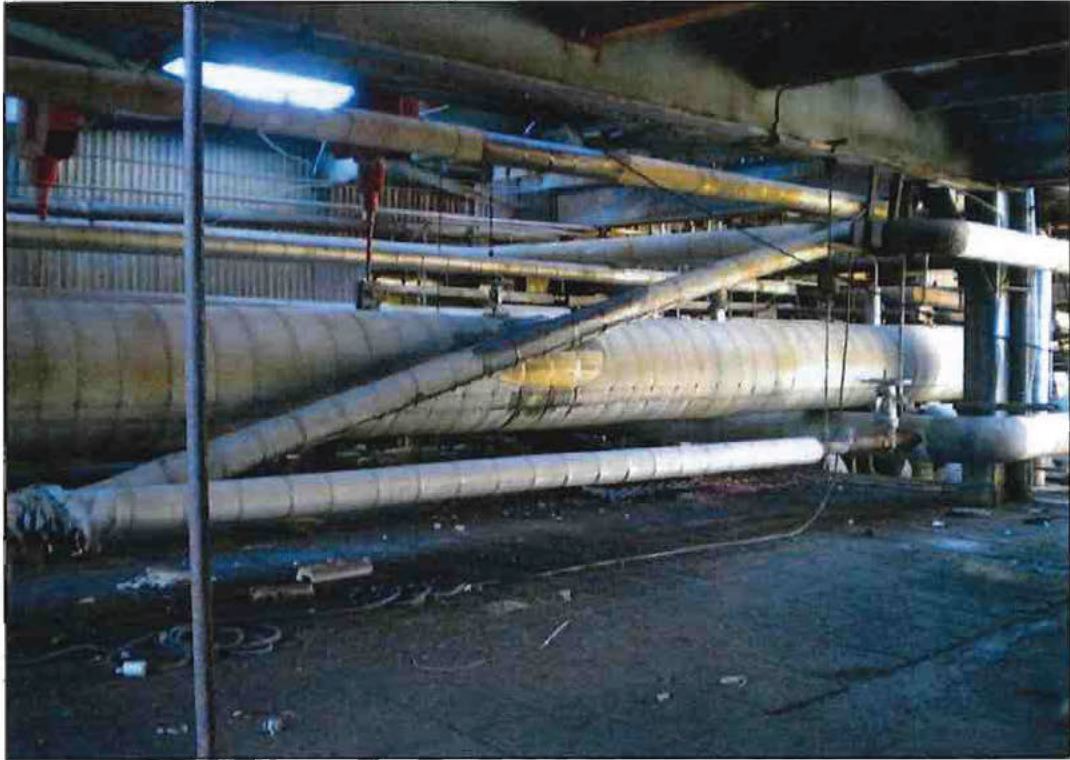
Photo 19 - U-5 Unidentified Line next to Cold Reheat

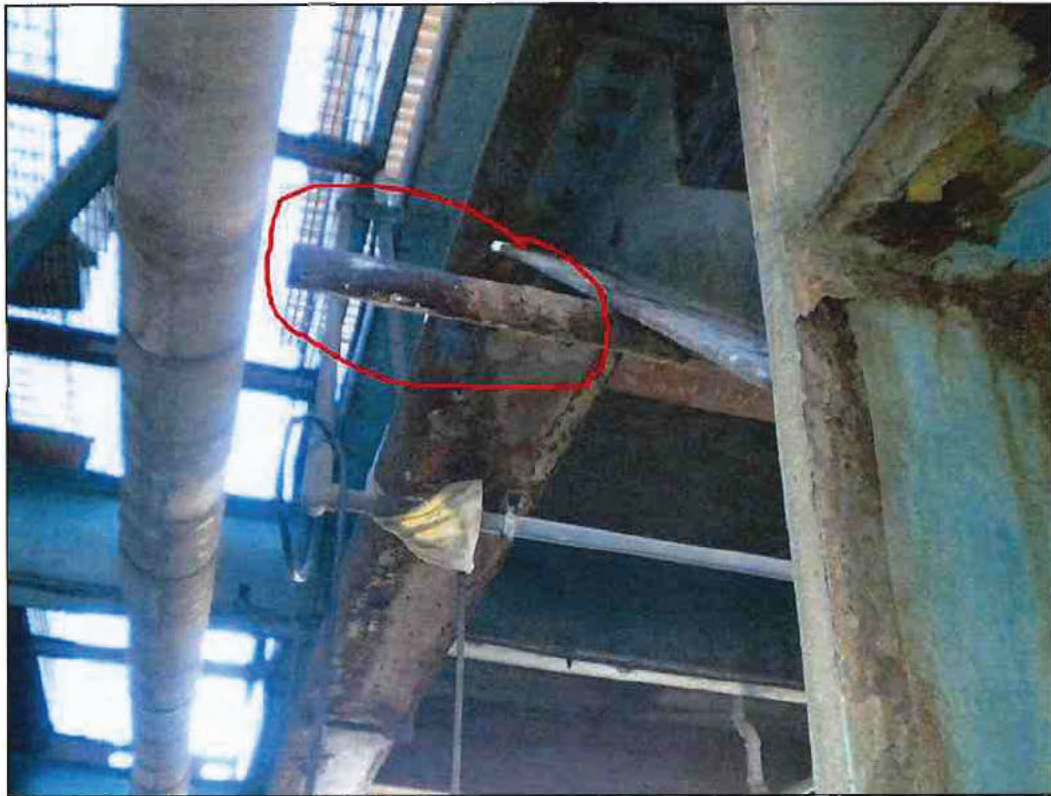
Photo 20 - U-5 Unidentified Line Support
