**REQUEST FOR PROPOSALS FOR
TEMPORARY EMERGENCY
GENERATION**

NEPR-AP-2020-0001

**SUPPLEMENT TO NOTIFICATION AND URGENT REQUEST
FOR APPROVAL OF REQUEST FOR PROPOSALS FOR
TEMPORARY EMERGENCY GENERATION**

COSTA SUR RECOVERY PROJECT REPORT

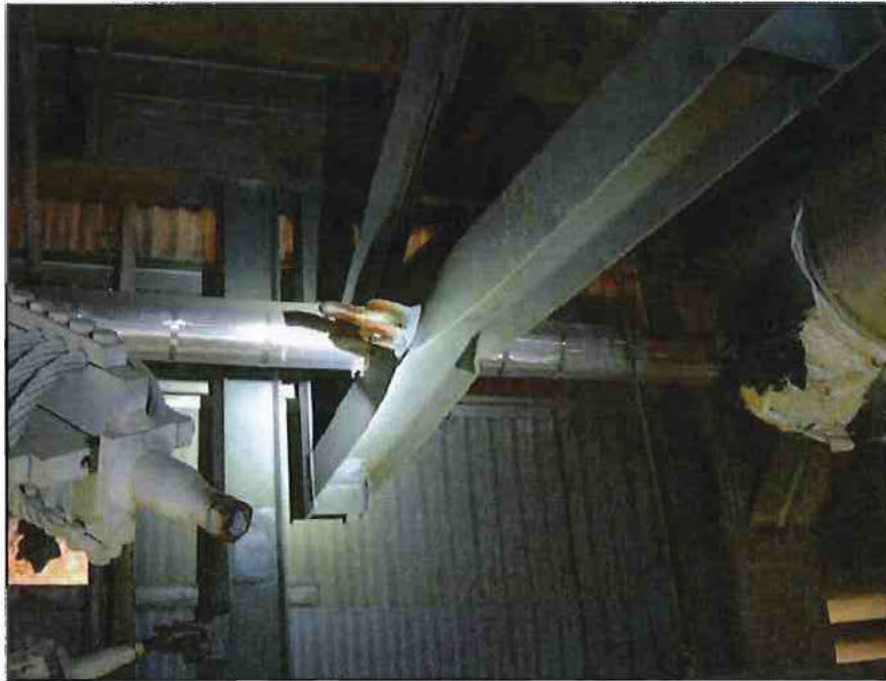
Photo 21 - U-6 Failed Steel and WEAR Restraint WR-9

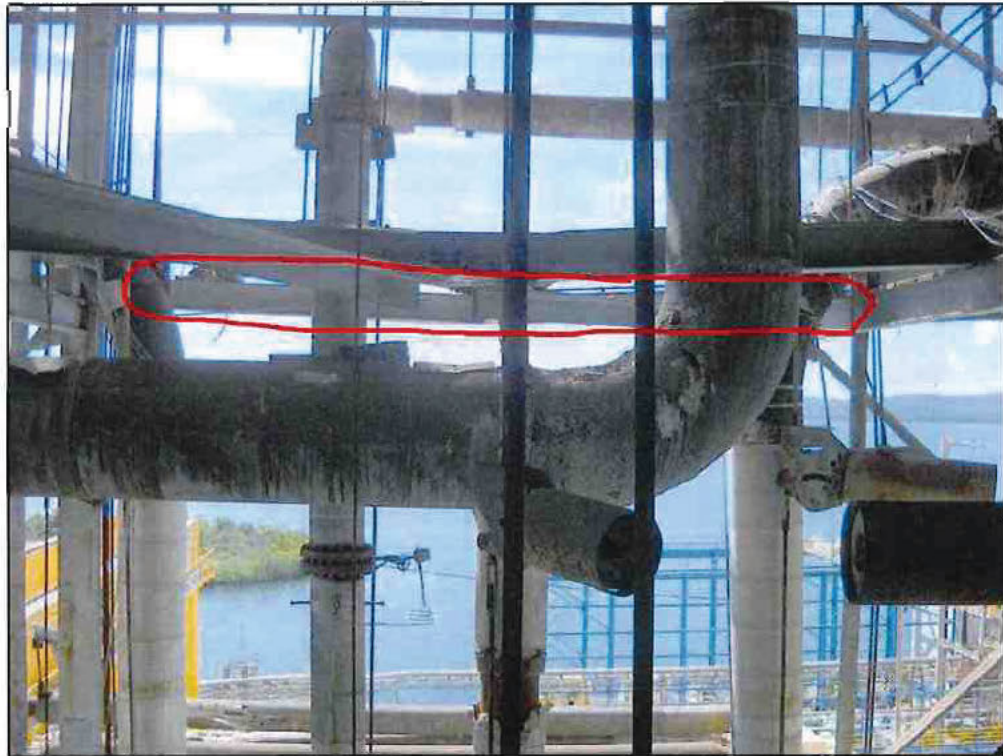
Photo 27 - U-6 Bent Beam that Supports the Hot Suction Riser

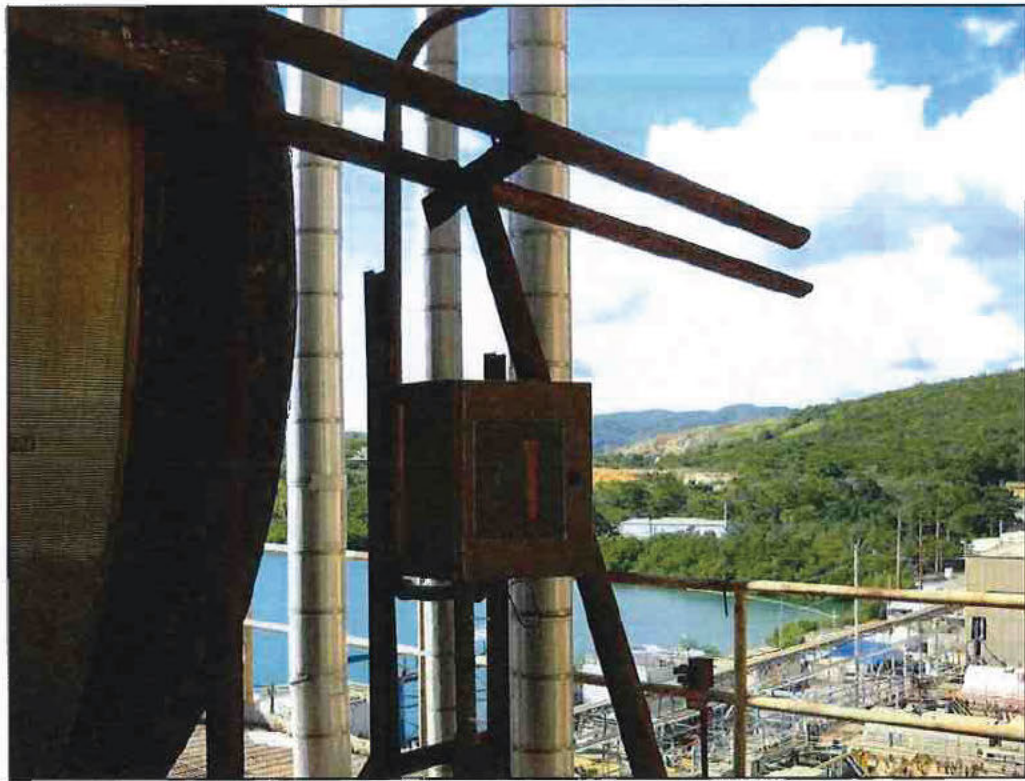
Photo 29 - U-6 Hot Suction Bottomed Out Spring

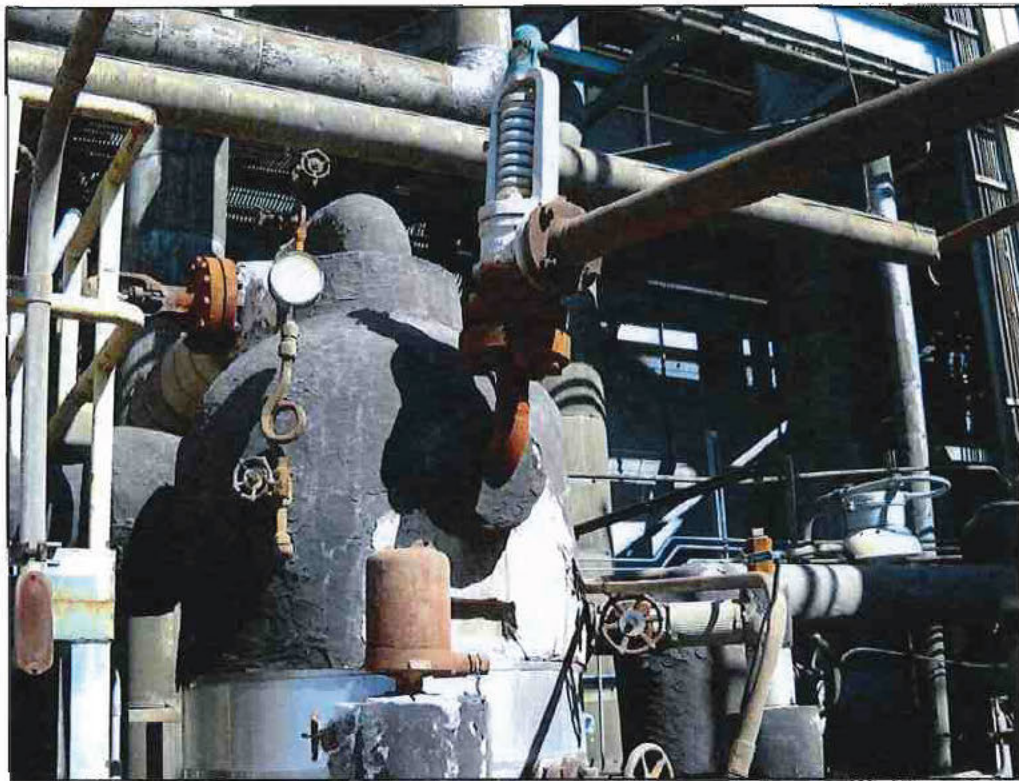
Photo 30 - U-6 HP Flash Tank SRV Discharge

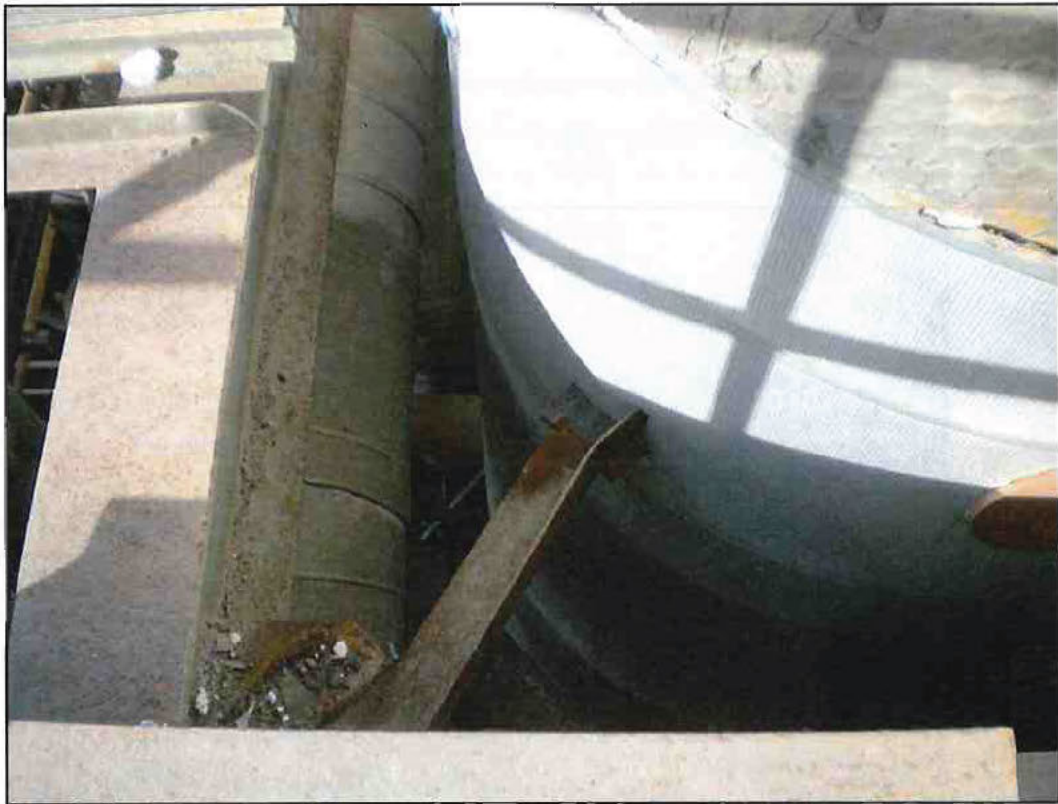
Photo 35 - U-6 Bent Heater 6 Lateral Restraint

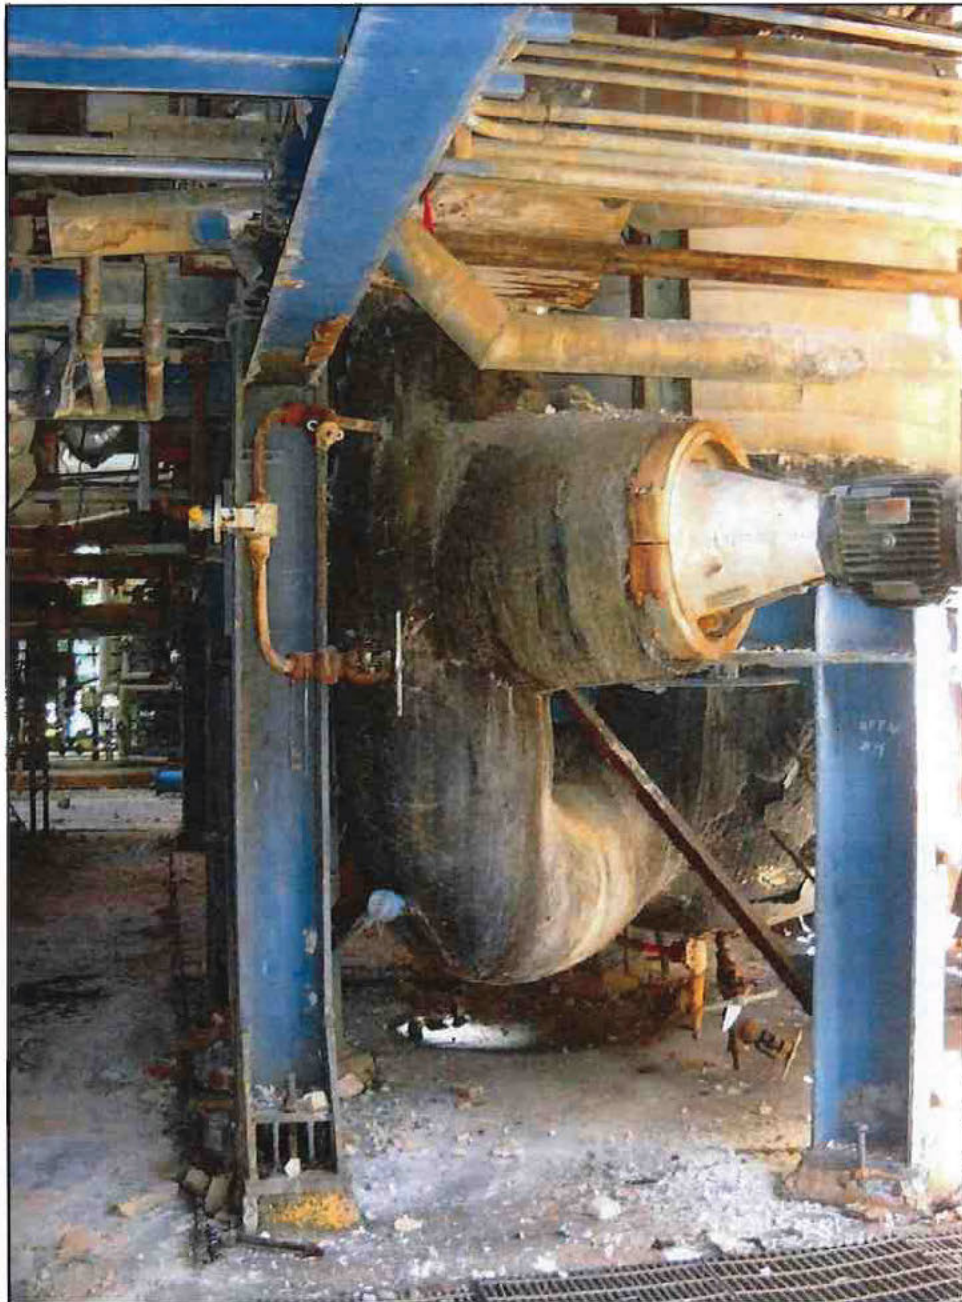
Photo 37 - U-6 Heater 7 Typical Support Leg (Right Side)

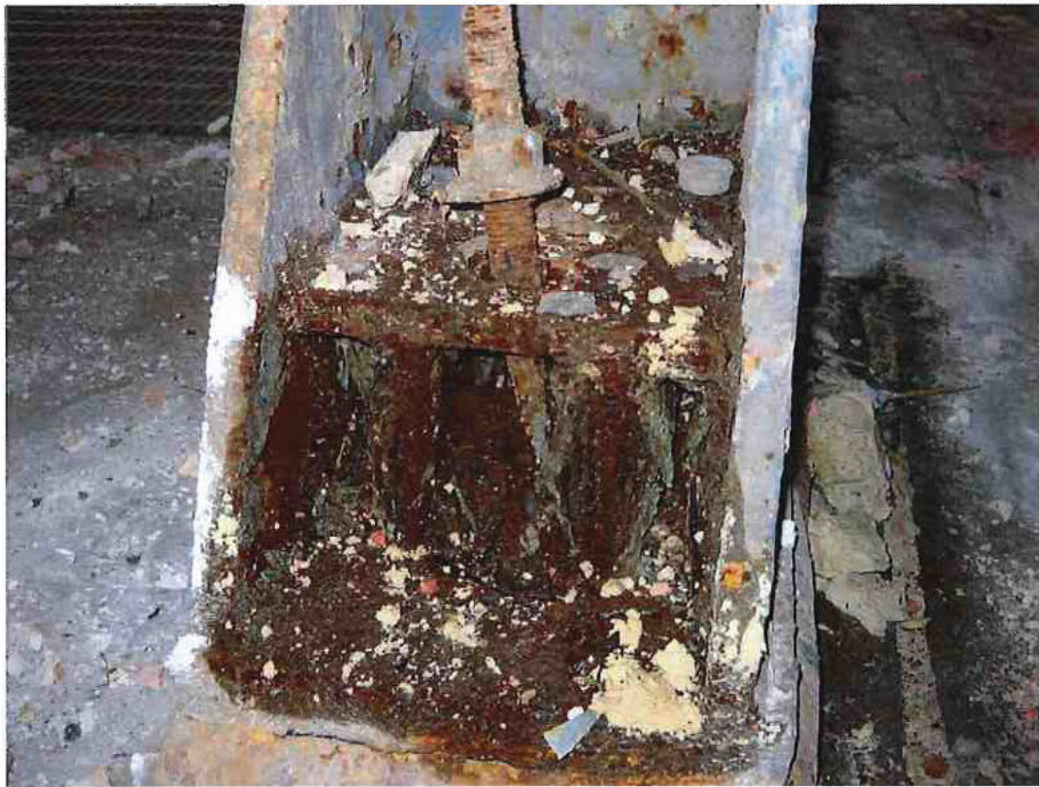
Photo 38 - U-6 Heater 7 Support Leg Base

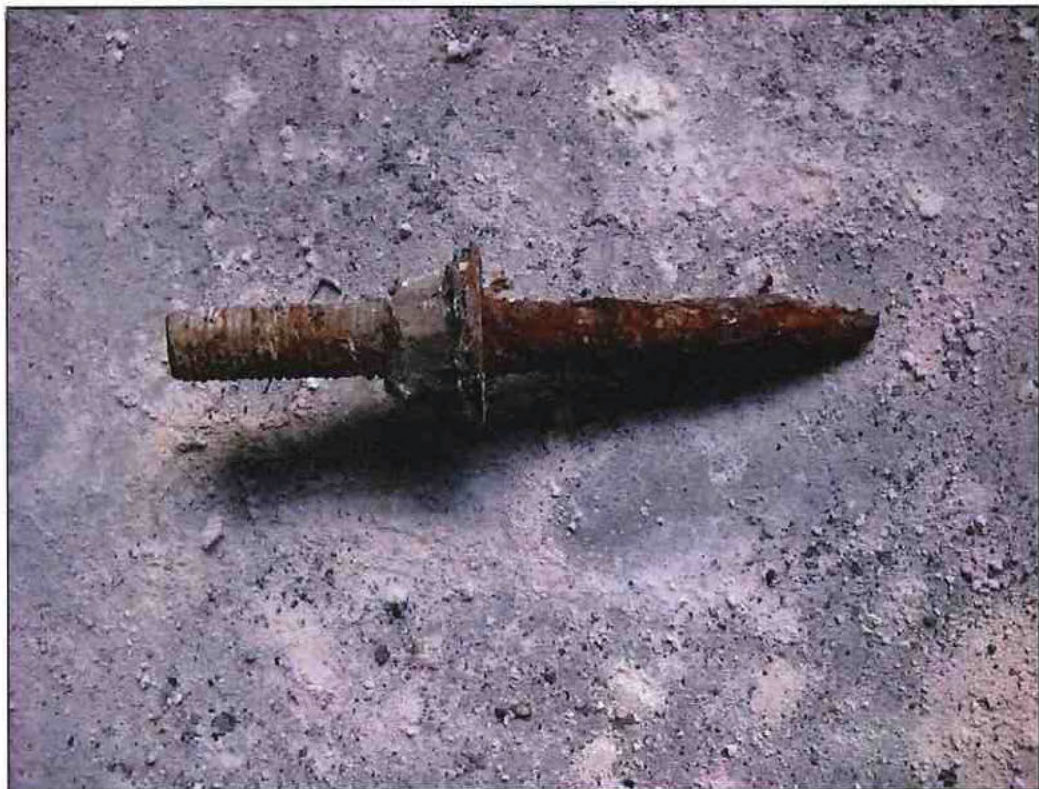
Photo 39 - U-6 Heater 7 Structural Support Leg Anchor Bolt

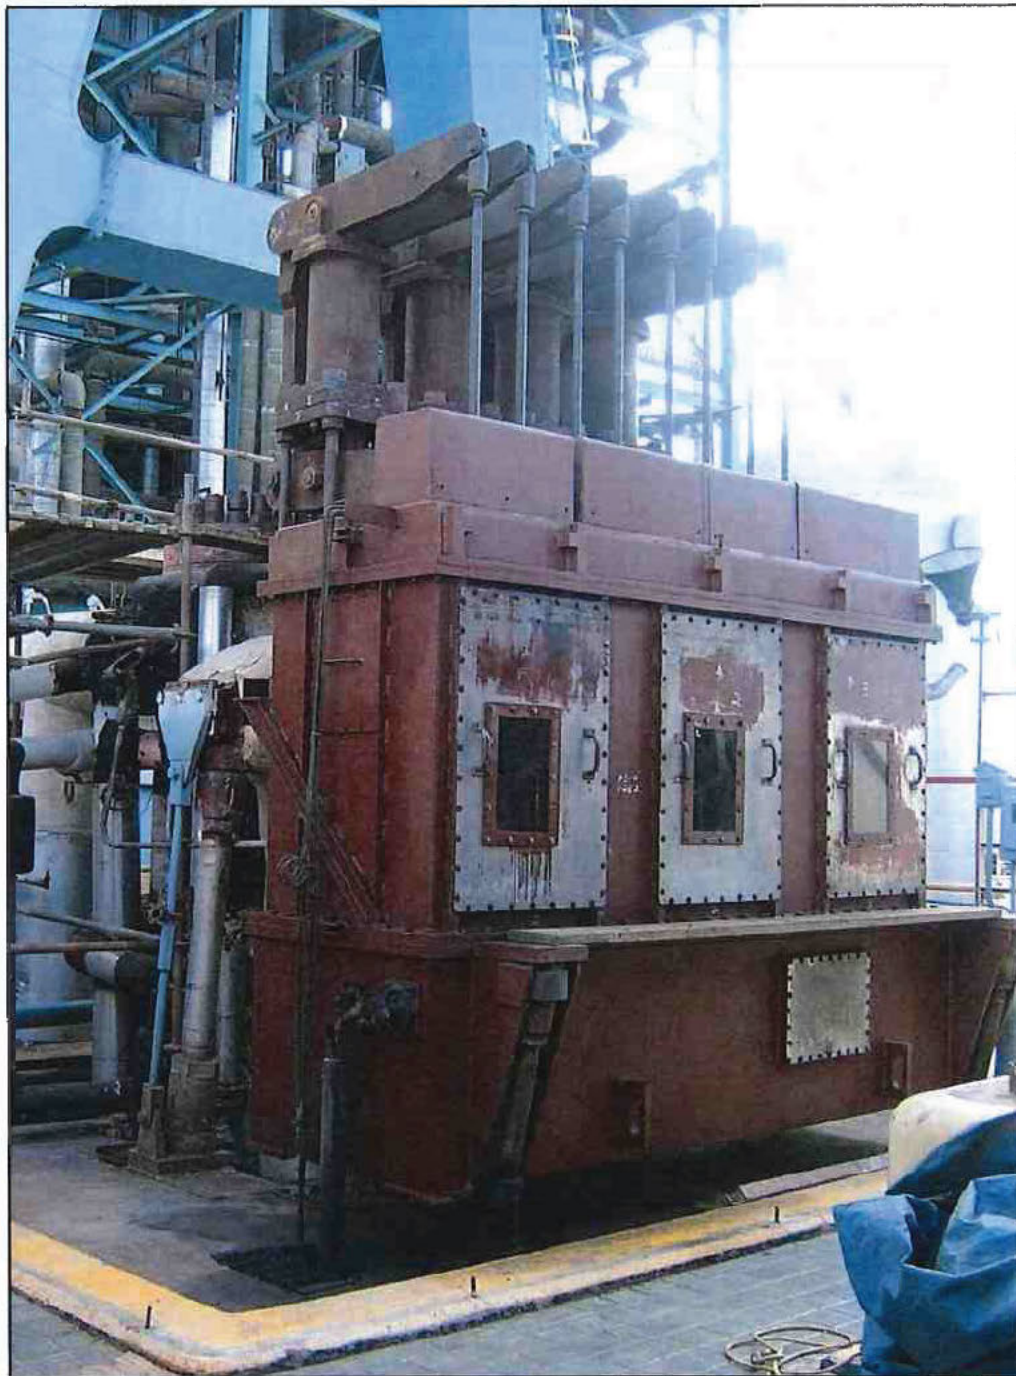
Photo 40 - U-6 Main Steam Control Valve Actuator Assembly
(Archive Photo prior to 2009 Steam Chest Stabilizing Restraint Modification)

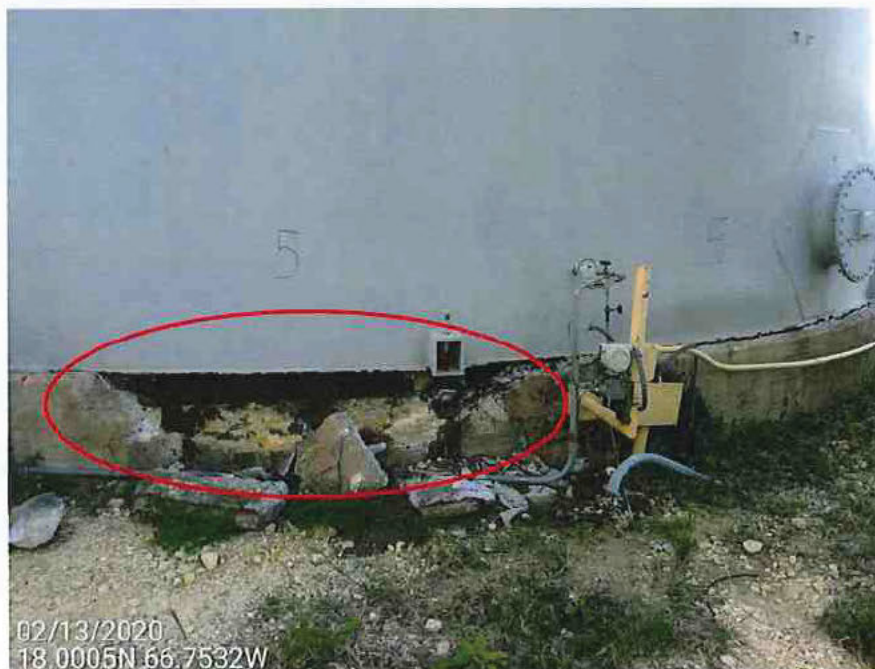
Picture 3 – Foundation concrete base and shell support ring crushed, due to seismic overturning moment.

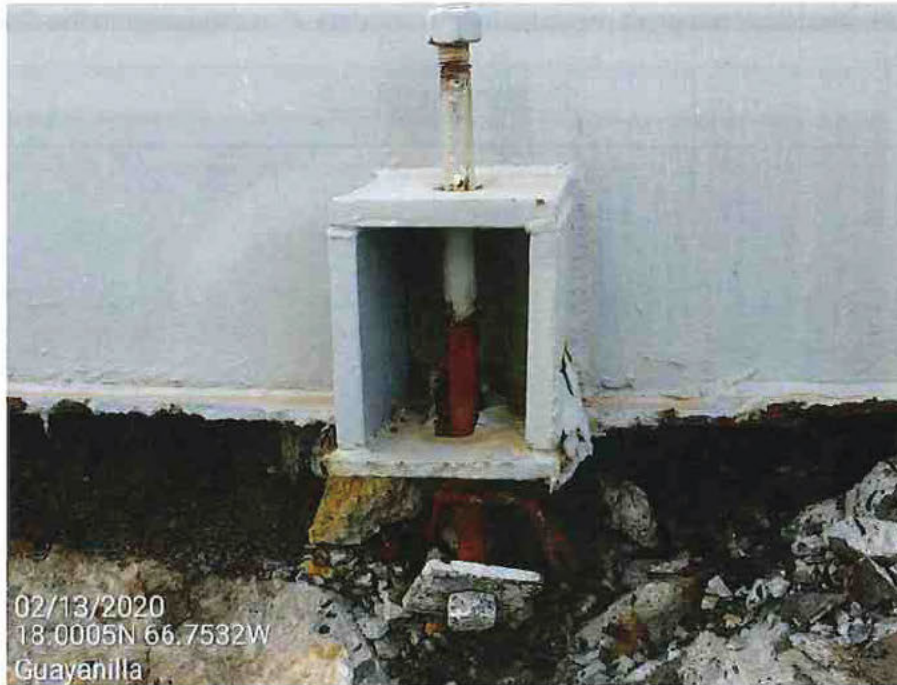
Picture 4 – Anchor bolt ripped off from concrete base, due to seismic overturning forces.

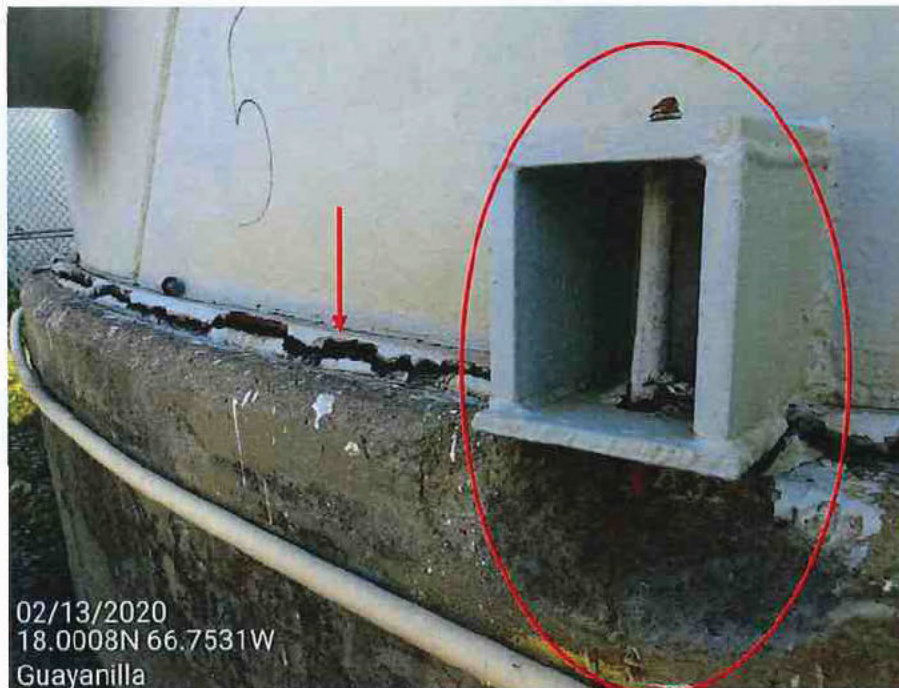
Picture 11 – Tank bottom seal joint cracked and lift from base. Anchor bolt nut and concrete around anchor bolt ripped off, due to seismic overturning moment.

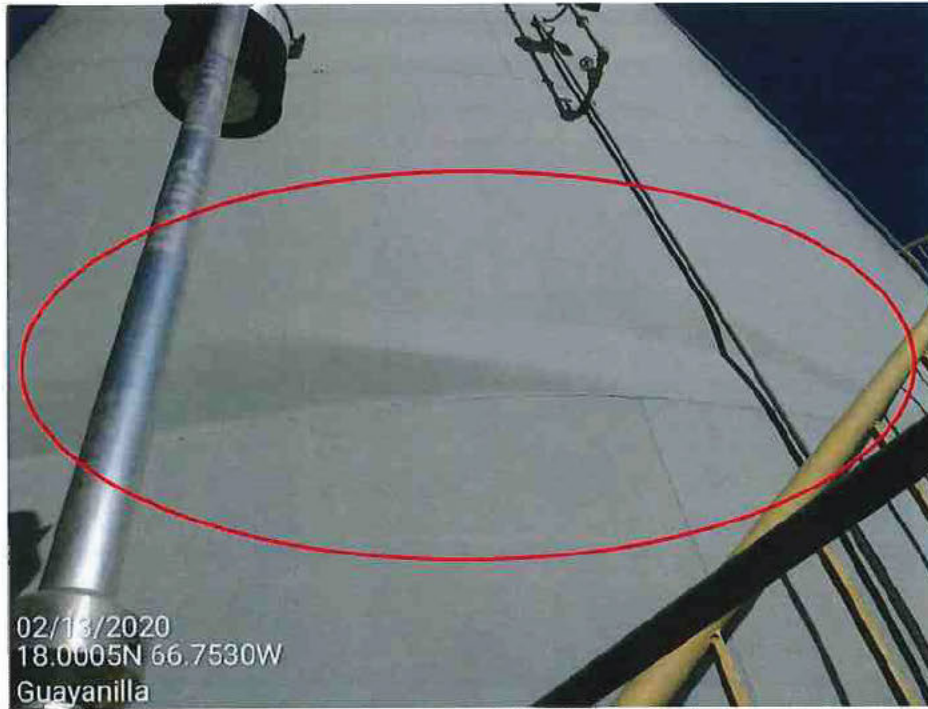
Picture 26 – Tank shell has buckling at second ring, due to seismic overturning moment.

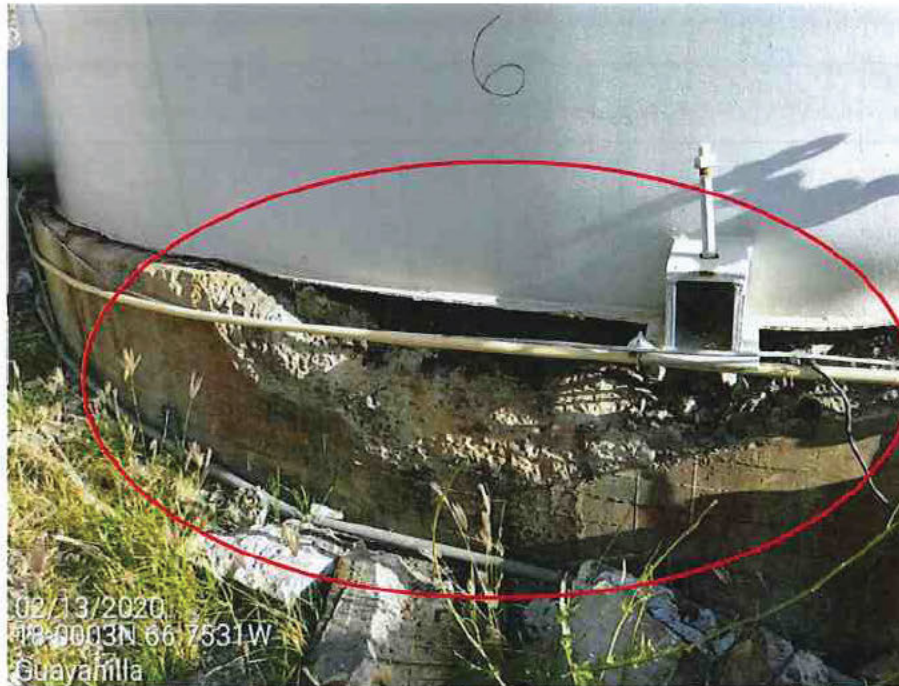
Picture 28 – Foundation concrete base and shell support ring crushed and anchor bolt ripped off from concrete base, due to seismic overturning moment.

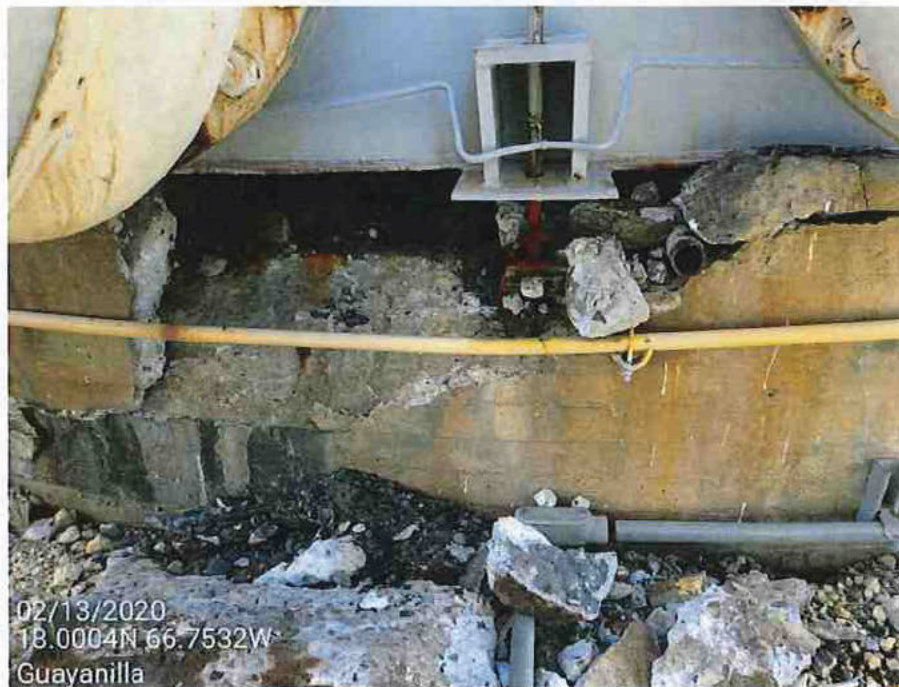
Picture 29 – Foundation concrete base and shell support ring crushed and anchor bolt ripped off from concrete base, due to seismic overturning moment.

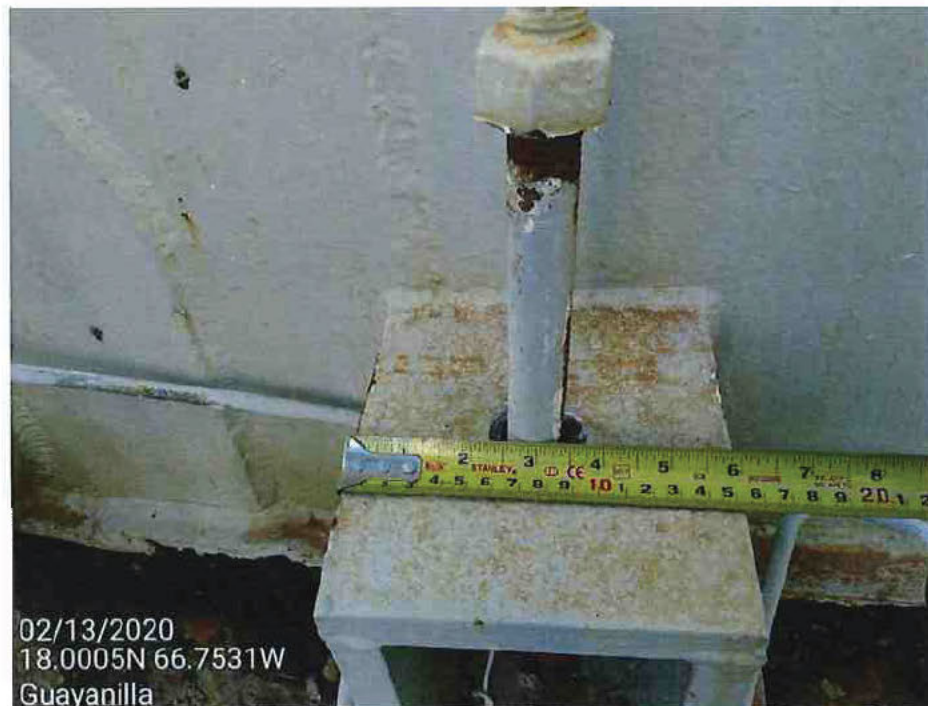
Picture 31 – Anchor assembly chair top plate measurements.

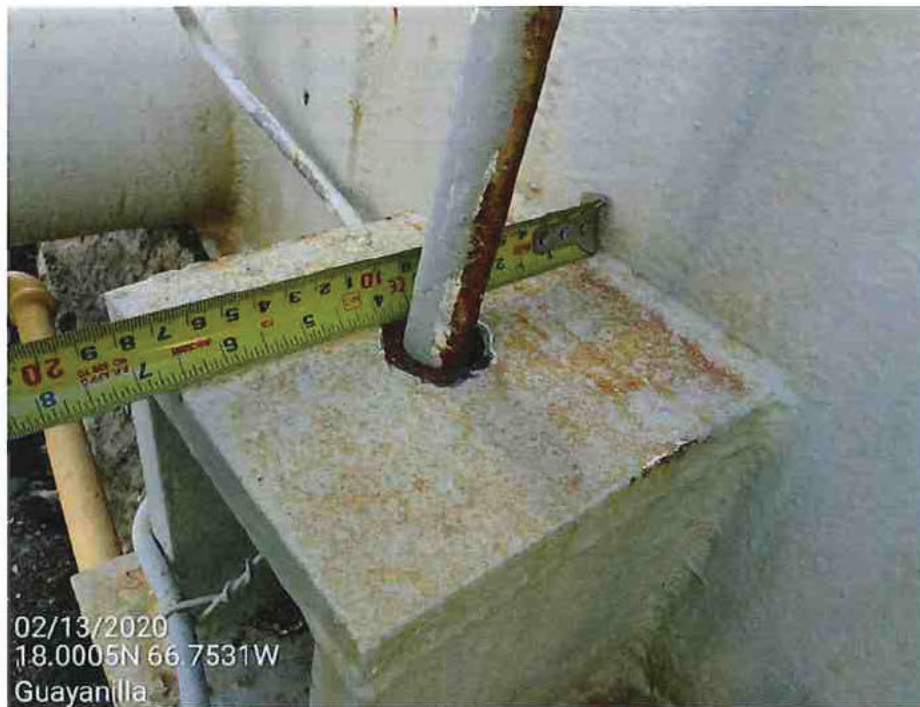
Picture 32 – Anchor assembly chair top plate measurements.

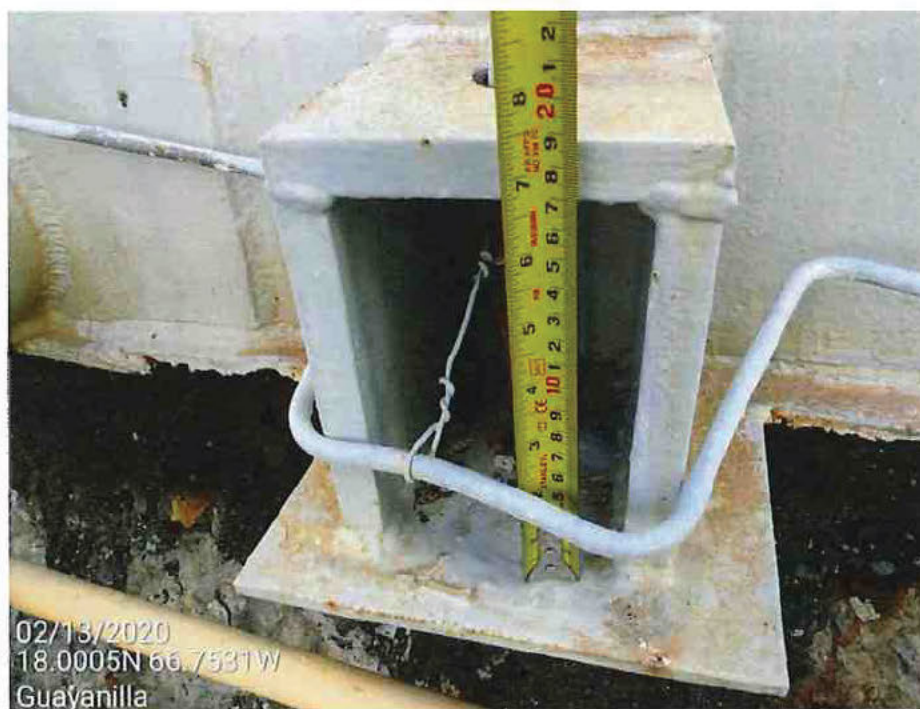
Picture 33 – Anchor assembly chair top plate measurements.

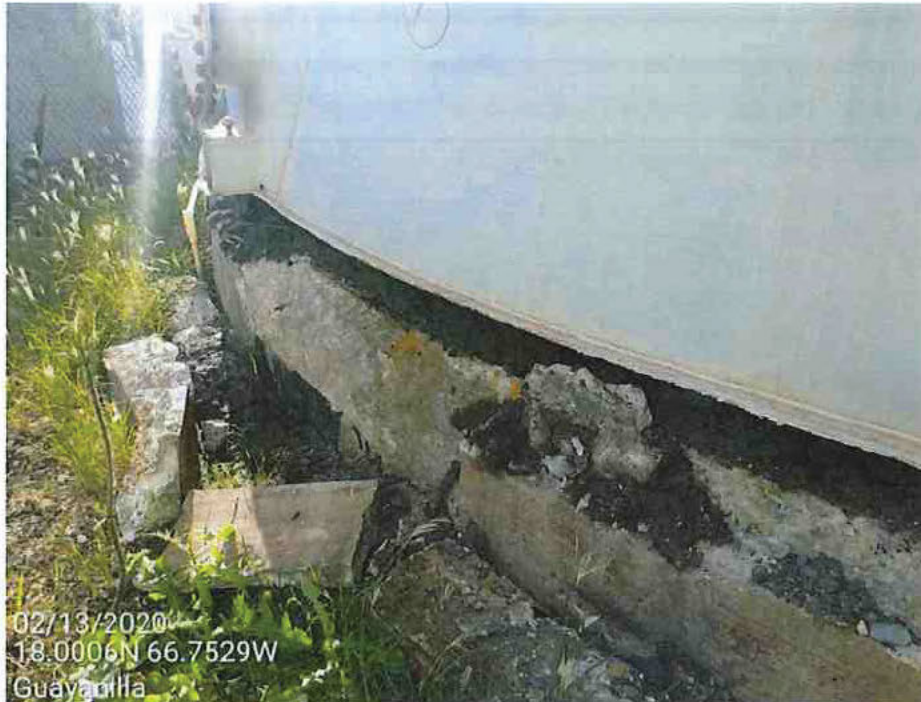
Picture 36 – Foundation concrete base shell support ring crushed, due to seismic overturning moment.

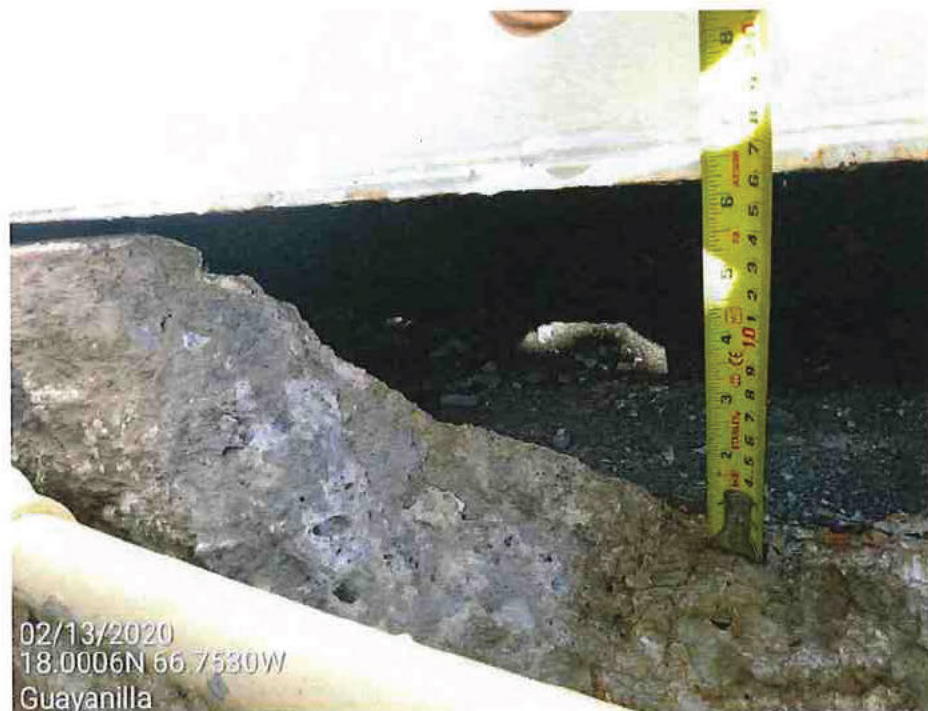
Picture 43 – Concrete shell support ring measurements (6" deep).

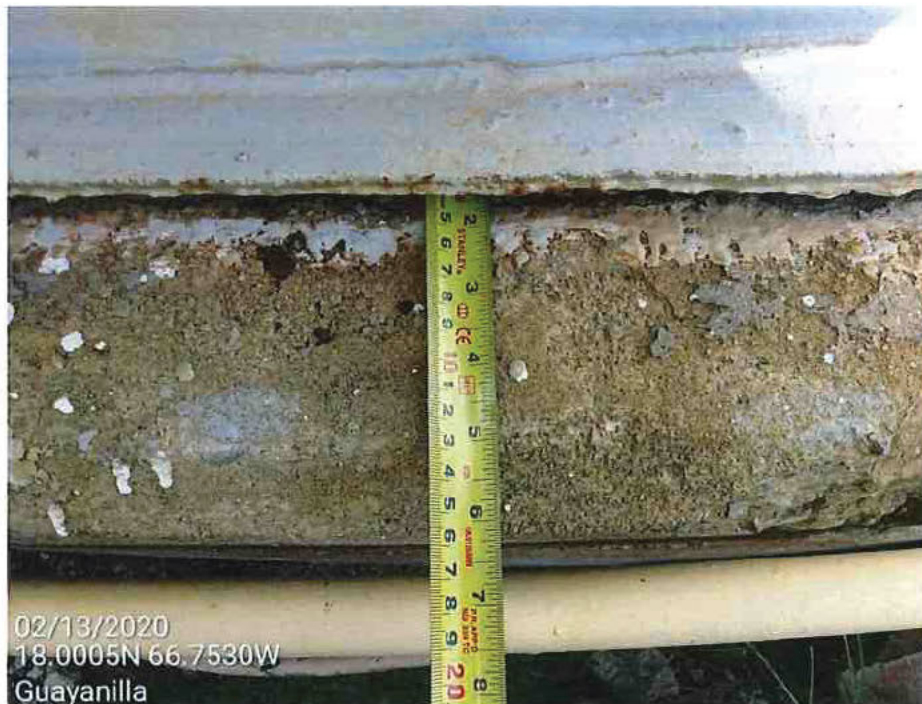
Picture 44 – Concrete shell support ring measurements (6" wide).

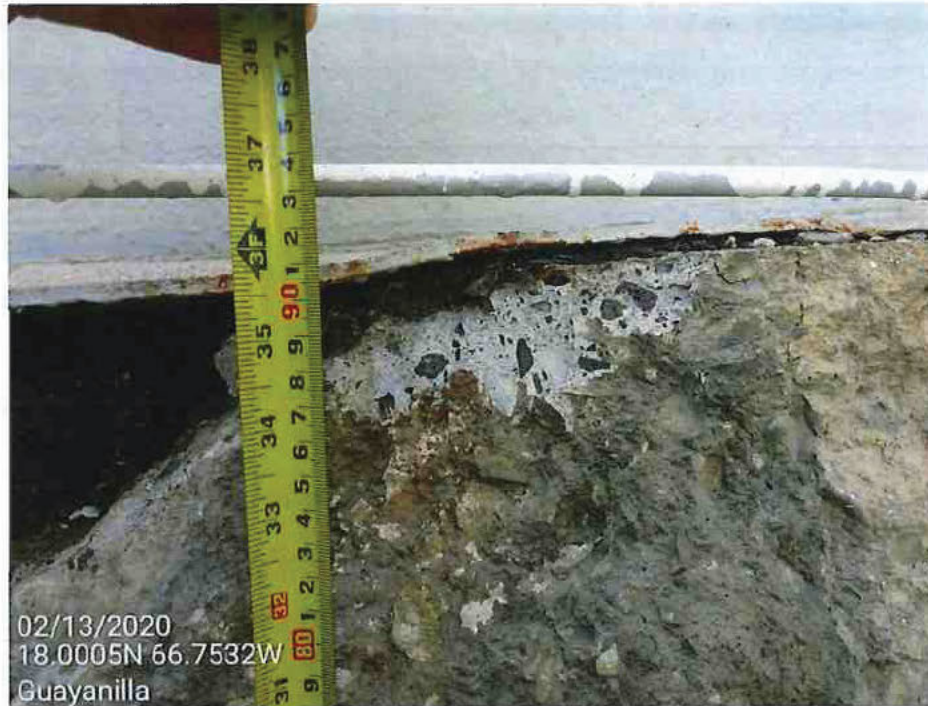
Picture 46 – Foundation concrete base is about 36" high.

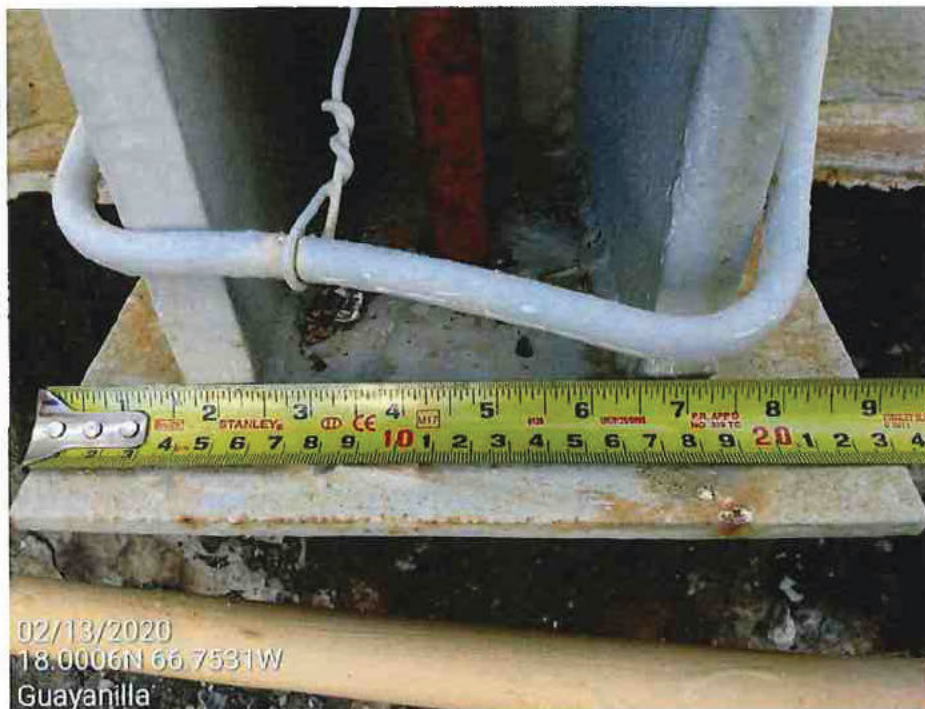
Picture 47 – Anchor assembly chair bottom plate measurements.
